STM32F427/437xx and STM32F429/439xx

Errata sheet

STM32F427/437 and STM32F429/439 device errata

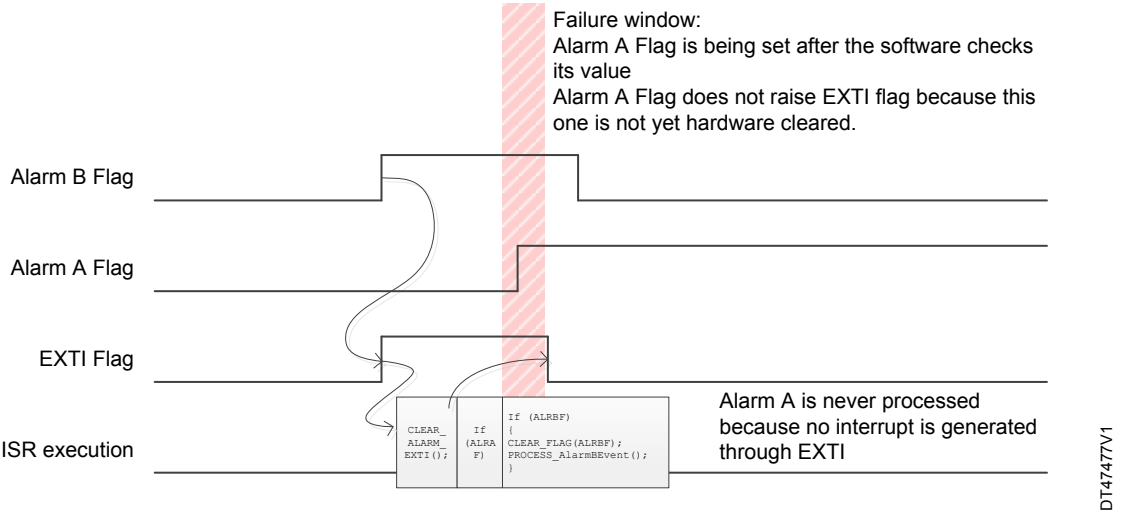
Figure 1. Masked RTC interrupt

The following code example and figure illustrate the failure mechanism: The Alarm A event is lost (fails to generate interrupt) as it occurs in the failure window, that is, after checking the Alarm A event flag but before the effective clear of the EXTI interrupt flag by hardware. The effective clear of the EXTI interrupt flag is delayed with respect to the software instruction to clear it.
