STM32F469xx and STM32F479xx device errata

Applicability

This document applies to the part numbers of STM32F469xx/STM32F479xx devices and the device variants as stated in this page.

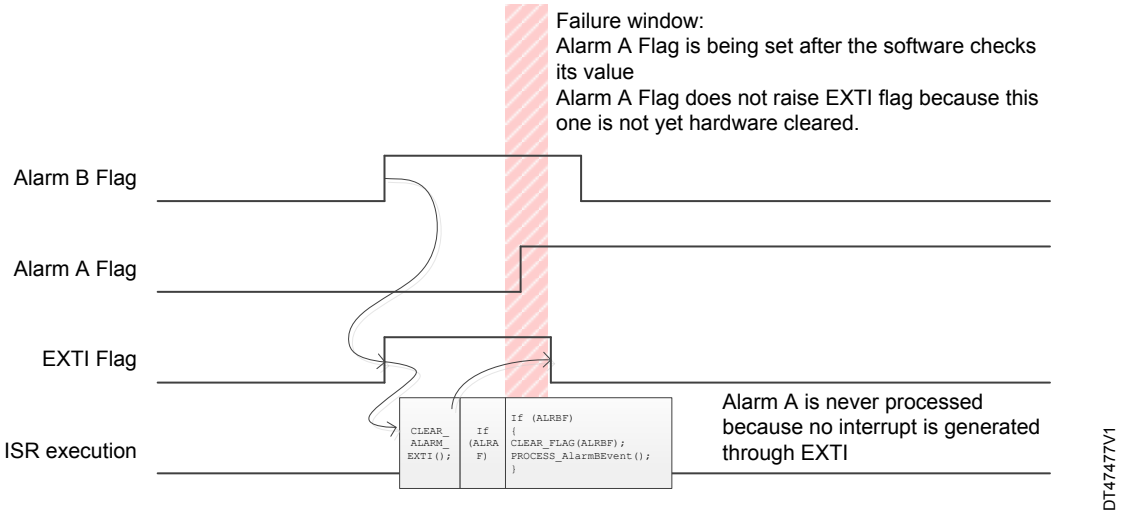
Figure 1. Masked RTC interrupt

The following code example and figure illustrate the failure mechanism: The Alarm A event is lost (fails to generate interrupt) as it occurs in the failure window, that is, after checking the Alarm A event flag but before the effective clear of the EXTI interrupt flag by hardware. The effective clear of the EXTI interrupt flag is delayed with respect to the software instruction to clear it.
