Loss Solutions Group, LLC
Toll Free 866.899.8756
Fax 860.639.5158
www.LossSolutionsGroup.com

RE:	Insured:	LIQUID 8 TECHNOLOGY, INC.
	Claimant:	BROOKFIELD PROPERTIES NEW YORK
	Claim Number:	F8J0848
	LSG Matter Number:	787200.12801-00
	Date of Loss:	September 8, 2025

Loss Solutions Group was contacted by Ms. Kate Raab of Travelers Insurance. The scope of this assignment was to assess the extent of damage and salvage value associated with the claimant's Secure USA-branded wedge-type barrier/security gate unit that sustained damage during a vehicle accident event on September 8, 2025.

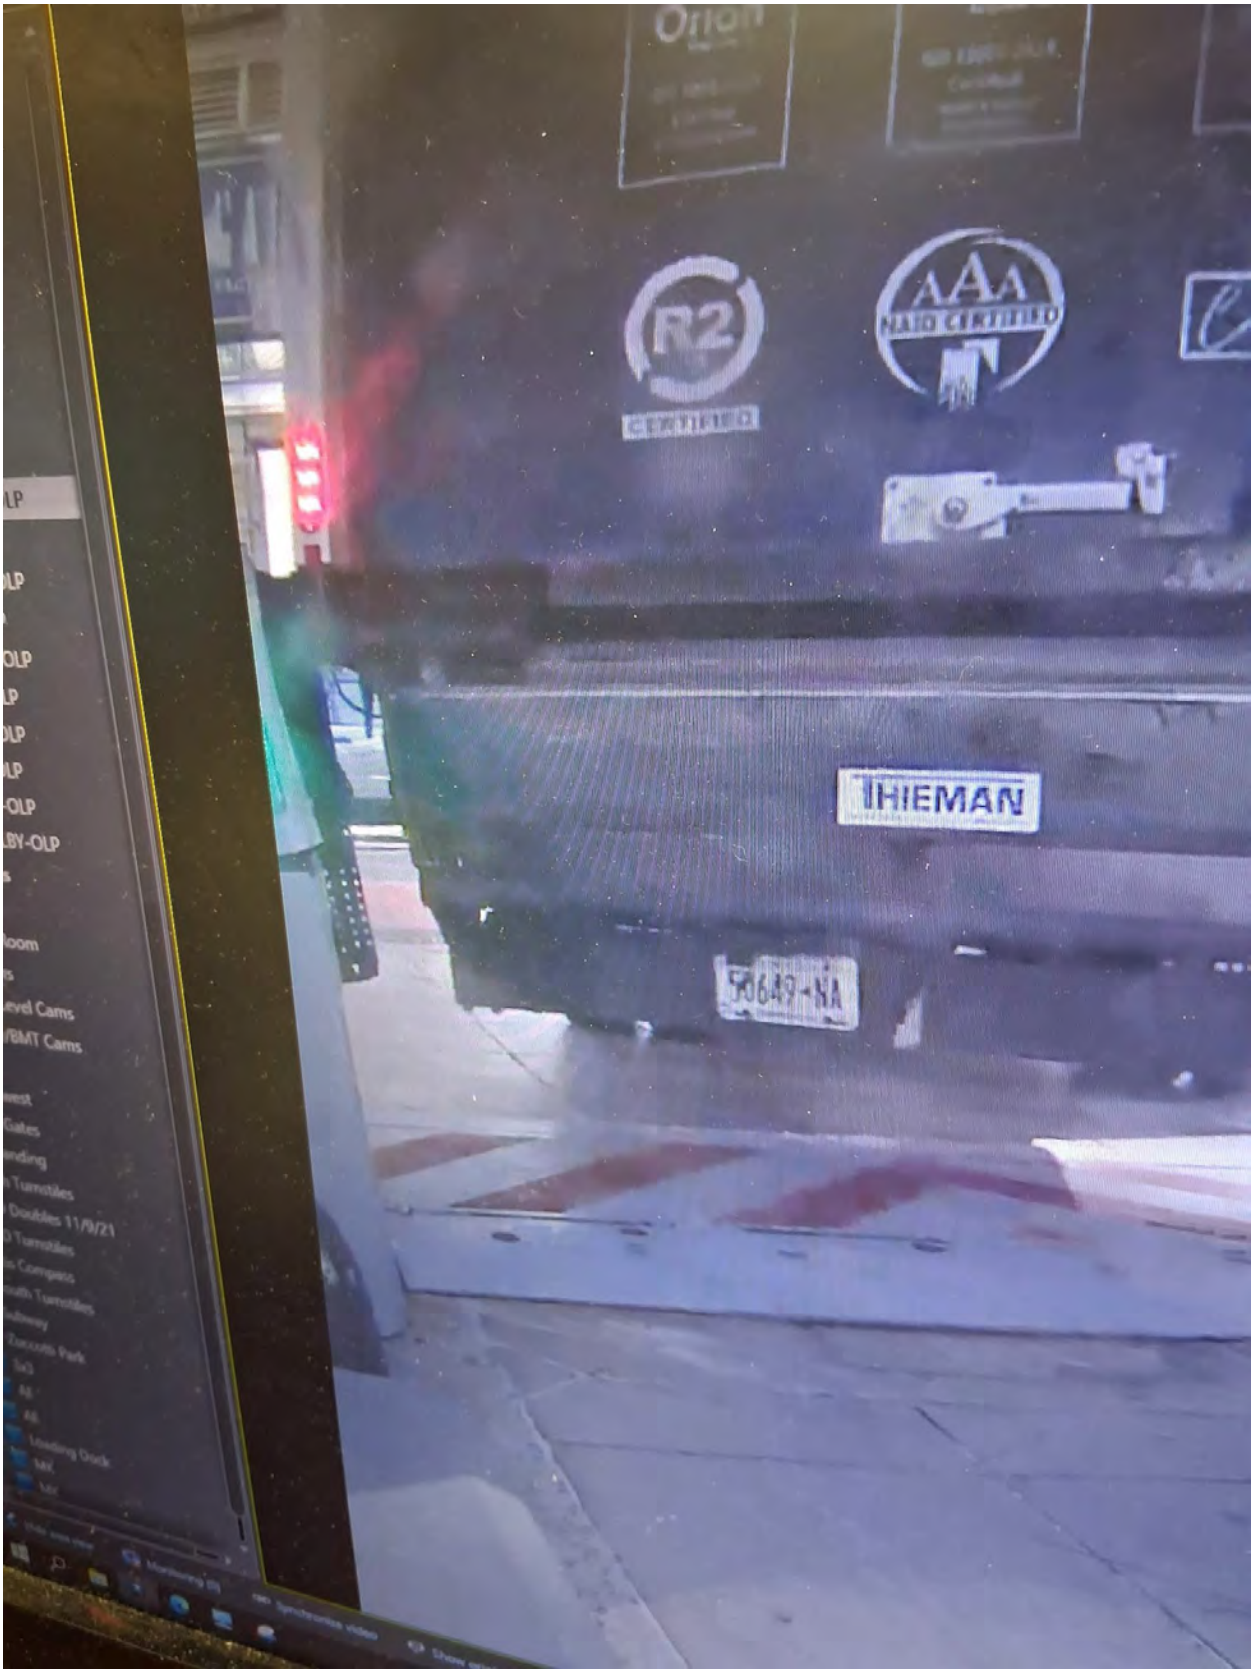
Responded to emergency service call on 9/9 that wedge barrier was struck by truck and not functioning properly.
Disassembled housing to inspect unit.
Upon inspection found broken gearbox shaft and gate arm motor. Also found visible damage to housing.
Re-installed housing and left barrier out of commission.
Supply labor and materials to remove and replace gear box assembly and gate arm motor.
Supply labor and materials to make cosmetic repairs as best possible to barrier housing.
Disassemble housing and set aside.
Disconnect gate arm motor and discard
Disconnect gearbox assembly and discard.
Supply and install new gear box assembly.
Supply and install new gate arm motor.
Straighten, Bondo and paint barrier housing as needed.
Run system to check for proper operation. Any other defects found will be reported back to customer for additional repairs.
All work to be performed on regular business hours by OSHA approved personnel.
