RE:	Insured:	Spare Time Inc.
	Claim Number:	85-00893419
	LSG Matter Number:	426600.4162-00
	Date of Loss:	December 24, 2025

Loss Solutions Group was contacted by Ms. Teri Tucker of Hanover Insurance. The scope of this assignment was to assess the extent of damage and salvage value associated with the insured's two (2) Trane-branded ten (10) ton packaged HVAC units that sustained damage during a vandalism/theft event on December 24, 2025.

Scope of Damage

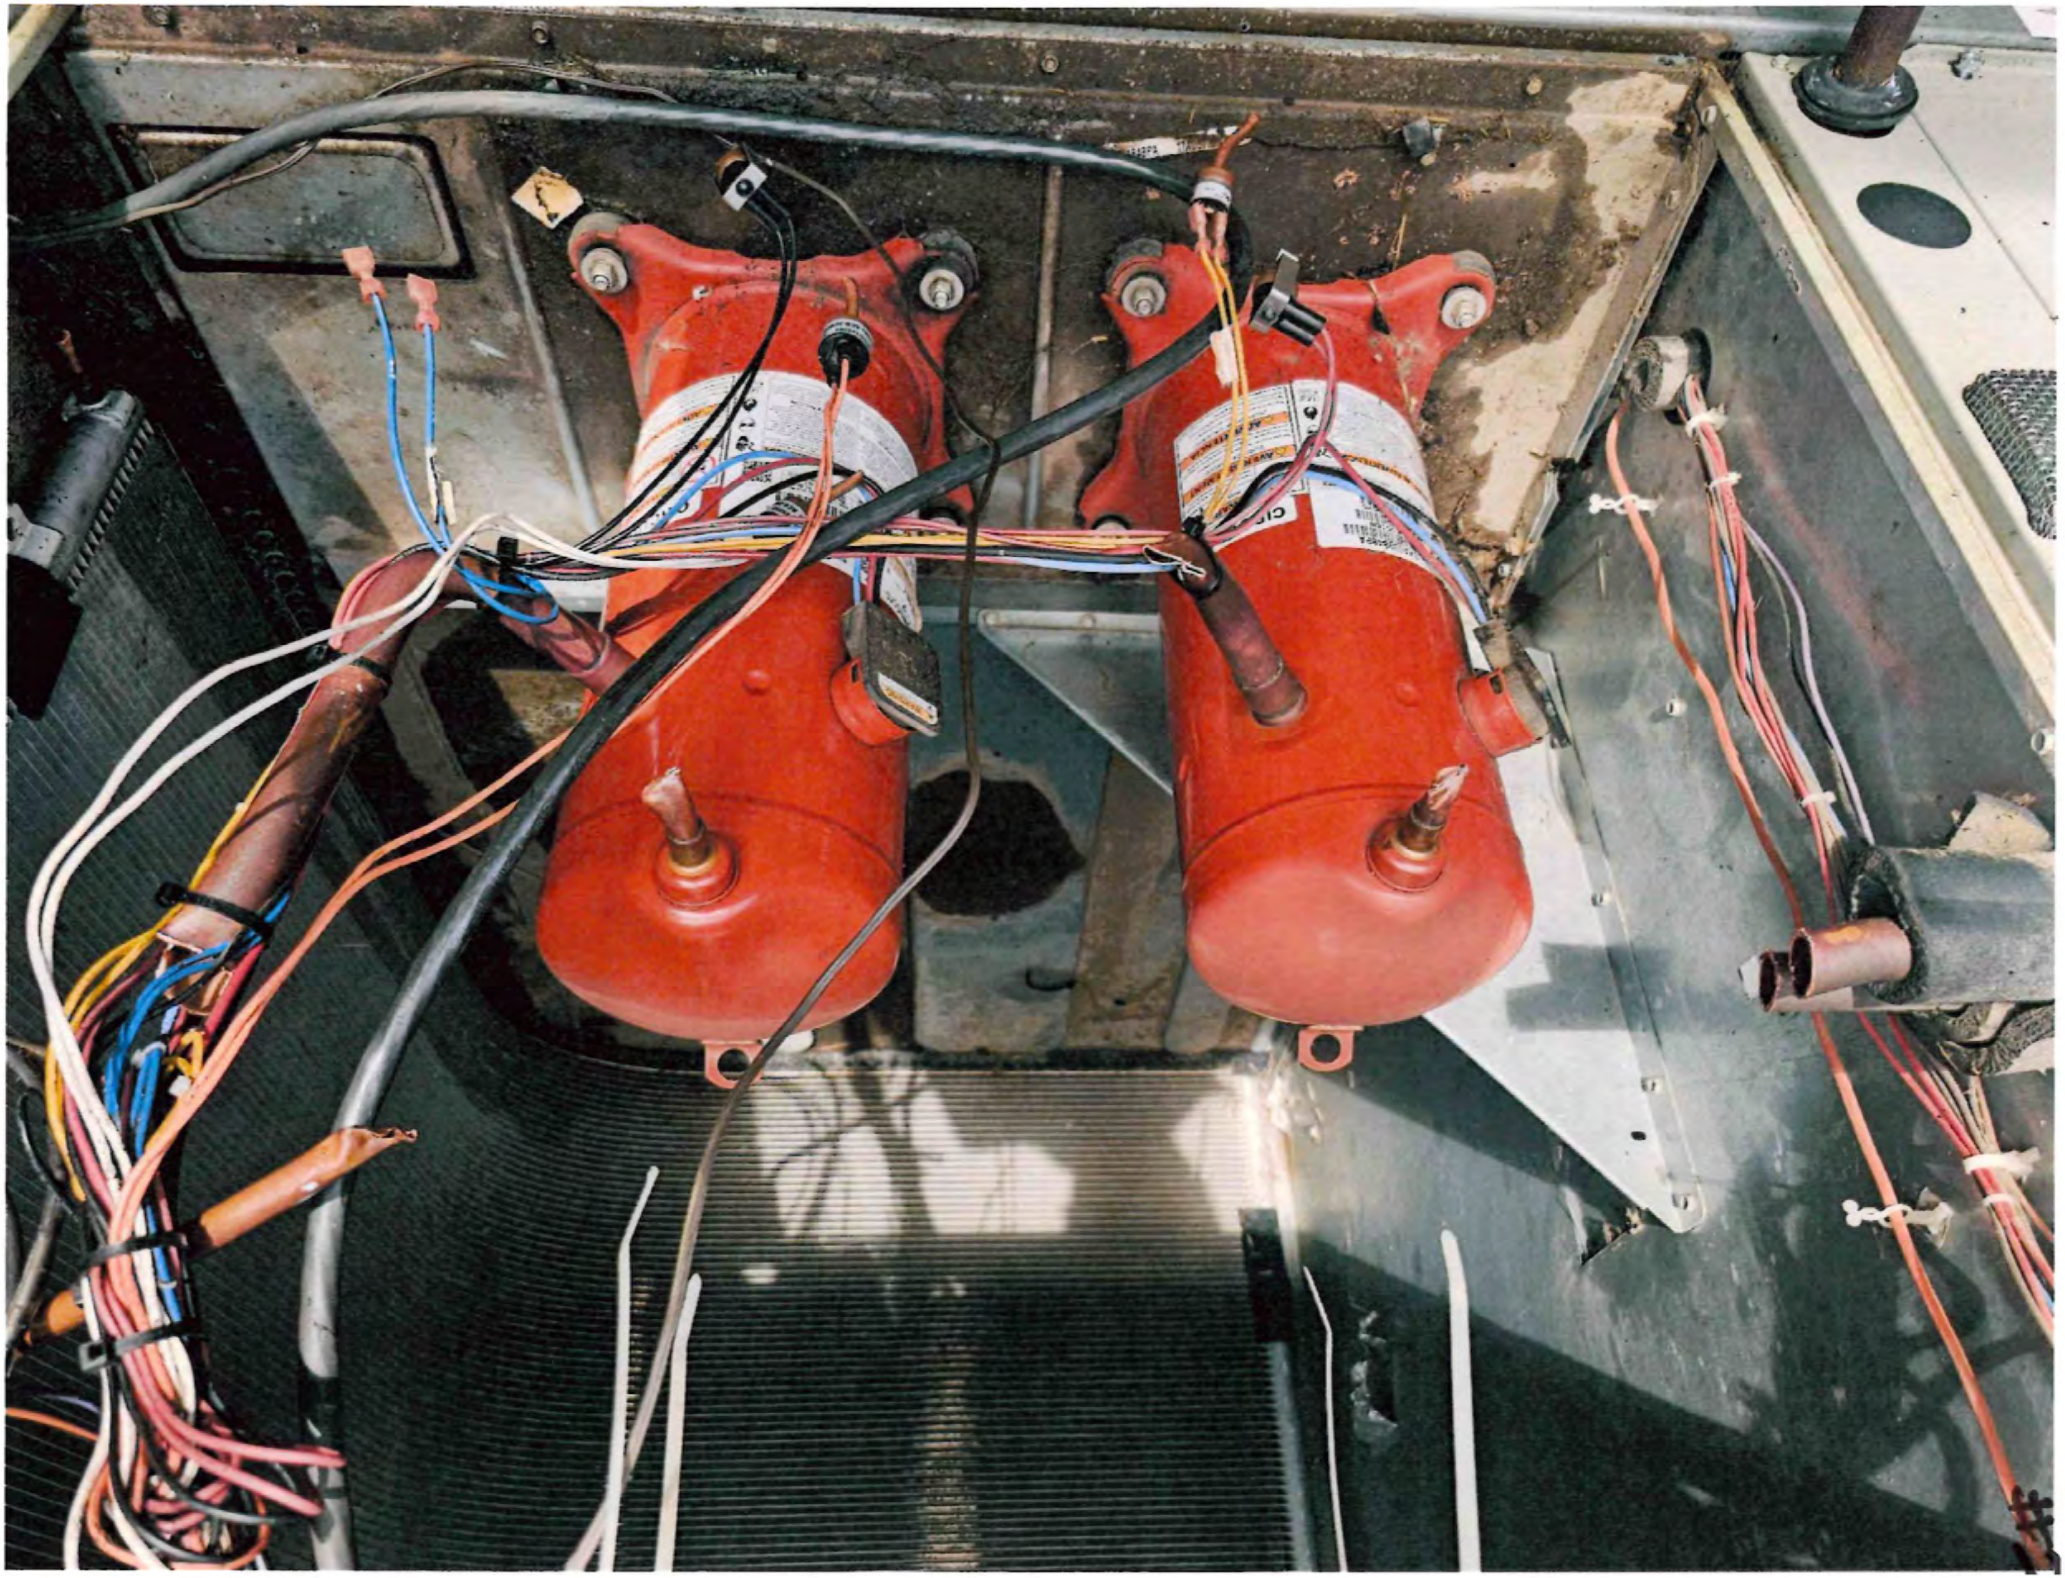
TOTAL LOSS UNIT - BACK WEST UNIT
FRONT #1

TOTAL LOSS UNIT - FRONT WEST UNIT
FRONT #2

REPAIR UNIT EAST SIDE BACK #2 #1

TOTAL LOSS UNIT #3 WEST SIDE BACK

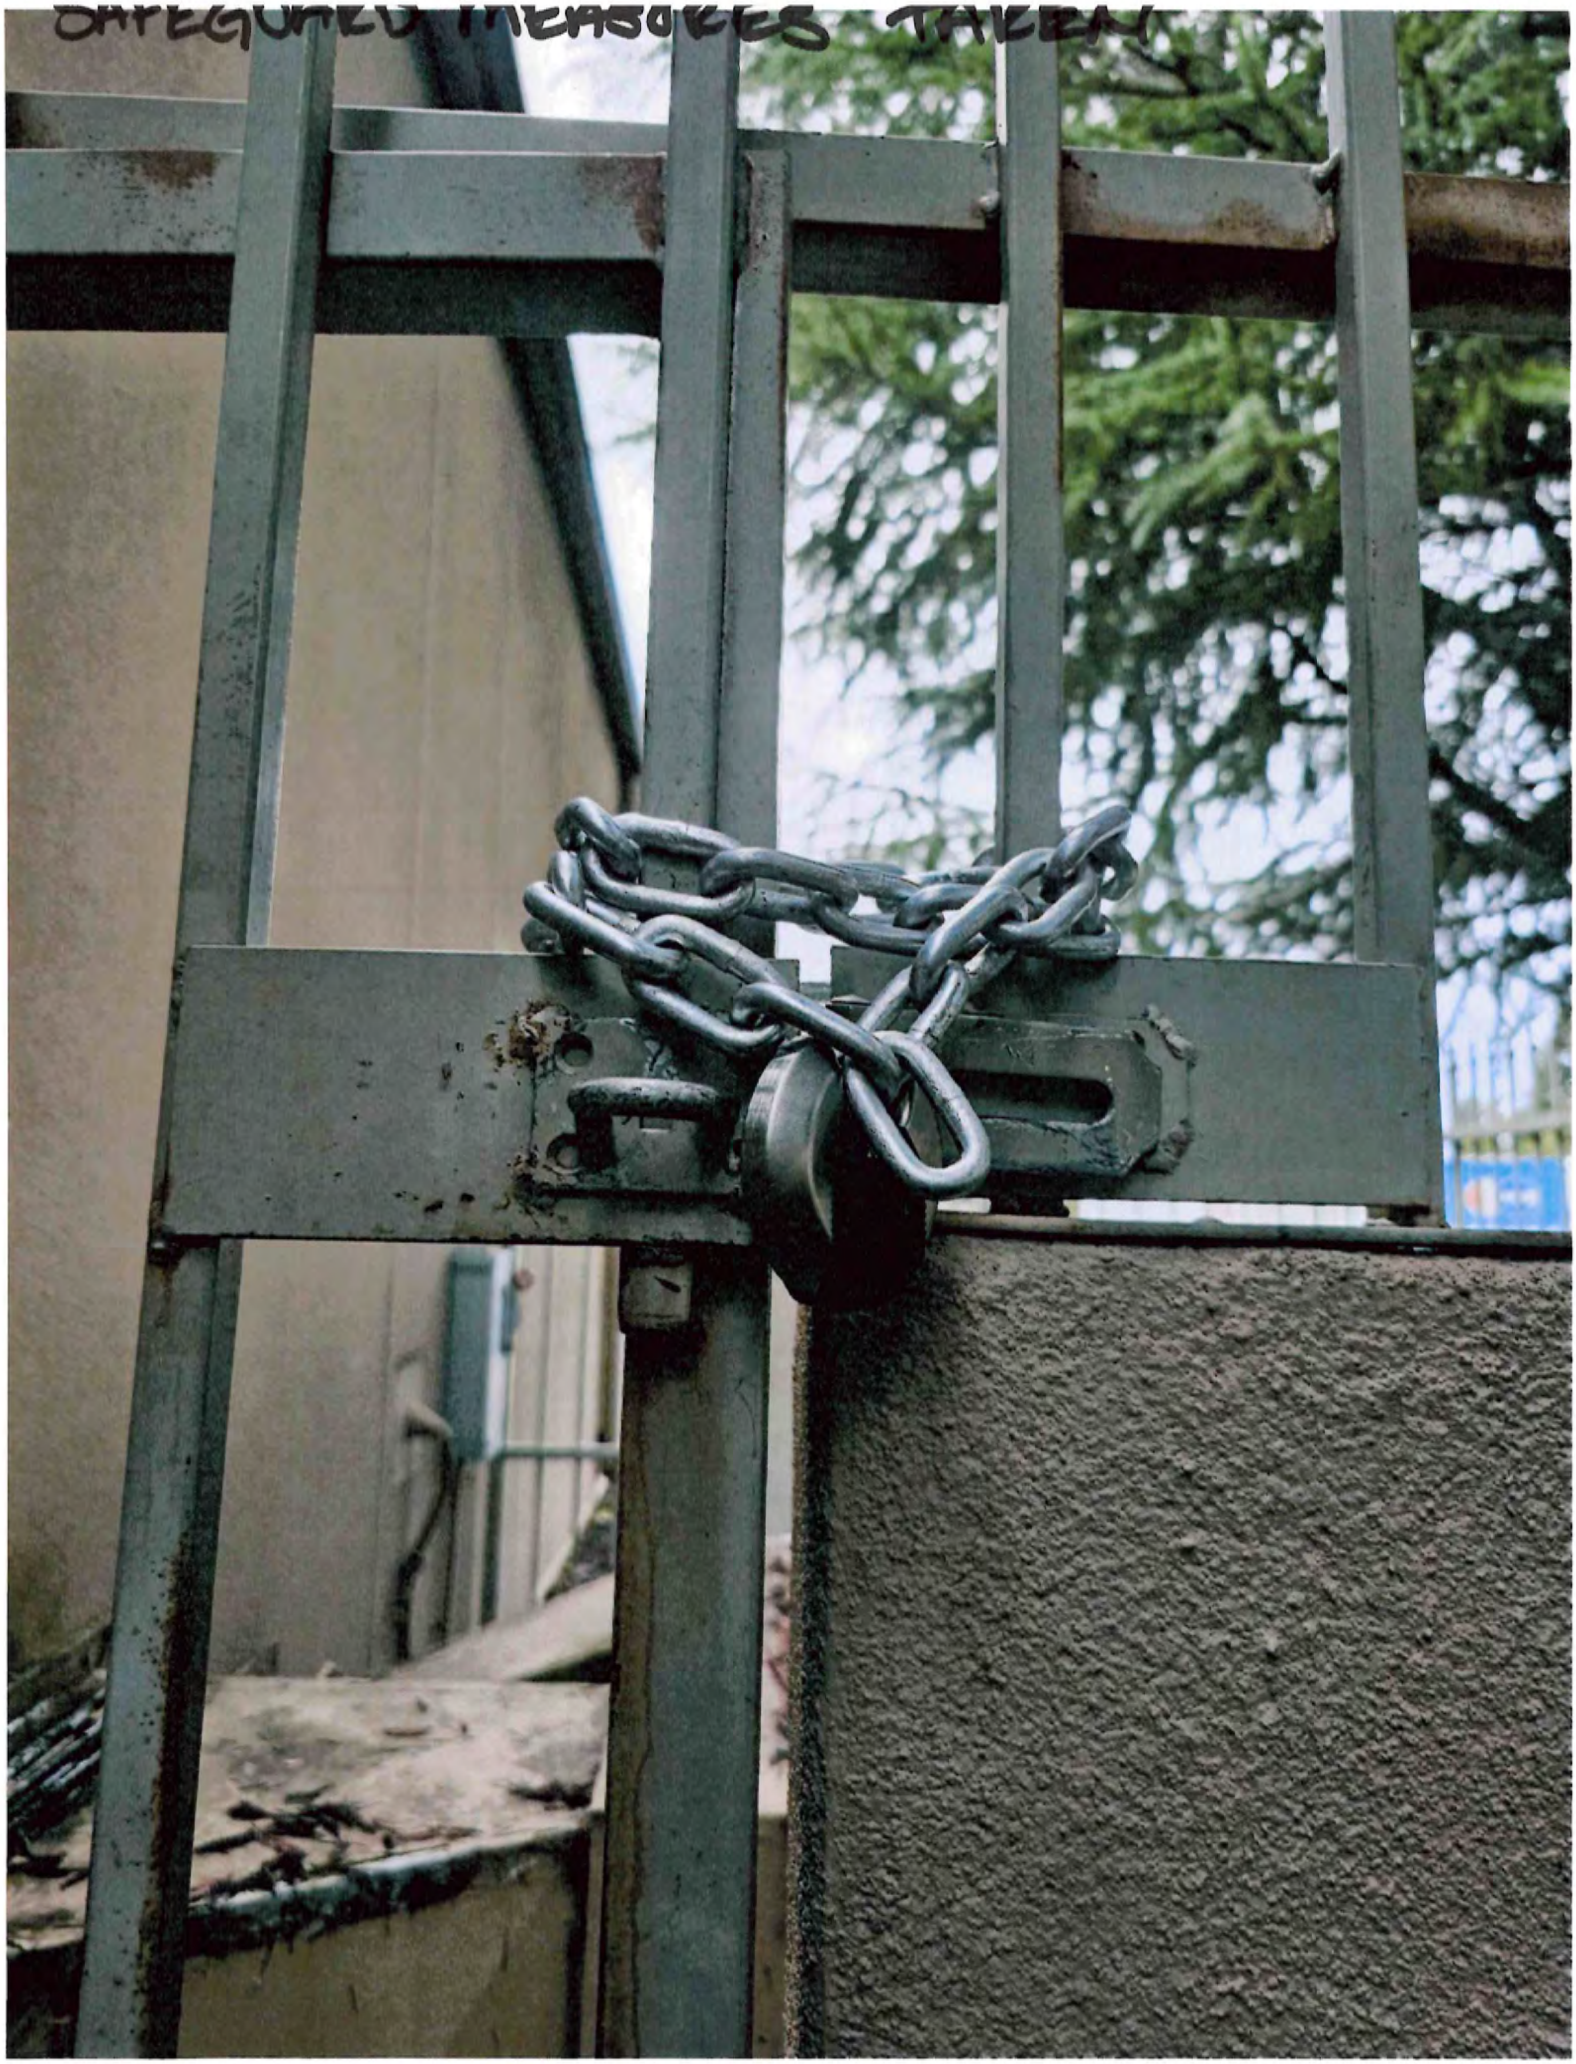
PRESSURES MEASURED TAKEN

SAFEGUARD MEASURES TAKEN
