MCDU-40-2024-067533

CDU sustained major damage when it was dropped from a forklift onto its left side. The incident took place on-site at NAL1-DC1 in New Albany Ohio.

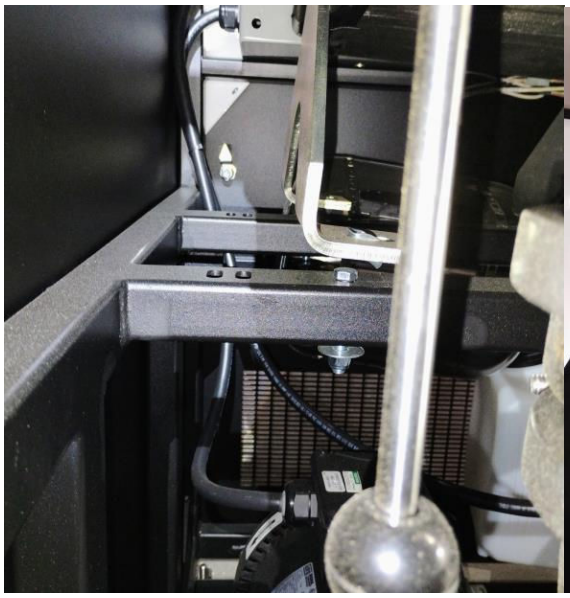
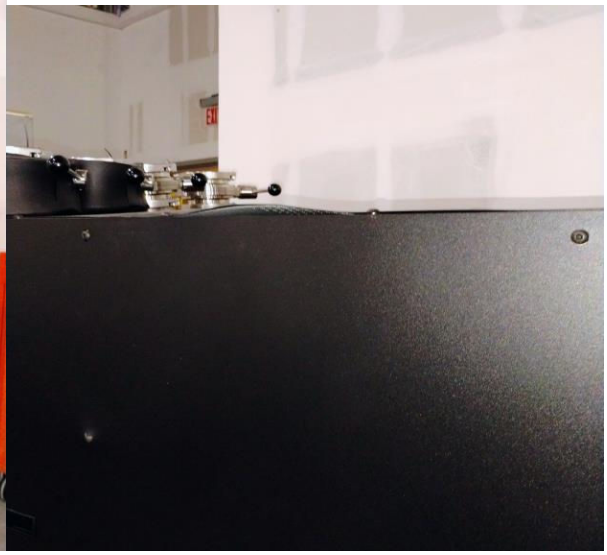
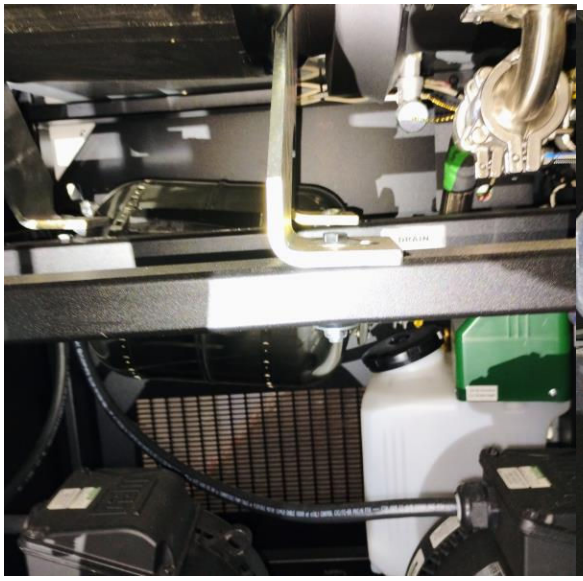
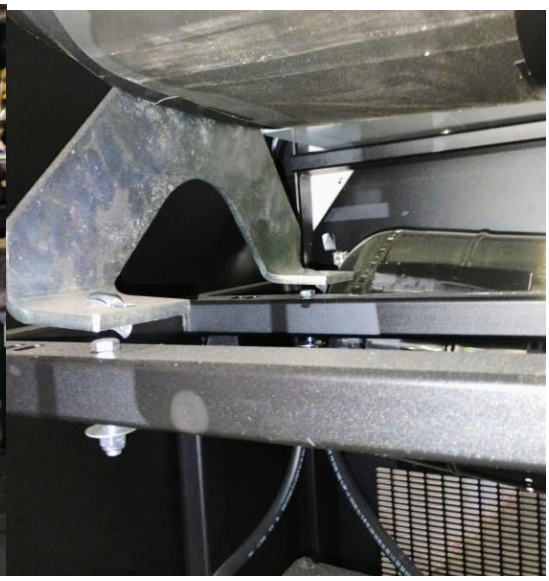
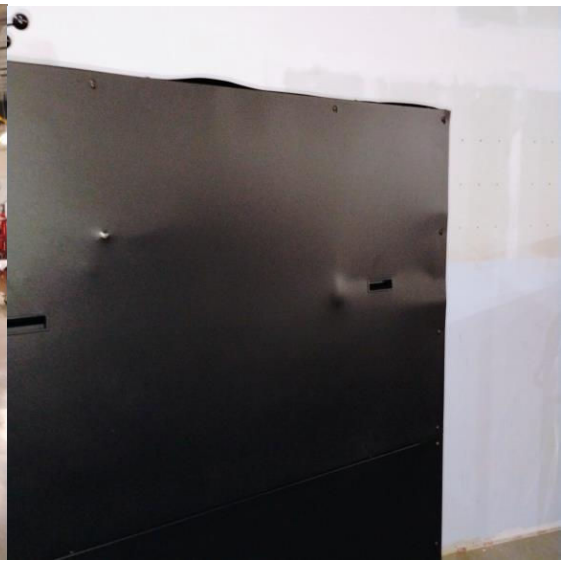
CDU shows extensive internal and external damage. The Belimo Actuator Valve punched a heavy indent on the left side of the cabinet and the top panel also buckled upon impact. Support brackets for the Heat Exchanger are bent on the left side and broken off completely on the right side of the unit. The Primary and Secondary Source / Return pipes are also bent and shifted out of place along with connected internal piping.
