# TORSIONAL NATURAL FREQUENCIES: MEASUREMENT VS. PREDICTION

## ABSTRACT

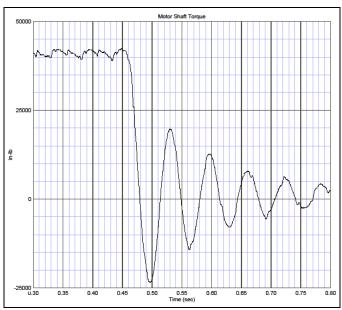
Figure 10. Free Torsional Vibration after Trip Event.

An example is shown in Figure 10. By examining the period of vibration, the first TNF was approximately 15 Hz. The damping can be determined from the logarithmic decrement,  $\delta$ , which was approximately 0.44. This converted to a damping ratio  $\zeta$  of 0.07 and an amplification factor AF of approximately 7 (see Randall, 1990 for detailed explanations). This system had a VFD motor and MVR (mechanical vapor recompression) fan with a rubber coupling, which had a reported dynamic magnifier of 8. Therefore, the measurements confirmed the analytical results.

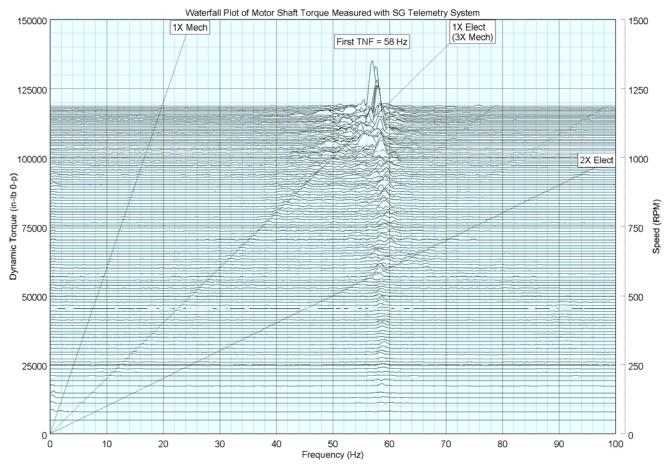
Figure 21. Waterfall Plot of Dynamic Torque.

To help diagnose the actual cause of the coupling failure, field tests were performed. The torque was measured using a wireless strain gage telemetry system mounted on the motor shaft extension near the coupling hub. See APPENDIX for various methods of measuring torsional vibration. The waterfall plot in Figure 21 shows the measured frequency spectra of the alternating torque versus speed. The first TNF of the system was identified at 58 Hz.

Torsional resonances occur when energy at multiples of mechanical running speed and electrical harmonics from the VFD intersect a TNF. Because the motor has 6 poles (3 pole pairs), the mechanical frequency will be approximately 20 Hz (1200 RPM) when the fundamental VFD frequency is 60 Hz, neglecting slip of the induction motor. High dynamic torque in the coupling was found when operating the fan from 1000 to 1200 RPM due to excitation at the 1× electrical frequency of the VFD.

Because the fan normally operates between 1000 RPM and 1200 RPM, which was the speed range where excessive dynamic torque occurred, this is believed to be the reason for the coupling failure. For example, the VFD excitation was approximately 5% of the full load torque (FLT) and at torsional resonance the dynamic torque is amplified by a factor of 30. Therefore, the maximum alternating torque in the coupling was approximately 150% of the transmitted torque, which exceeded the rating from the manufacturer.

Since switching back to the original motor was not an option; a temporary solution was recommended where the running speed should be limited to a maximum motor speed of 1000 RPM (VFD frequency of 50 Hz) to avoid exciting the first TNF at 58 Hz. This provided a SM of 13% between the VFD excitation frequency and the first TNF of the system.

A torsional analysis of the system was performed and normalized to match the measured field data. Based on the results of the computer analysis, an alternate coupling was selected to detune the TNF away from the 1× electrical frequency of the VFD. A coupling with elastomer blocks in compression (Figure 22) generally has a lower torsional stiffness than a flexible disc coupling and provides additional damping. The damping reduces the dynamic torque when operating near resonance. Elastomeric couplings in compression are often used on large VFD motor / fan systems found at power plants.

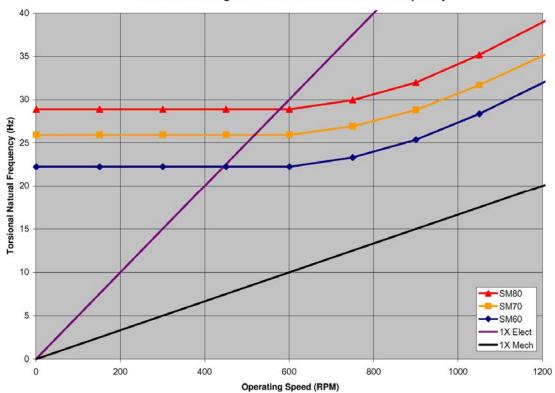
Figure 23. Campbell Diagram.

In the case study from Alexander, et al., (2010), the instability occurred at a VFD operating frequency 20% - 30% above the first TNF, which was well outside the API separation margin of concern; therefore, a steady-state analysis performed according to API would not predict or prevent this type of torsional problem. Therefore, the VFD must be properly tuned during commissioning.

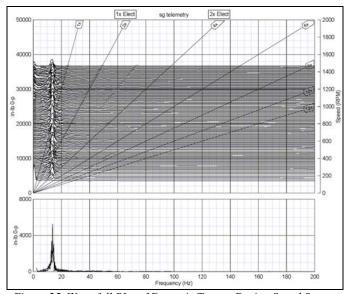
Figure 25. Waterfall Plot of Dynamic Torque During Speed Sweep.

Some load was applied to the compressor, but since the plant was not in operation, a true full-load evaluation was not possible. It was found that the first TNF was continually excited by the VFD when in Direct Torque Control Mode as shown in Figure 25. Based on the modeshapes, it is believed that the first TNF and not the second TNF was responsible for the coupling failures.

The action of the drive control system is to continuously adjust the power to precisely maintain the speed of the motor. These adjustments can excite the first TNF and put high stresses on the low speed coupling. It was shown that the control system was very sensitive to the time delay parameter. When the time constant was changed to 50 milliseconds, the dynamic torque increased dramatically, although the system was operating well away from the first TNF.

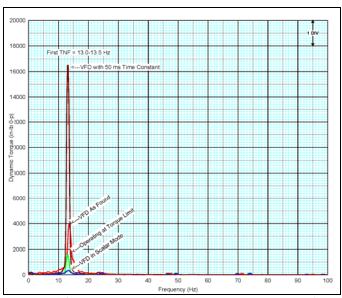
Figure 26. Comparison of Various VFD Operating Modes.

When switched to the basic control method of Scalar Mode without any virtual feedback loops, the excitation was greatly reduced as shown in Figure 26. Note that nothing in the mechanical system was changed, only the operating mode of the VFD was switched.

The motor speed is not accurately controlled in the Scalar Mode, but this was not required for the process. Scalar Mode is used in the factory to test motors, but could not be used in the field because of loss of protections. During one test run, it was found that the current spiked, and the motor had to be tripped. It was later concluded that the VFD may have run out of voltage indicating a possible problem with the line power supply at the plant.
