To,
THE PRESIDENT,
LAXMI NIVAS, OWNERS' WELFARE ASSOCIATION,
NAGARJUNA HOMES, NIZAMPET, HYDERABAD.

Dear Sir,
Sub: Inspection Report for Leakage Issues.

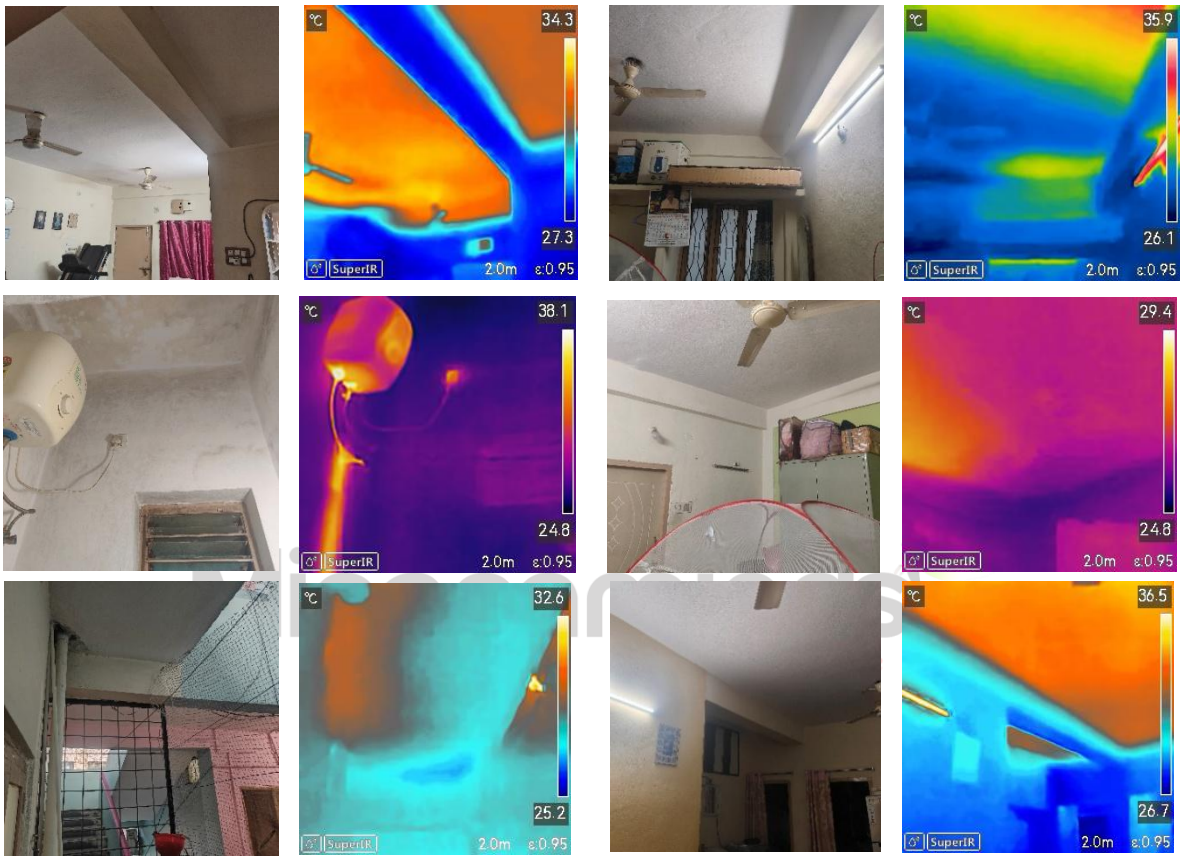
Flat No. 404

Observations

- Extensive damp patches observed on multiple wall surfaces.
- Severe paint peeling and surface deterioration evident.
- Thermal scans show widespread moisture activity.
- Condition indicates long-term and continuous seepage.

Findings

- Long-standing seepage confirmed.
- Likely caused by external wall seepage and/or water migration from upper-floor wet areas.
- Comprehensive remedial treatment is required.

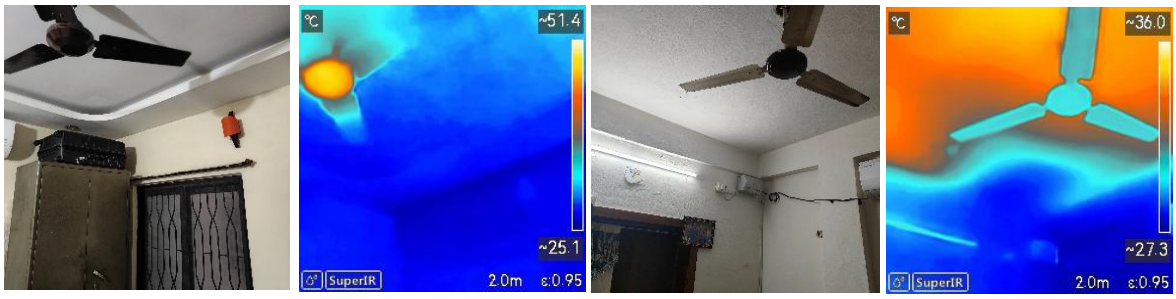
Flat No. 410

Observations

- Visible dampness and paint failure observed near wall junctions.
- Moisture concentration aligns with concealed plumbing routes.

- Thermal scans show clear temperature variations indicating active seepage.

Findings

- Active moisture ingress confirmed.
- Likely source is leakage from adjacent flat plumbing lines.
- Prompt rectification is necessary to prevent spread.

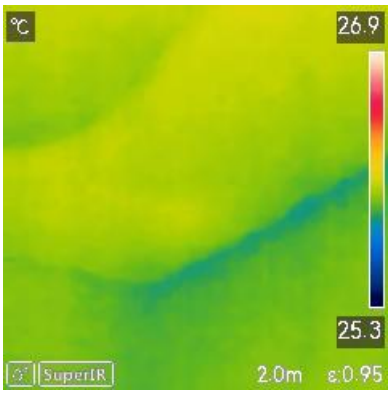
Flat No. 411

Observations

- Minor damp markings observed on wall surfaces.
- Paint condition largely intact with no major peeling.
- Thermal images show isolated moisture zones.
- Dampness appears recent and limited in extent.

Findings

- Early-stage localized seepage detected.
- Preventive waterproofing and periodic monitoring recommended.

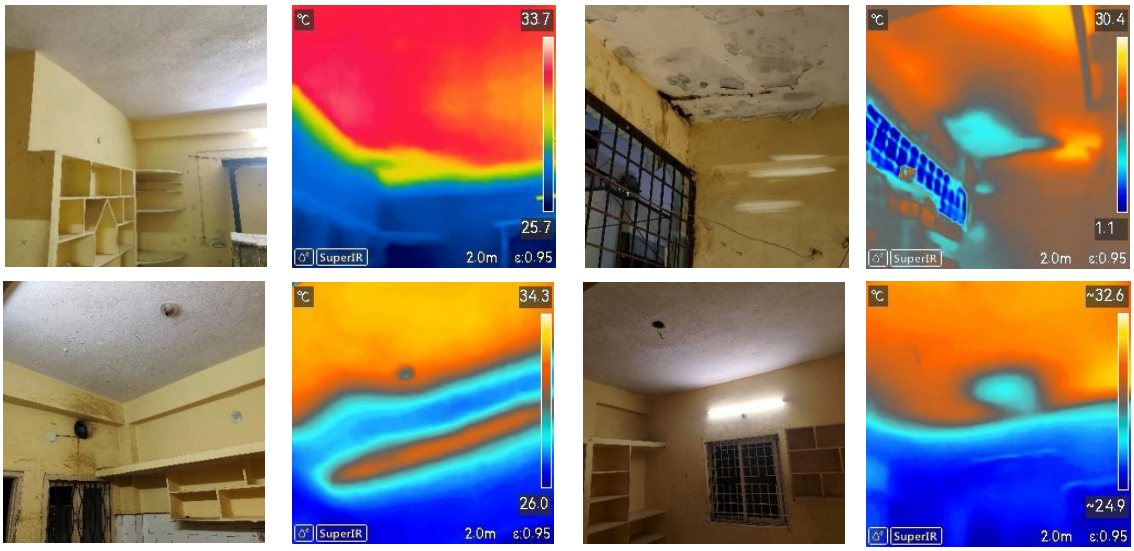
Flat No. 412

Observations

- Damp patches with peeling paint observed on internal walls.
- Plaster shows moisture-related distress.
- Thermal scans indicate multiple active moisture zones.
- Dampness severity higher compared to neighboring flats.

Findings

- Active seepage condition confirmed.
- Possible sources include concealed plumbing leakage and overhead wet areas.

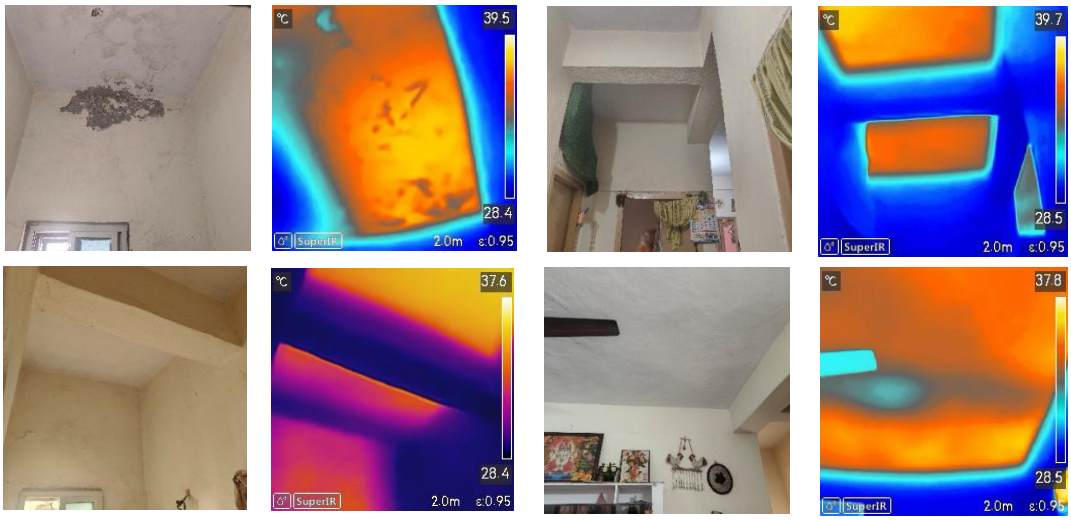
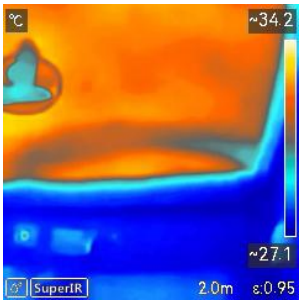
Flat No. 501

Observations

- Severe dampness observed on walls and ceilings.
- Extensive paint failure and plaster deterioration evident.
- Thermal images show widespread moisture presence.
- Dampness pattern clearly indicates an overhead source.

Findings

- Chronic moisture ingress confirmed.
- Strongly linked to terrace waterproofing failure.
- Terrace-level intervention is critical.

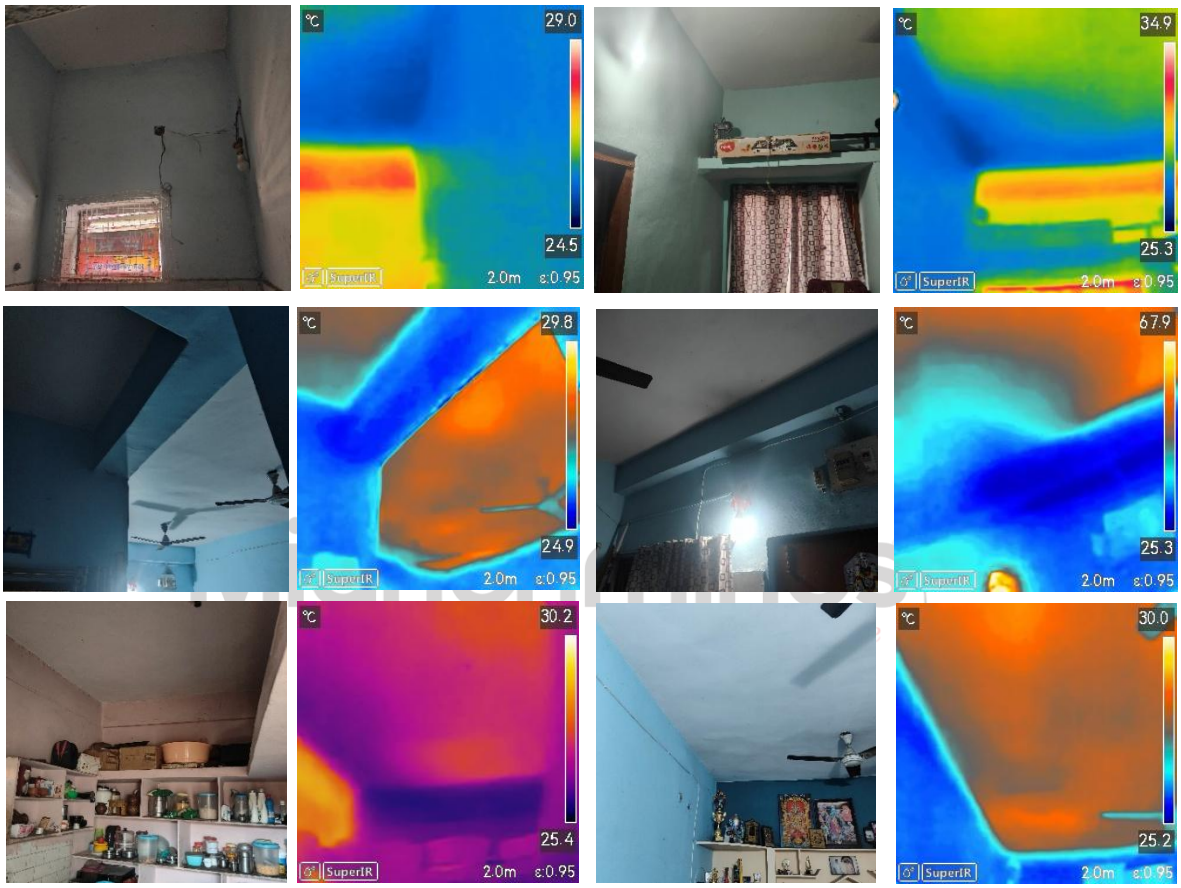
Flat No. 503

Observations

- Linear water stains observed on wall surfaces.
- Paint deterioration follows concealed service line routes.
- Thermal images show linear moisture patterns.
- Dampness consistent along plumbing/service lines.

Findings

- Seepage likely due to concealed plumbing leakage.
- Moisture migration along service lines confirmed.
