MIGNON MINDS LLP
42 & 43 Shop No. A6,
Praneeth Pranav Blooms,
Bowrampet, Hyderabad - 500043.

Dear Madam,
Sub: Inspection Report & Recommended Remedial Measures for Leakage Issues.

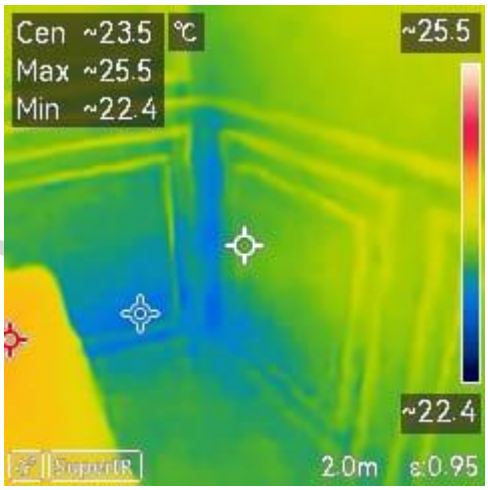
Entrance Internal Wall & Surface Conditions

- Extensive moisture damage was observed on internal walls, evidenced by discoloration and deterioration of paint finishes.
- Decorative areas showed clear signs of moisture impact and loss of adhesion.

- ✓ Remove damaged paint, putty, and loose plaster from affected areas.
- ✓ Allow surfaces to dry thoroughly.
- ✓ Apply damp-proof / waterproof internal coating wherever required.
- ✓ Re-apply waterproof wall putty.
- ✓ Repaint using high-quality anti-fungal interior emulsion paint.

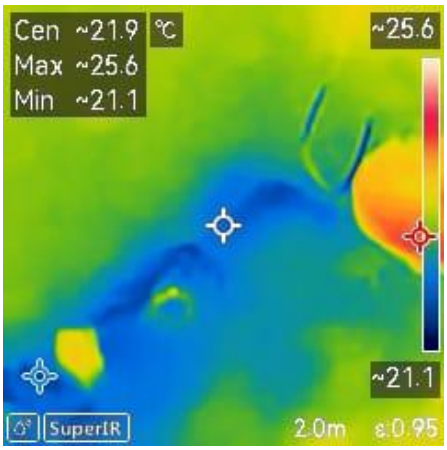
- Water seepage was identified originating from the bathroom area and migrating through walls into adjacent hall and utility spaces.
- Signs of rising damp were observed, possibly due to capillary action from floor level.
- Leakage is further aggravated by ineffective sealing at slab–wall junctions and sanitary fixture interfaces.

- ✓ Seal slab-to-wall junctions using a flexible waterproof sealant.
- ✓ Apply waterproof coating on slab undersides and adjoining wall surfaces.
- ✓ Check and correct floor slopes wherever required to ensure proper drainage.
- ✓ Seal all window frame gaps using PU / elastomeric sealant.
- ✓ Close and waterproof all AC pipe entry points.

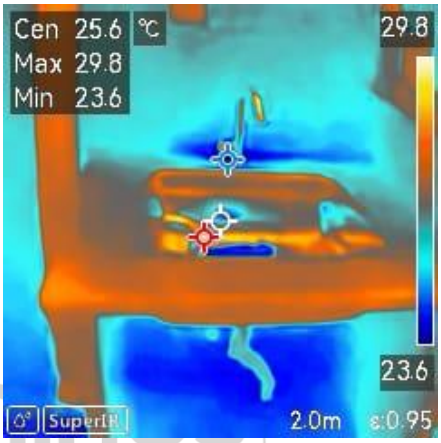
Flooring & Tiled Areas

- The bathroom and adjacent areas were recently renovated with new tiles and fresh grouting.
- Despite the recent works, persistent moisture and wetness were observed on floor surfaces.
- Presence of debris and unfinished materials indicates incomplete or improper finishing.
- Temperature differential readings indicate active water seepage beneath tiles and/or through grout lines.
- Possible causes include failure of grout curing or the absence of an effective waterproof sealing system.

- Removal of defective grout and sealant from floor and wall tile joints wherever required.
- Thorough cleaning and surface preparation of tiled areas.
- Application of waterproof grout / joint sealant to tile joints.
- Sealing of all sanitary fixture junctions (WC, wash basin, shower, taps) using silicone sealant.
- Testing of treated areas to ensure complete stoppage of seepage.
