# Calibration Report Brewer #157; Izaña, Spain; October 2-6, 2000

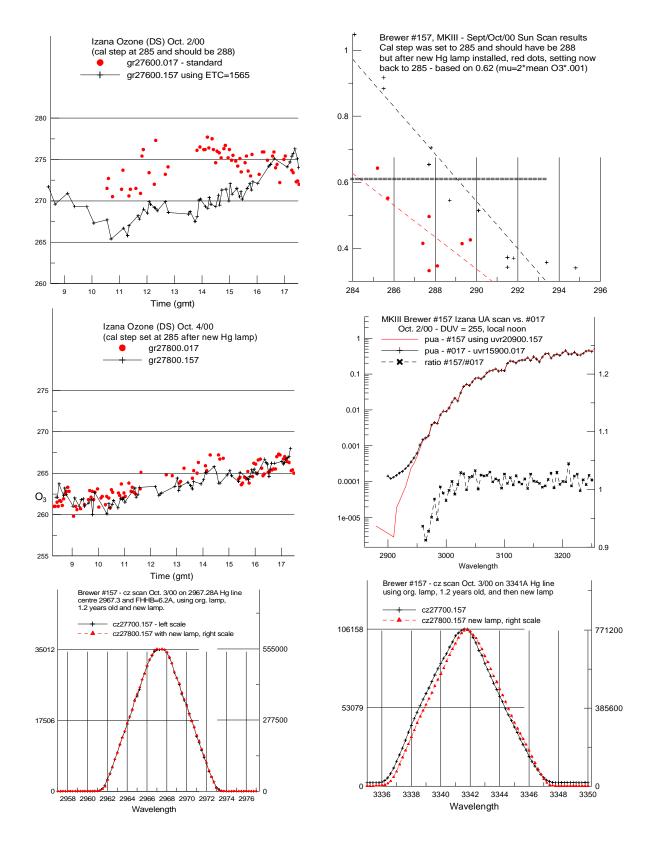
This inter-comparison resulted in approximately two hundred near simultaneous Direct Sun measurements of #157 with #017. The sun scan results showed (reference graph on next page) that the cal step should be 288 initially but changed back to 285 after a new Hg lamp was installed. The dispersion test results at step 285 produced an absorption coefficient of 0.342/1.15.

The dispersion test was completed (dcf27900.157) and results compared well to constants in use (dcf28898.157) and so no changes are recommended. A timed UA scan was completed with #017 and the irradiance agreement was very good, reference graph next page. A portable 1000w UV lamp system was delivered by IOS and was tested versus laboratory lamp system at Izana using local lamps. The comparison results are not known at this time.

To correct the past years ozone data of #157 consideration should be given to using revised absorption coefficients for the wavelengths being used. However it may be difficult to determine what period should be corrected. From the dispersion results the coefficients at step 288 would be 0.337 and 1.1343 for ozone/SO<sub>2</sub>. Sun scans (~6) should be completed every 3 months or just before and after Hg lamp change to monitor proper wavelength operation.
