BMW ZF 5-HP-30 NO REVERSE

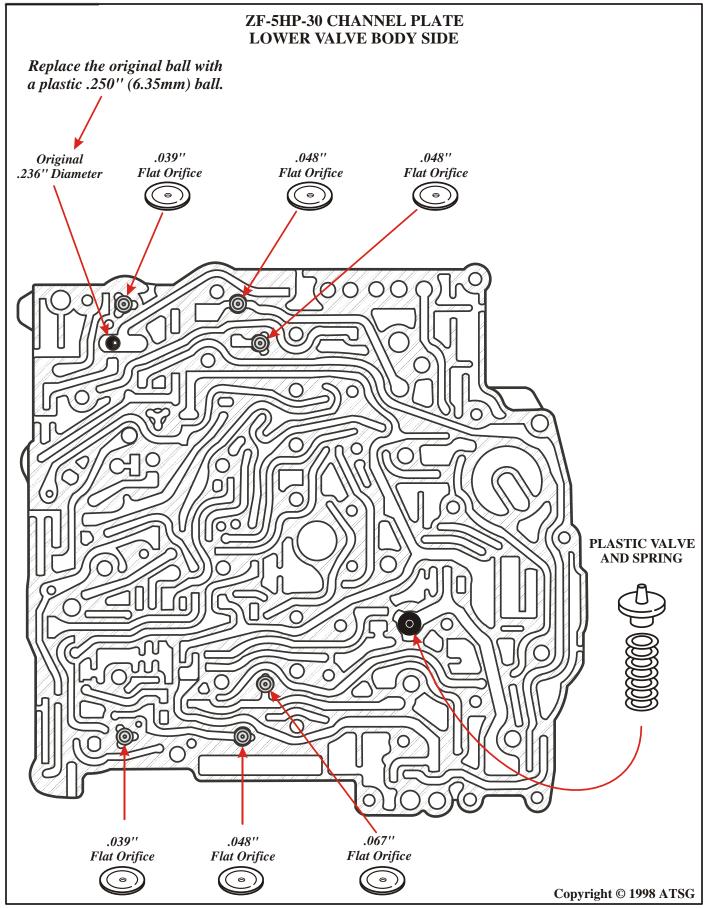
Figure 1
AUTOMATIC TRANSMISSION SERVICE GROUP

CAUSE: The cause may be, the .236" diameter checkball located in the bathtub in the channel plate

has blown through the spacer plate, which will now exhaust "F" clutch (Reverse) oil

pressure.

CORRECTION: Install a .250" diameter plastic checkball into the bathtub in the channel plate as shown in

Figure 1. The holes in the spacer plate over the bathtub measure .198" and the larger diameter checkball will greatly decrease the probability of this condition occurring again. There is also ample room in the bathtub for the increased diameter checkball to perform its duties. Refer to Figure 1. Figure 2 illustrates the location of the only other checkball in this

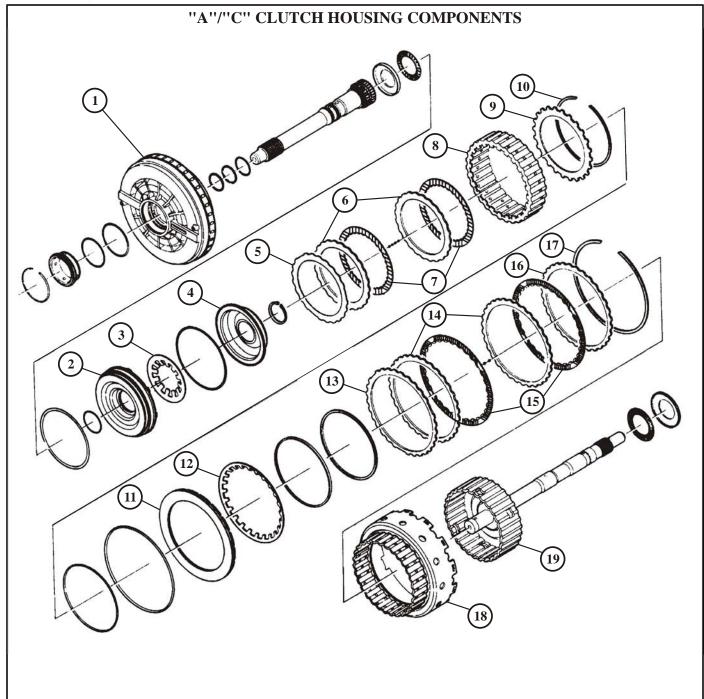
When the unit is removed and the "A"/"C" Clutch Housing is dis-assembled, it is not uncommon for the unit to set for over a week waiting on parts. When re-assembling it is very easy to *mis-assemble* the "B" Clutch Hub on top of the retaining snap ring for the "A" Clutch pack. This mis-assembly will create a neutralizing on the 3-4 upshift, and the Trans light will begin flashing.

Ensure that you assemble the "B" Clutch Hub on top of the "A" Clutch stack, and then

install the "A" Clutch Pressure Plate and snap ring, as shown in Figure 3.
