ALLISON MT545 ELECTRIC MODULATOR OPERATION

ELECTRIC MODULATOR OPERATION

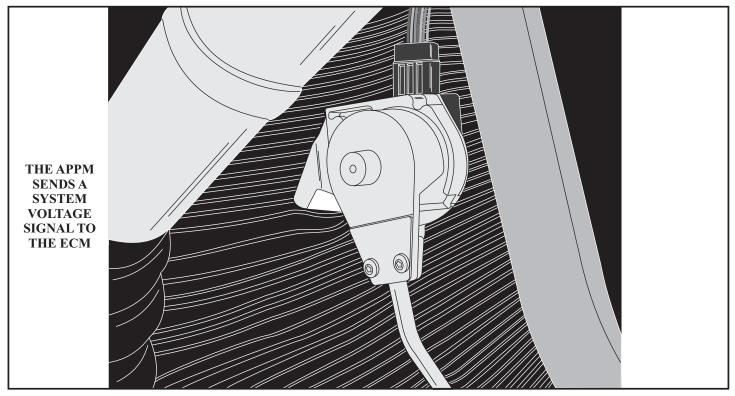
Figure 1

The components involved are the vehicles Engine Control Module, Accelerator Pedal Position Module, (See Figure 1), Modulator Control Relay, (See Figure 2), and the Electric Modulator, (See Figure 3).

If the APPM signal is faulty, the relay would not be energized or could be energized at all times.

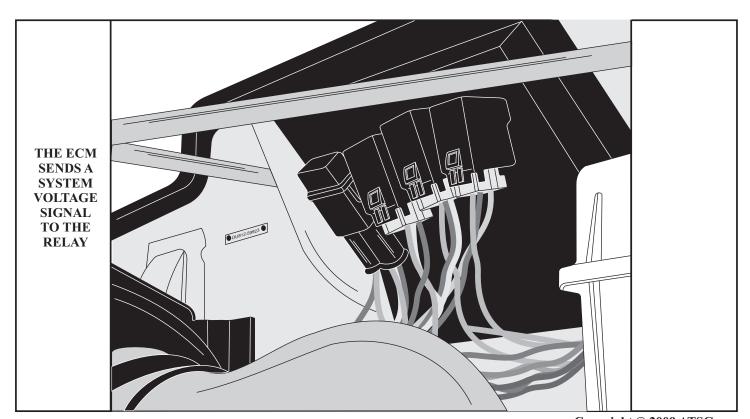
Figure 2

The relay could be open which would not energize the modulator or it could be stuck closed which would result in the modulator not withdrawing.

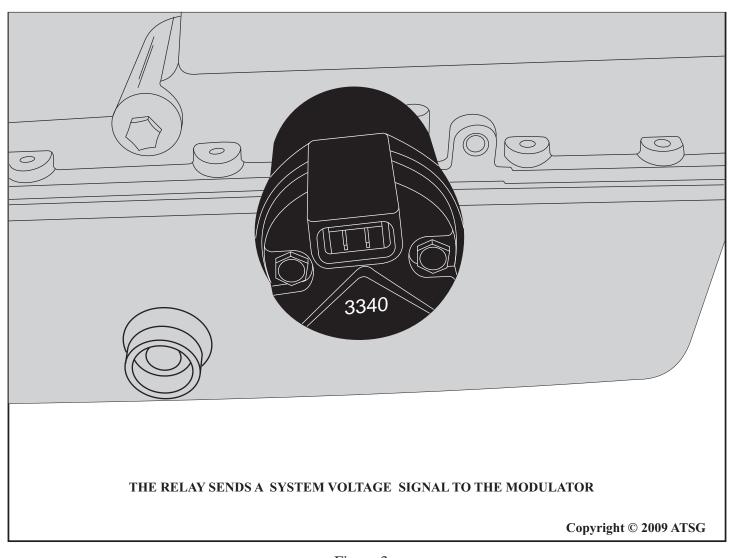
Figure 3

The modulator can be mechanically faulty if it is stuck in or out, or, it can be electrically faulty if it is shorted or open.

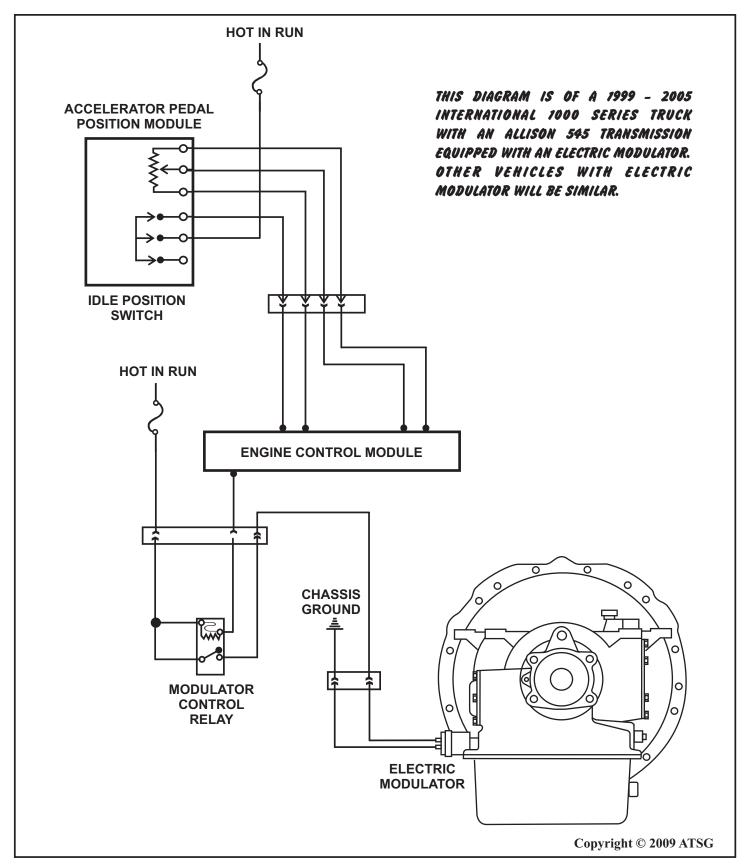
Figure 4

The modulator has two wires, one is from the relay which provides electricity to the modulator. The other is ground which is usually grounded to the chassis nearby. Check for system voltage to be present at the modulator on full throttle and no electricity when the throttle is released, (Refer to the wire diagram in Figure 4). In most cases the faulty component is usually the modulator or the relay.

ELECTRIC MODULATOR SYSTEM DIAGRAM
