FORD E4OD CHECK BALL CHANGE FOR 1990

There has been a change in checkball locations (CASE ONLY), for all 1990 model E4OD transmissions. Valve body locations remained the same as previous models.

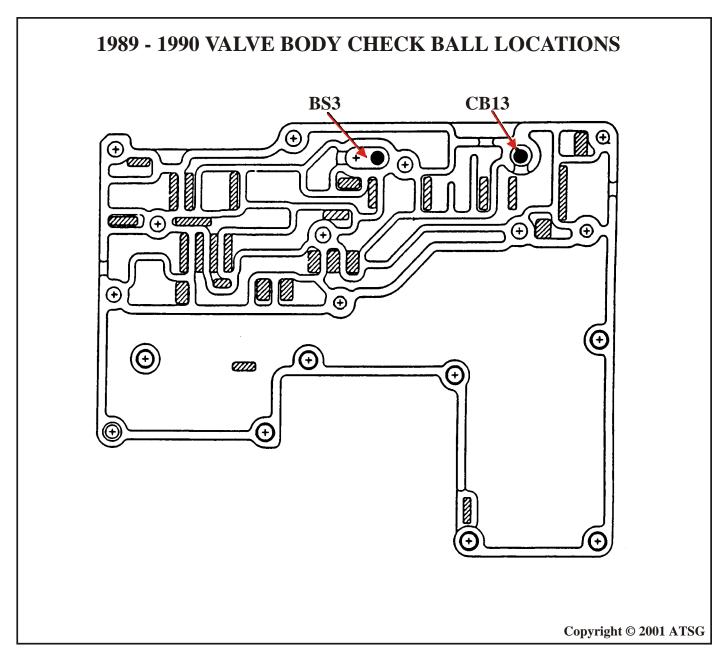
REFER TO FIGURE 1 FOR BOTH YEARS, FOR THE VALVE BODY CHECKBALL LOCATION.

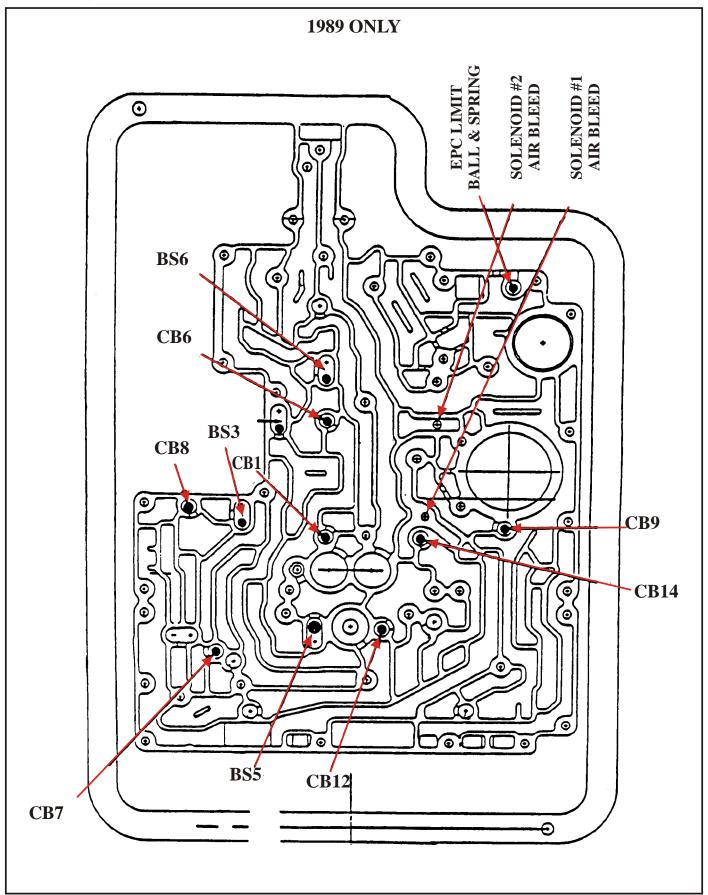
Figure 2

REFER TO FIGURE 2 FOR "1989" CHECKBALL LOCATIONS.

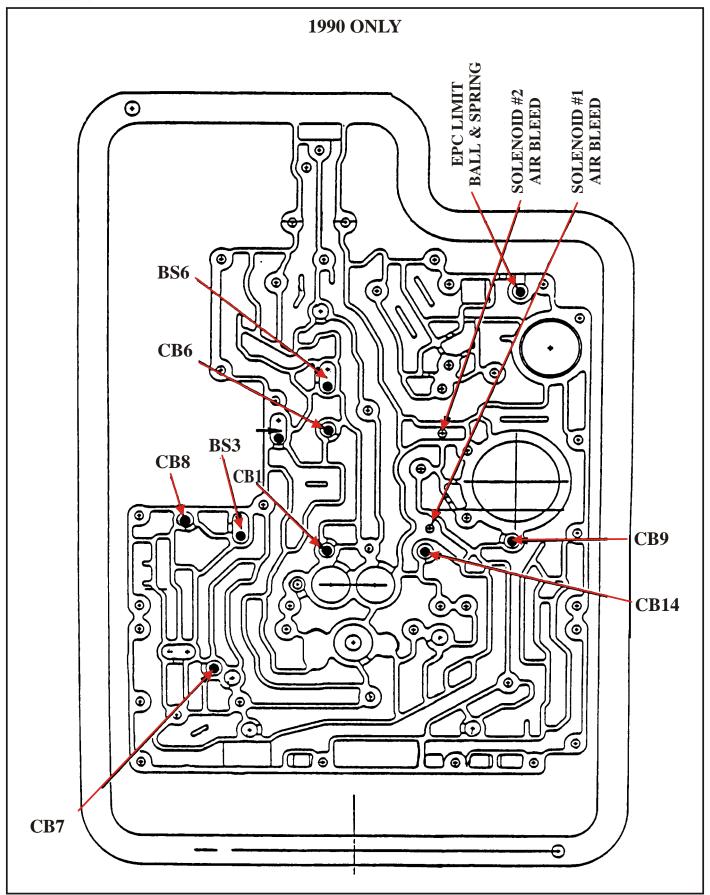
Figure 3

REFER TO FIGURE 3 FOR "1990" CHECKBALL LOCATIONS.
