# FORD 5R55N AND 5R55W/S SOLENOID BODY GASKET IDENTIFICATION

04-32

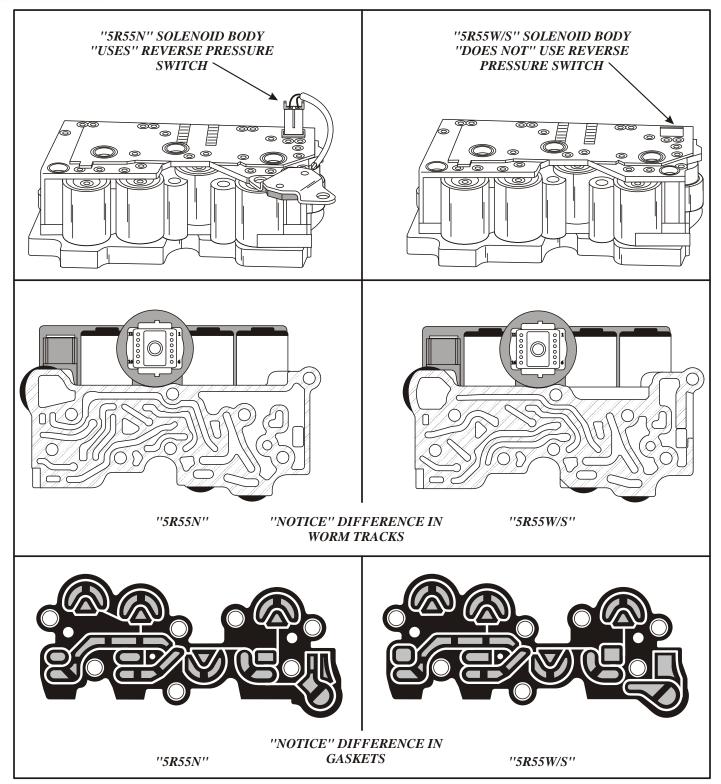
**COMPLAINT:** Installing the wrong solenoid body gasket onto a 5R55W/S usually creates a no reverse

condition and the gaskets are almost identical, as shown in Figure 1.

CAUSE: Currently, most aftermarket gasket sources package the 5R55N gasket into the 5R55W/S

gasket pack by mistake. They are currently in the process of correcting this error.

None of the parts shown in Figure 1 will interchange with one another, nor will the solenoid packs correctly assembled interchange between the 5R55N and 5R55W/S.

**CORRECTION:** Ensure that you install the correct solenoid body gasket during overhaul or repair. Use the

illustrations in Figure 1 to identify the different solenoid blocks and the different solenoid

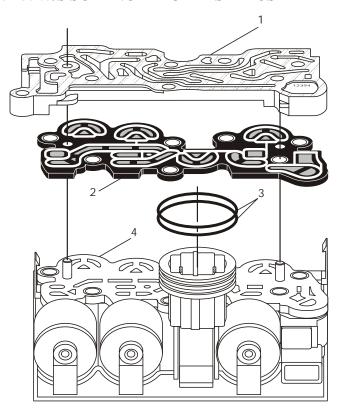
#### 5R55W/S SOLENOID BODY IS ILLUSTRATED

gaskets. Refer to Figure 2 for the proper assembly procedure.
