## **Technical Service Information**

# FORD 5R110W-TORQSHIFT TRANSMISSION DELAYED FORWARD AND, OR REVERSE ENGAGEMENT LOW MAINLINE PRESSURE

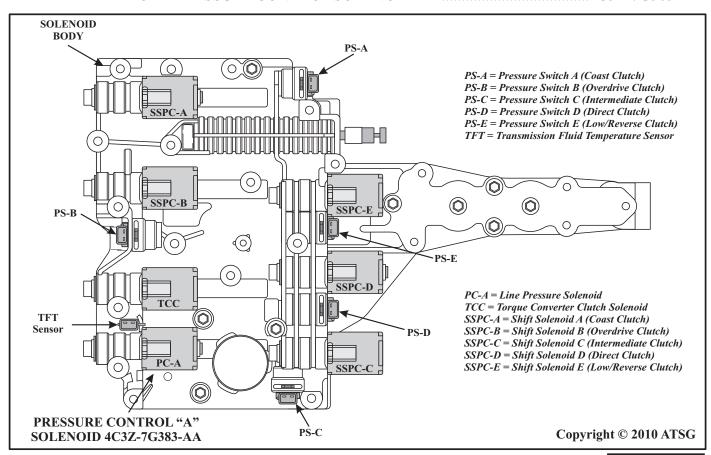
Figure 1

(See Figure 3) A faulty pressure control "A" Solenoid may also cause a low line pressure

condition as well (See Figure 1)

Replace pressure control solenoid "A". Note: ATSG recommends replacing the PCA

solenoid during overhaul. See service information.

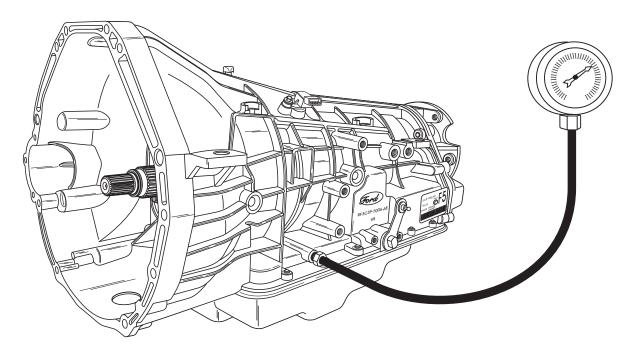
**CAUSE:** If the line pressure readings are found to be below specifications, the cause may be, that in

the pump cover assembly, there may be either a sticking pressure regulator valve, or that the

pressure regulator valve, or the pressure regulator valve bore may be worn.

**CORRECTION:** If the pressure regulator valve, or the pump cover is found to be damaged, repair bore, and

install new pressure regulator valve assembly with Sonnax kit. See service information.
