Technical Service Information

THM 440-T4 / 4T60-E BOTTOM PAN OIL FILTER CHANGES

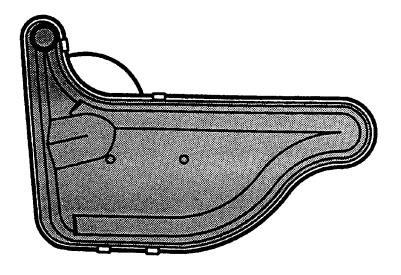
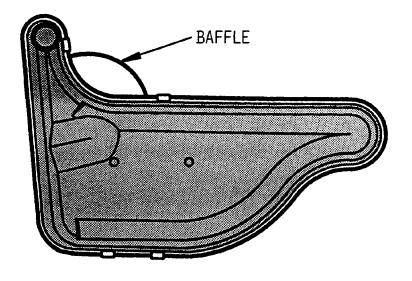
Figure 1

THM 4T60 (440-T4)
PREVIOUS DESIGN OIL FILTER

THM 4T60 (440-T4)
NEW "SEALED SEAM" DESIGN OIL FILTER

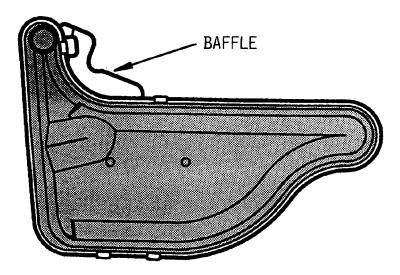
Figure 2

THM 4T60 (440-T4)
CURRENT DESIGN OIL FILTER

THM 4T60-E CURRENT DESIGN OIL FILTER

THM 4T60 AND 4T60-E TRANSAXLE OIL FILTERS WILL NOT INTERCHANGE!
