Technical Service Information

RENAULT MB1/MJ3 SPRAG ROTATION

88-31 Page 1 of 1

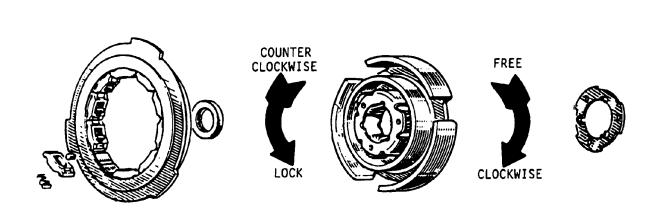
FOR PROPER SPRAG ROTATION, IT SHOULD LOCK COUNTER CLOCKWISE AND FREEWHEEL CLOCKWISE.
