Technical Service Information

FORD AXOD-E (AX4S) NO FORWARD MOVEMENT AFTER PULLING TO STOP

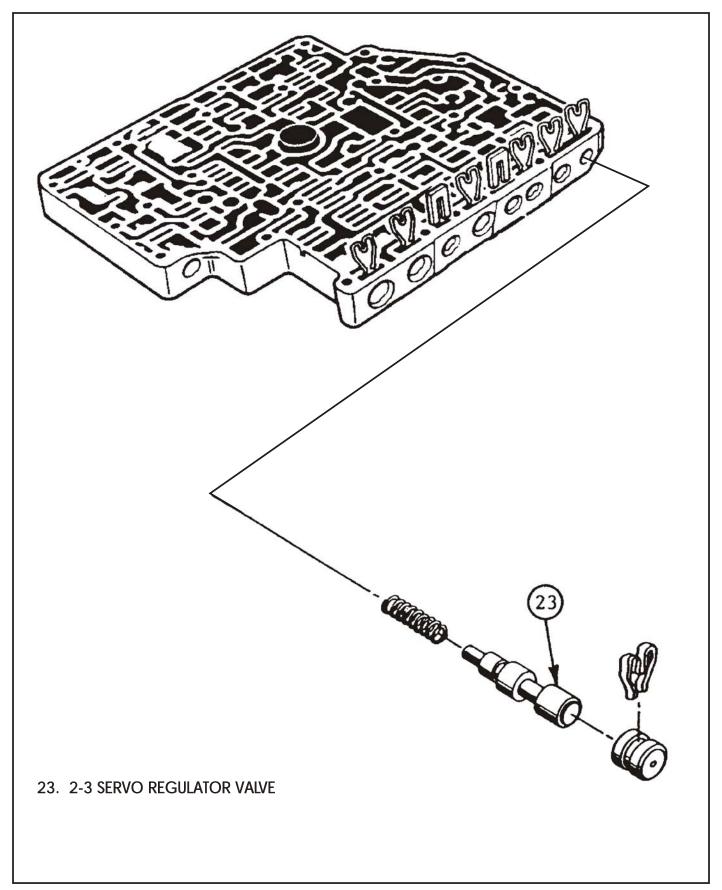
Figure 1

COMPLAINT: After driving the vehicle fast enough to achieve fourth gear, the vehicle will no longer move

forward, after coming to a stop. You will still have reverse.

CAUSE: The cause may be, the 2-3 servo regulator valve in the valve body stuck, which will block

servo apply oil to the 1-2 band (See Figure 1).

CORRECTION: Free the 2-3 servo regulator valve in the valve body from whatever contamination or debris

that is keeping the valve stuck (See Figure 1).
