GM 5L40E / BMW A5S 360/390R 1-2 BIND UP

(SAFETY MODE VALVE STRATEGY)

Technical Service Information

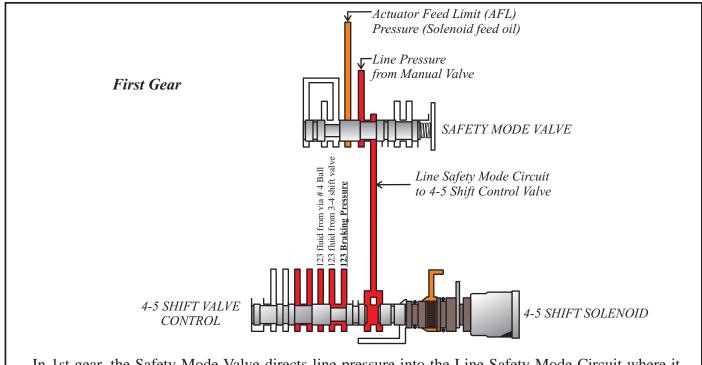
The Safety Mode Valve allows for 5th gear failsafe and 4th gear failsafe. If a fault occurs during driving conditions 5th gear failsafe will occur. After the ignition is cycled, 4th gear will be the failsafe gear.

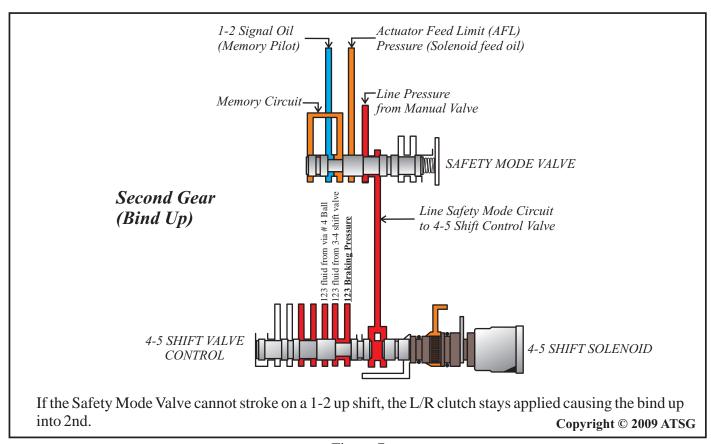
Figure 6

One cause may be that the Safety Mode Valve in the valve body is stuck in an un-stroked position. In first gear, this Safety Mode Valve is held closed by spring tension. This allows line pressure to pass through the valve into the Line Safety Mode circuit which then strokes the 4-5 Shift Valve. The 4-5 Shift Valve then directs 123 oil into the 123 Braking circuit applying the L/R Clutch with regulated line pressure for engine breaking in first gear. (Figure 6)

In 1st gear, the Safety Mode Valve directs line pressure into the Line Safety Mode Circuit where it strokes the 4-5 Shift Valve. The 4-5 Shift Valve then directs 123 Fluid into the 123 Braking Circuit where it applies the L/R Clutches for engine breaking in 1st gear.

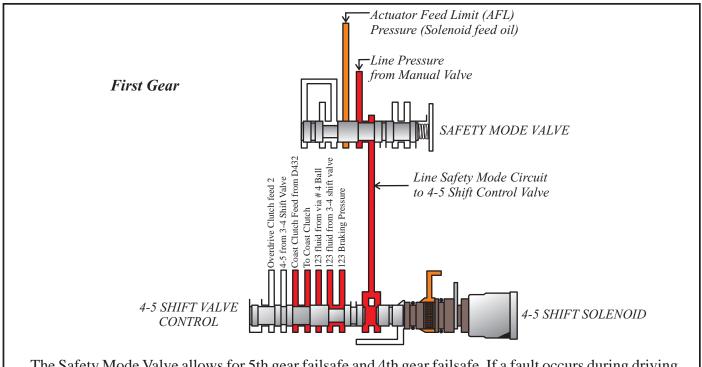
Figure 7

When a 1-2 shift occurs, 1-2 signal oil which becomes memory pilot pressure is suppose to stroke the Line Safety Mode Valve blocking the line pressure feed going to the 4-5 Shift Valve. If the Safety Mode Valve can not stroke, the L/R Clutches remain on and a bind up on a shift into second gear will occur. (Figure 7)

CORRECTION: Clean and free up the Safety Mode Valve. Determine what other problems may have occurred to cause enough debris to stick the valve and repair as necessary.

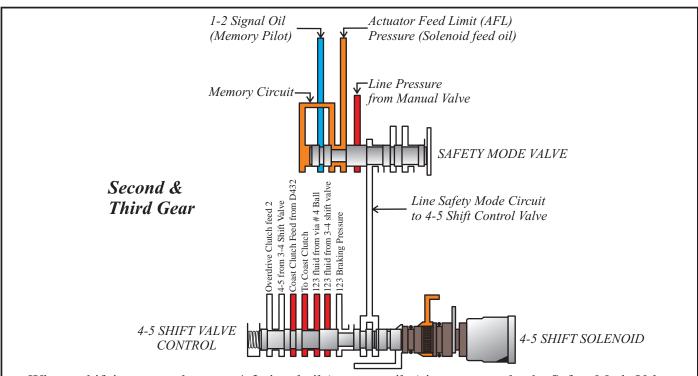
Figure 8

When a shift into second occurs, 1-2 signal oil (memory pilot) is sent to stroke the Safety Mode Valve. When the valve is stroked, actuator feed limit fluid is used to hold the valve in a stroked position. Should all the solenoids turn off due to a fault, this valve is held in a stroked position which will allow for 5th gear failsafe. When the ignition is cycled, the valve will un-stroke making 4th gear the failsafe gear.

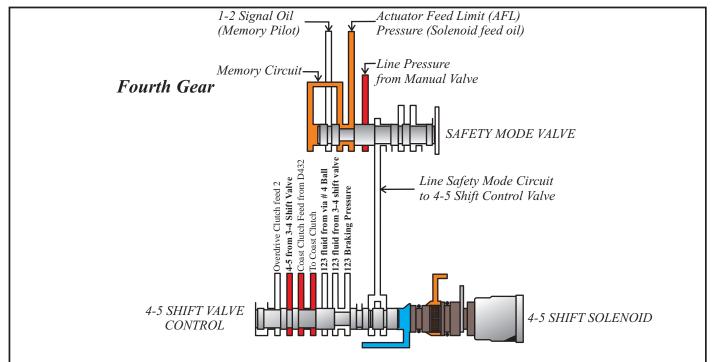
Figure 10

When a shift into 4th is made, the 1-2 Shift Solenoid turns Off causing the 1-2 signal oil to be exhausted This causes the 3-4 shift valve to un-stroke simultaneously exhausting 123 fluid and supplying 4-5 oil pressure at the 4-5 Shift Control Valve. The 4-5 Shift solenoid turns on stroking the 4-5 Shift Control Valve blocking 4-5 oil from entering the Overdrive Clutch Feed 2 circuit. The Safety Mode Valve remains stroked by AFL fluid called the Memory Circuit.

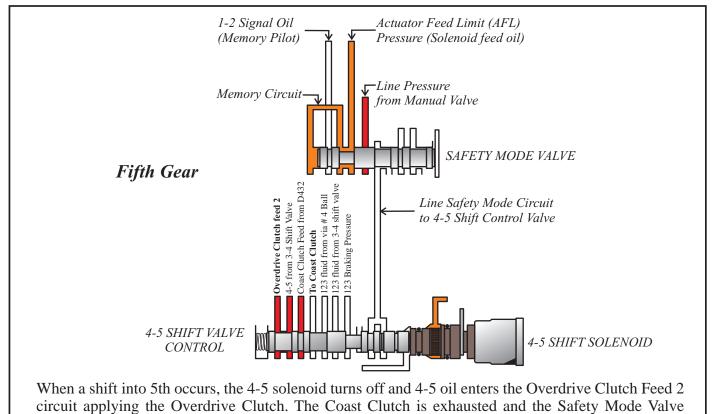
Figure 11

Once the Safety Mode Valve is stroked it remains stroked throughout 2nd, 3rd, 4th and 5th gear. (See Figures 10 and 11) When a shift into 5th occurs, the 4-5 solenoid turns off and 4-5 oil enters the Overdrive Clutch Feed 2 circuit applying the Overdrive Clutch. The Coast Clutch is exhausted. (Figure 11) And this is exactly what takes place when the vehicle failsafes to 5th while driving. (Figure 12)

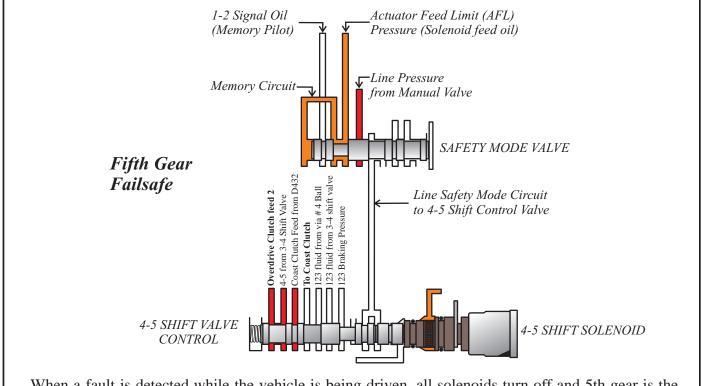
Figure 12

When a fault is detected while the vehicle is being driven, all solenoids turn off and 5th gear is the failsafe gear.

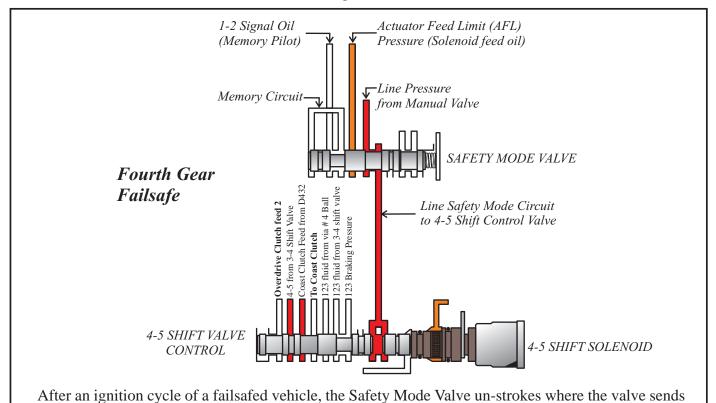
Figure 13

But once the vehicle stops and the ignition is cycled, the Safety Mode Valve is forced closed by spring pressure. Line pressure passes through the valve and into the Line Safety Mode Circuit where it strokes the 4-5 Shift Control Valve. With all solenoids Off, this blocks 4-5 oil from entering the Overdrive Clutch Feed 2 circuit placing the vehicle into a 4th gear failsafe. (See Figure 13)

line pressure to stroke the 4-5 Shift Control Valve. This blocks 4-5 oil from entering the Overdrive

Clutch Feed 2 circuit and now the vehicle will have a 4th gear failsafe.
