Human Factors Evaluation of an Experimental Locomotive Engineer Crewstation

DOT/FRA/ORD-19/50

Final Report
December 2019

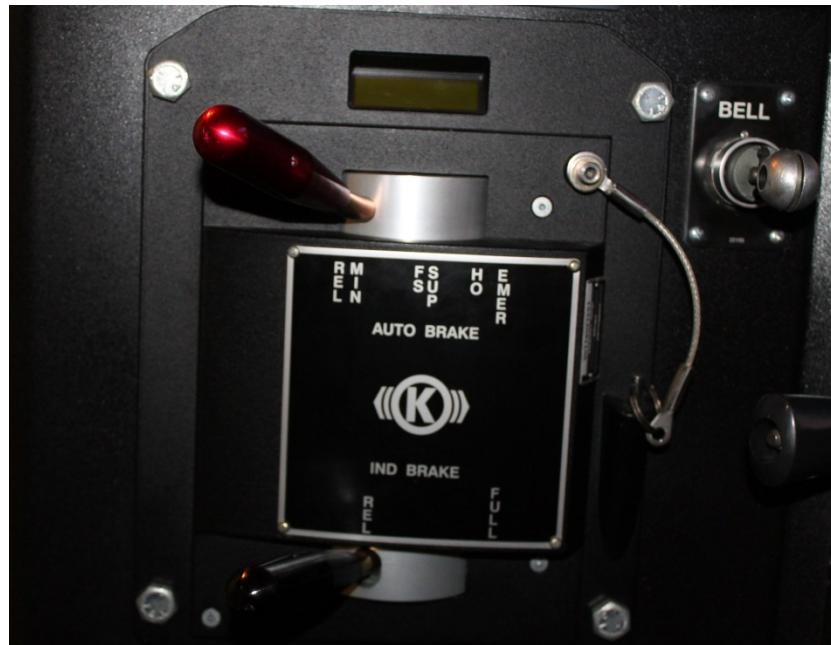
The Automatic brake in CTIL's AAR-105 control stand was designed based on the New York Air Brake model 26-L (see [Figure 15](#)). It has detents for the release position and minimum service, then a 3.28-inch arc of continuous movement to provide different application levels of the brake.¹ After this application range are detents for full service, suppression, handle off, and emergency positions. The range of movement between minimum and full service allows engineers to make small adjustments in braking to accurately control the train in different environments and scenarios.

Figure 15. Automatic brake in CTIL's AAR-105 control stand, modeled after New York Air Brake model 26-L

The continuous service portion of experimental crewstation's automatic brake extends only 1.76 inches. We were concerned that this small range of movement might lead engineers to accidentally apply heavier braking than intended. The worst case for this type of error would be an accidental application of full service braking, an action that costs railroads money over time (due to replacement cost for brakes).

This action could also be dangerous because in direct release braking used in freight operations, the engineer cannot make an adjustment to lower a braking application without first releasing the brake. An accidental full service application of the automatic brake at the wrong time could lead to train damage; an unnecessary release of the brakes at an inopportune time could also result in acceleration of the train. If noticed, this acceleration could lead the engineer to force the train to stop to wait for the brakes to recharge. On the other hand, an unnoticed acceleration could lead a train to be extremely difficult for an engineer to control.

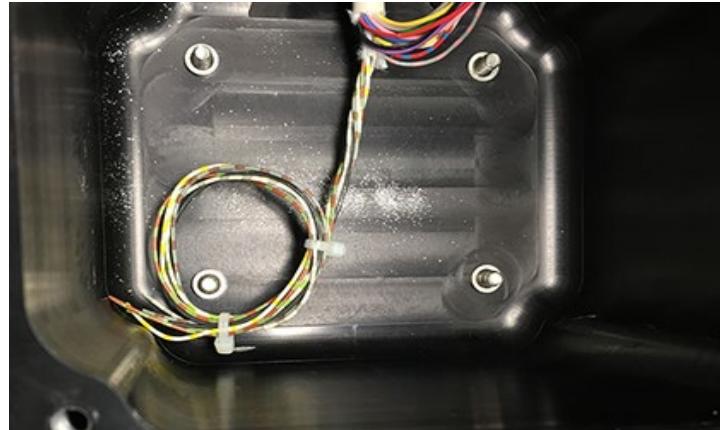
We noticed that the detents for the combined throttle were particularly weak and could lead to inadvertent actuation. We were concerned that it may be easy for an engineer to move through multiple notches without realizing that is happening. This may lead to the engineer using more or less throttle than intended and to additional head-down time as the engineer determines where the throttle is positioned.

Further, the detents weakened over time. Over the course of approximately 80 hours of use, the detented controls that received the most use (such as the throttle) became noticeably smoother and shallower than the ones that received less use (such as the reverser). We attributed this change in detent depth to the construction materials used in the controls.

Figure 17. The silver powder-like crystals shown inside of the throttle control box are aluminum shavings from the detent housing caused by wear from the control lever's steel ball bearing

The detented control levers on the experimental crewstation consist of two pieces: a housing with hemispherical indentations attached to the control casing, and a ball bearing and spring attached to underside of the lever. As the lever moves, the ball bearing slides along the housing and into the indentations, which are aligned with the labeled lever positions.

The experimental crewstation's detent housings are aluminum, and the ball bearings are stainless steel. As a result, the ball bearing wore down the housing (see [Figure 17](#)). While it was understood that the experimental crewstation is a conceptual prototype that may not yet have been put through the mechanical rigor necessary for field implementation, it occurred to us that a materials engineering mismatch like this could be easily overlooked.

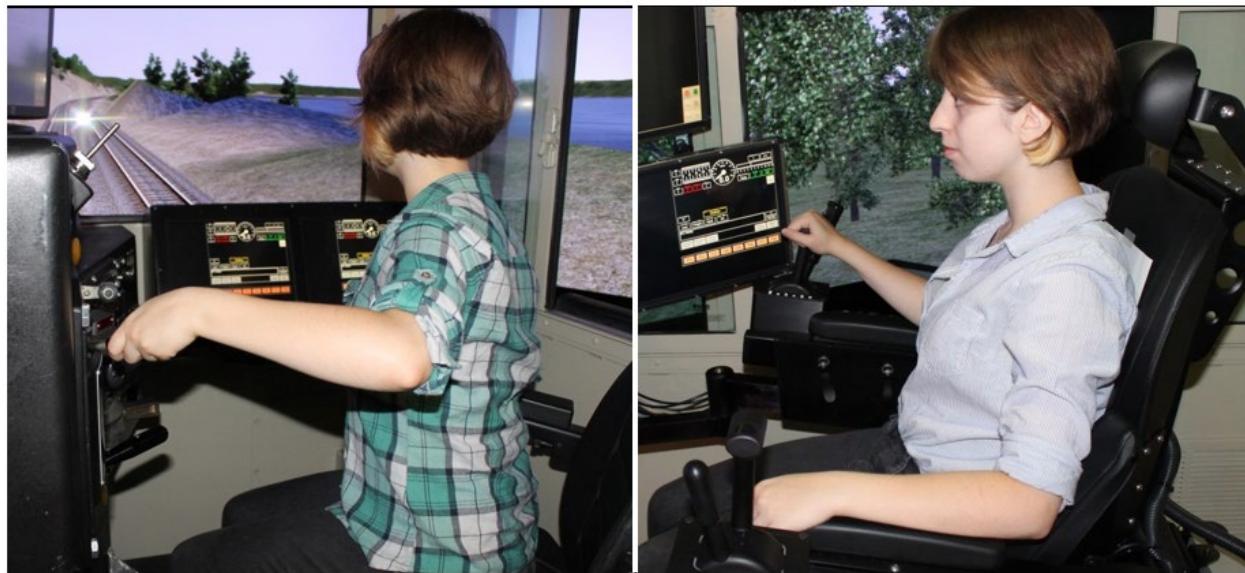
Consideration of Personnel). As an example, Figure 21 illustrates the uncomfortable wrist positions required to operate several of the controls in the AAR-105 control stand; these positions are eliminated in the experimental crewstation.

Figure 21. A 50th percentile female evaluator operating the automatic brake in the AAR-105 control stand in CTIL (left), and the experimental crewstation (right)

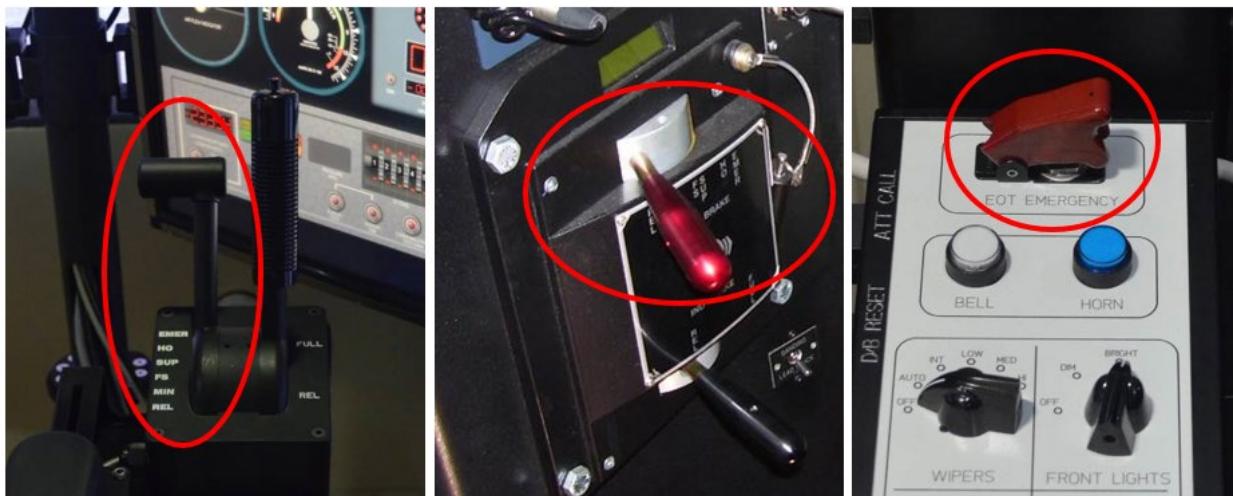
According to the criterion for Emergency Shutoff Controls, these should be used exclusively in emergency situations, but in current locomotive control stations this is not the case; emergency braking is done by increasing the application of the automatic brake beyond a certain point. Because so many trains operate this way, recommending that the experimental crewstation follow these criteria rather than matching existing control stations could lead to negative transfer effects. Therefore, in this case, consistency between workstations may be more important than adherence to the Consistency of Use criterion.

In contrast to the emergency brake, the end-of-train (EOT) emergency device is an example of a control used exclusively for emergencies and properly protected from inadvertent actuation in both workstations. It is properly protected from inadvertent actuation with a cover and is only used for emergency functions in accordance with criteria for Control of Hazardous Operations and Consistency of Use. Though it is covered, it remains easily accessible when needed as stated in the criterion for Emergency Shutoff Controls. The EOT Emergency switch is shown in [Figure 22](#) on the experimental crewstation, and is comparable in the AAR-105 control stand, though it is located farther away.

Figure 22. Emergency controls. Automatic brake lever with emergency brake function in the experimental crewstation (left), automatic brake lever with emergency brake function in the AAR-105 control stand (center), and end of train emergency device on the experimental crewstation

Continued protection of the EOT switch from inadvertent actuation and improved differentiation of the emergency functions of the automatic brake will help prevent accidental actuation of emergency controls in the experimental crewstation.

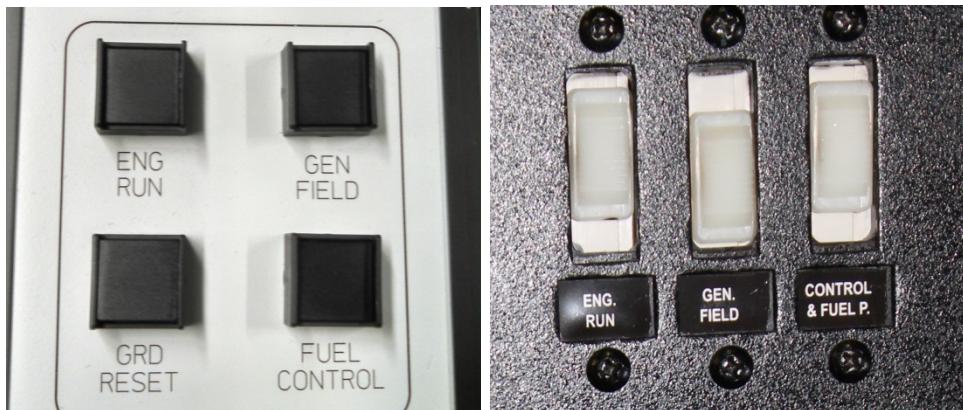
Push buttons on the experimental crewstation control panels are used for several on-off functions. The criterion for Discrete-Adjustment Linear Controls states that push buttons shall not be used for on-off functions, and upon examining these push buttons the reasoning for this becomes clear: it is difficult to determine whether the push buttons on the experimental crewstation are in the down position (“on”) or the up position (“off”). [Figure 25](#) shows the push buttons used in the experimental crewstation and several of the slide switches used in the AAR-105 control stand for the same functions.

Figure 25. Experimental crewstation push buttons (left) are shown in the down position with the exception of “GRD RESET.” AAR-105 control stand switches (right) are up with the exception of “GEN. FIELD”

The push buttons on the experimental crewstation also demonstrate why these criteria exist because similar-looking buttons do not always perform similar tasks. For example the ground relay reset button looks identical to the generator field, engine run and fuel control. Conversely,

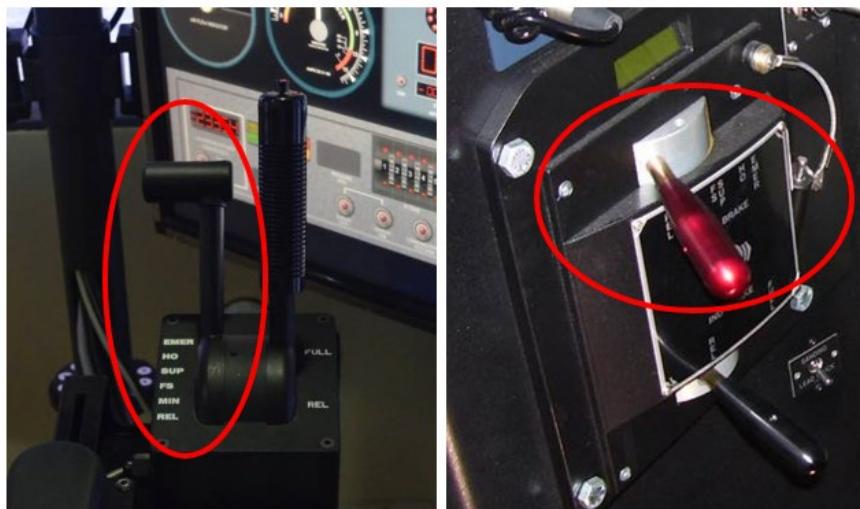
Figure 26. Automatic brake lever with emergency brake function in the experimental crewstation (left), automatic brake lever with emergency brake function in the AAR-105 control stand (right)

According to MIL-STD-1472G Table XVIII, color coding of lights, and MIL-STD-1472G Table XV (DoD, 2009), common color association meanings, the color red typically indicates “emergency,” “severe threat,” “stop,” or “failure.”⁸ Therefore, it makes sense for emergency controls to be colored red.

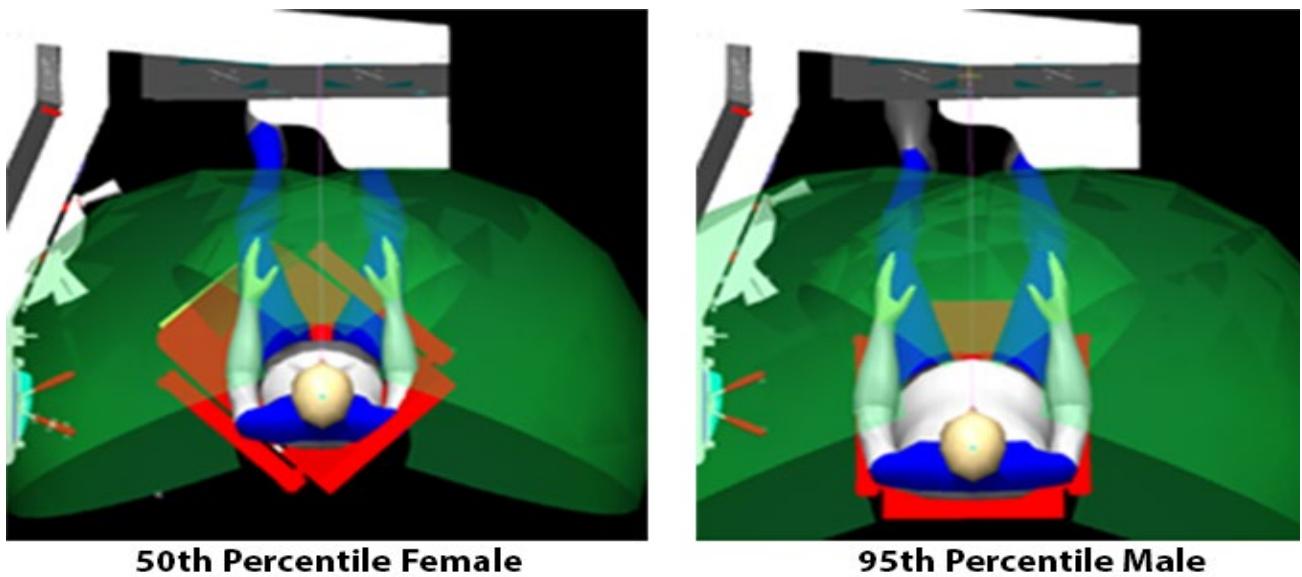
For the first set of reach envelopes (facing forward) we positioned the seat at the back of the operational range for the 95th percentile male and at the front of the range for the 50th percentile female. The resulting images in [Figure 31](#) indicate that that when users of all sizes face the forward window, none of the controls can be reached with the right hand without leaning forward or twisting.

Figure 31. Reach envelopes in the AAR-105 control stand while facing forward

The reach extents in the forward facing position also show that for the 50th percentile female, much of the controls are at the edge of the reach extents. Given this great distance, it is highly likely that smaller users would need to sit close to the edge of the seat to operate controls if they choose to face forward while operating, though doing so does not provide back support.

The relative position of the automatic brake and throttle pose another problem for small users. Figure 31 shows that the brake is near the back of the reach envelope of the left hand, which means that as users slide forward in the chair or move the chair forward, it will become more difficult for them to access the brake.

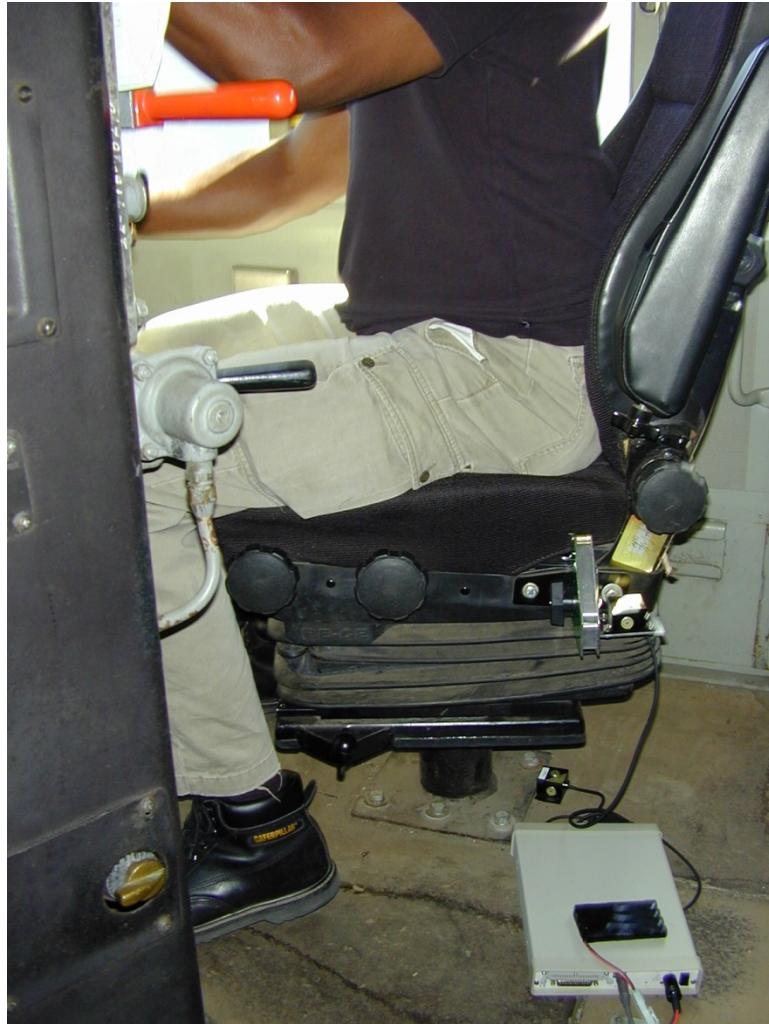
Given that the majority of the population is right-handed and the forward-facing body position in the AAR-105 control stand does not allow for easy access to controls with the right hand, we expect that users of all sizes may turn toward the control stand to operate it. This notion is supported by the photo in Figure 32, which taken during a previous study on vibration that the Volpe Center conducted.

Figure 32. Engineer facing the control stand in a real locomotive

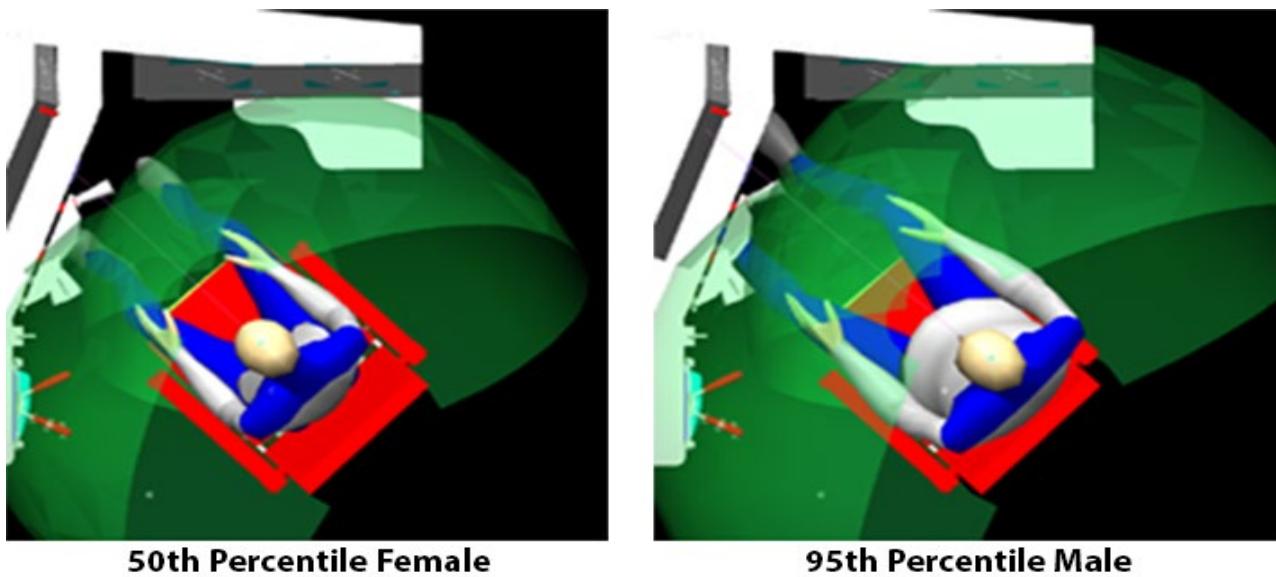
Due to this, we repositioned the test cases to face the controls and performed another reach extents analysis ([Figure 33](#)) using RAMSIS. To understand the best possible scenario for reachability, both test cases were positioned with the seat in the forward-most position. This new position facing the control stand brings the right-hand reach envelopes closer to the controls for both test cases. Even here, though, [Figure 33](#) shows that small engineers must bend forward to reach the throttle when it is positioned in the low ranges.

Figure 33. Reach envelopes in the AAR-105 control stand while facing the controls

In this seat position, it is nearly as easy for both test cases to reach the throttle in low position with the left hand as with the right. This makes two-handed operation somewhat easier. There are many situations in which two-handed control operations are preferred or even necessary, such as:

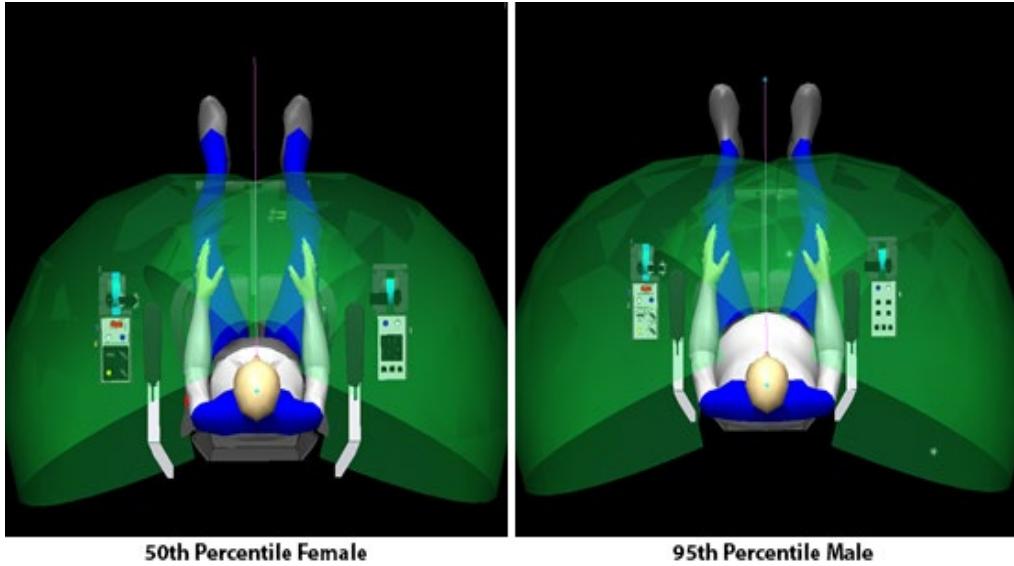
Figure 34. Reach envelope for both test cases positioned in the experimental crewstation. All controls are within the reach envelope of one hand¹⁶

According to the reach envelopes provided by RAMSIS, the experimental crewstation's control configuration shows significantly improved reachability over the configuration of the AAR-105 control stand because all controls are well within reach. Additionally, the position of the seat allows users of all sizes to face the forward window while using the controls. Finally, since the controls are mounted to the chair, accessibility does not change if the engineer decides to face another direction while operating.

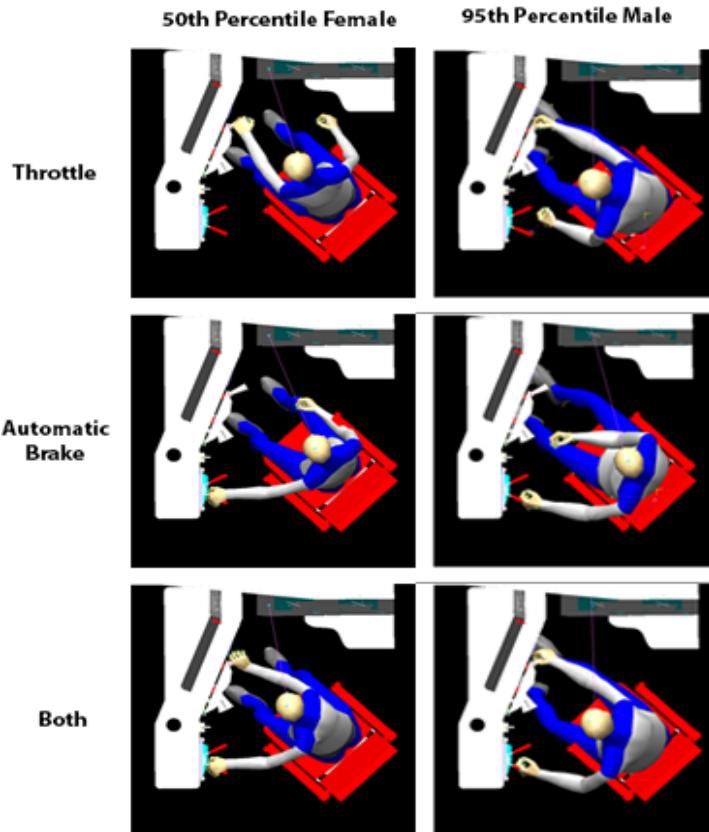
[Figure 35](#) shows the optimal body positioning for accessing the automatic brake, throttle, and both controls simultaneously for the large and small mannequins in the AAR-105 control stand. If positioned in the chair to make use of its back support, mannequins must bend at the waist and extend their arms to grasp the throttle.

Figure 35. Side-by-side comparison of the small and large test case for the three analyzed control operations

Figure 35 shows that this extension worsens if the user also reaches for the automatic brake, as may occur in situations such as stretch-braking, and it does so substantially for small users; the discomfort scores for the two different mannequins are only significantly different for the simultaneous operation of the two controls. In that operation, the discomfort score is significantly higher for the small test case in the neck (6.7 for the small test case and 5.4 for the large test case) and shoulders (5.4 for the small test case and 4.2 for the large test case).

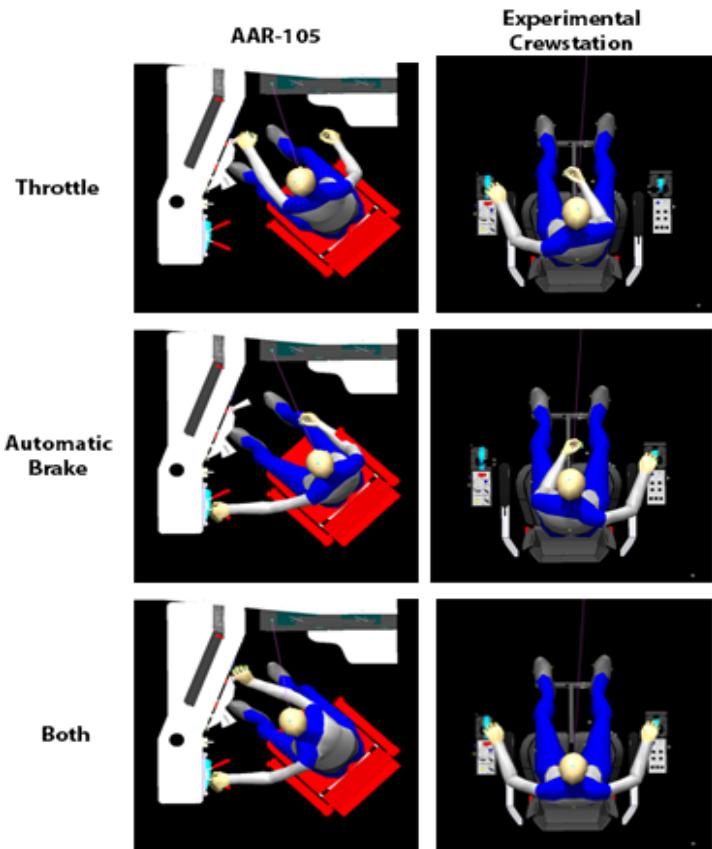
[Figure 36](#) shows side-by-side comparisons of the AAR-105 control stand in CTIL and the experimental crewstation using the small mannequin for the three test scenarios: grasping the throttle, grasping the automatic brake, and grasping both simultaneously. The experimental crewstation’s design greatly improves access to these controls. The RAMSIS body positions show that users use much more comfortable body positions to access the controls compared to the AAR-105 control stand. Additionally, the controls, while not in this case requiring high forces, are oriented closer to the engineer’s center of gravity, which allows engineers to generate more force if necessary. This may become critical if designers choose to deepen the control detents based on other findings in this report.

RAMSIS body positioning shows that mannequins used a slight back rotation in the most comfortable position for control access. This occurred because the controls are not directly in front of the armrest, and therefore RAMSIS judged rotating the back would yield slightly better overall discomfort scores than keeping the back stationary and moving only the arms.

Figure 36. Differences in body positioning between the AAR-105 control stand and the experimental crewstation, for 50th percentile female
