SITE OBSERVATION REPORT

Project:	Equinix CL1 Mantrap	Project No:	2201319
Location:	Calgary, AB	Report No:	1
Contractor:	Ellis Don	Date of Visit:	2025-09-02
Building Permit No:	BP2024-00799	Report Date:	2025-09-09
		Sheet:	1 OF 4

Reason for Site Visit: Final Review

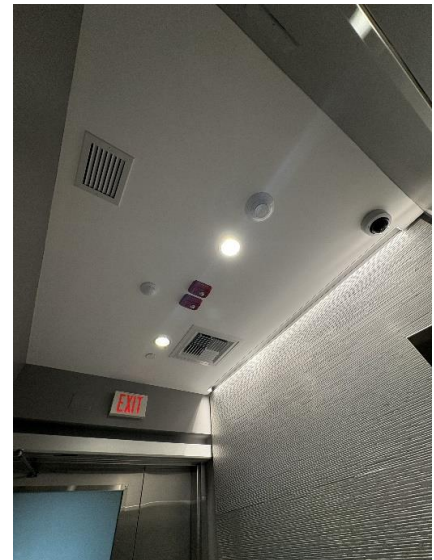
Figure 1 - New Luminaires Adjacent to Circle Lock

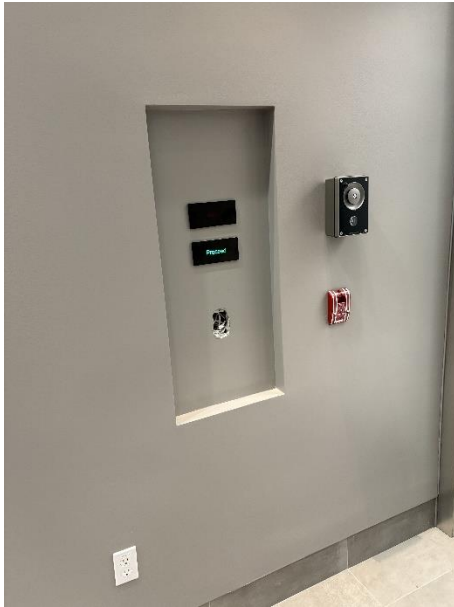
Figure 3 – Manual Station Installed on Secure-Side of Mantrap (Security Installation Ongoing)

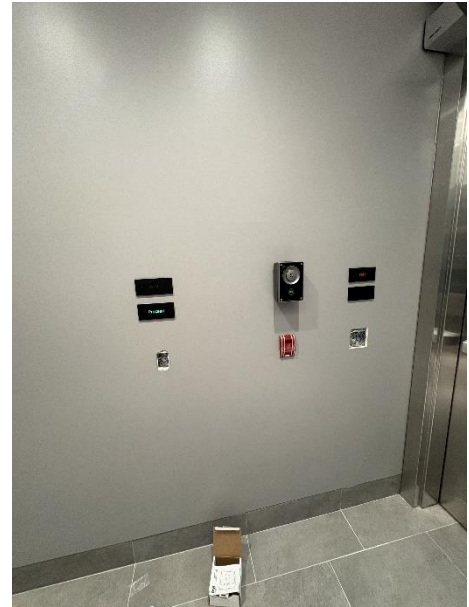
Figure 4 - Manual Station Installed Inside Mantrap (Security Installation Ongoing)

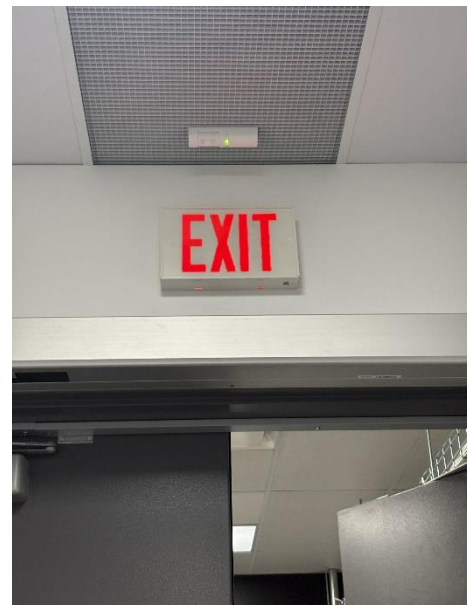
Figure 6 - New Exit Sign at Data Hall Exit

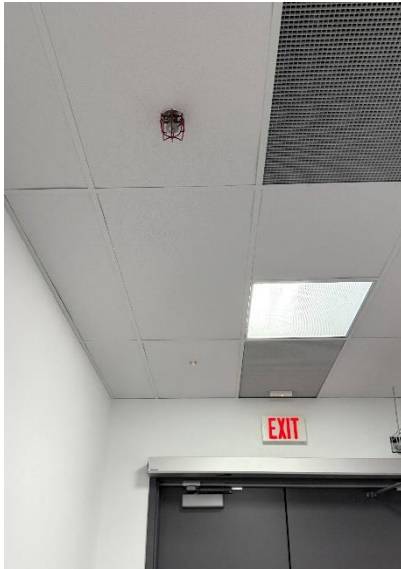
Figure 7 - Sprinkler Data Center Side of Double Door

2.1 During the site observation, it was noted that the two sprinkler heads which were issued as part of the revised drawings have not been installed. The issued package, identified as *GC-M-PC-007* dated 2025-06-23, required sprinkler heads to be added on either side of the double doors (Reference sheet F120 – Android L&F Phase 2, Mantraps Replacement, Bankers Hall, 315-8th Avenue S.W., Calgary, AB). These additions were indicated on the drawings; however, they were not observed on site. The Contractor is requested to review and confirm the installation requirements, with a plan for corrective action.

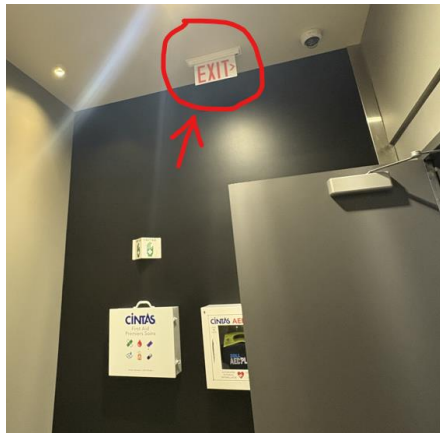
- 1.1 During the site observation, it was noted that an existing exit sign scheduled for removal, located at the end of Corridor-1, has been disconnected but not yet demolished (refer to figure below). Electrical contractor shall provide photographic evidence upon completion of associated demolition and patching.

Figure 9 - Exit Sign to be Demolished
