ASBESTOS AND LEAD SURVEY REPORT

United States Coast Guard – Sector San Diego

2170 N. Harbor Drive, San Diego, California 92101

AESS Job Number:	26-092
Survey / Sample Collection Date:	July 15, 2026
Report Date:	August 3, 2026
Prepared For:	United States Coast Guard – Sector San Diego
Prepared By:	Advantage Environmental & Safety Services (AESS)

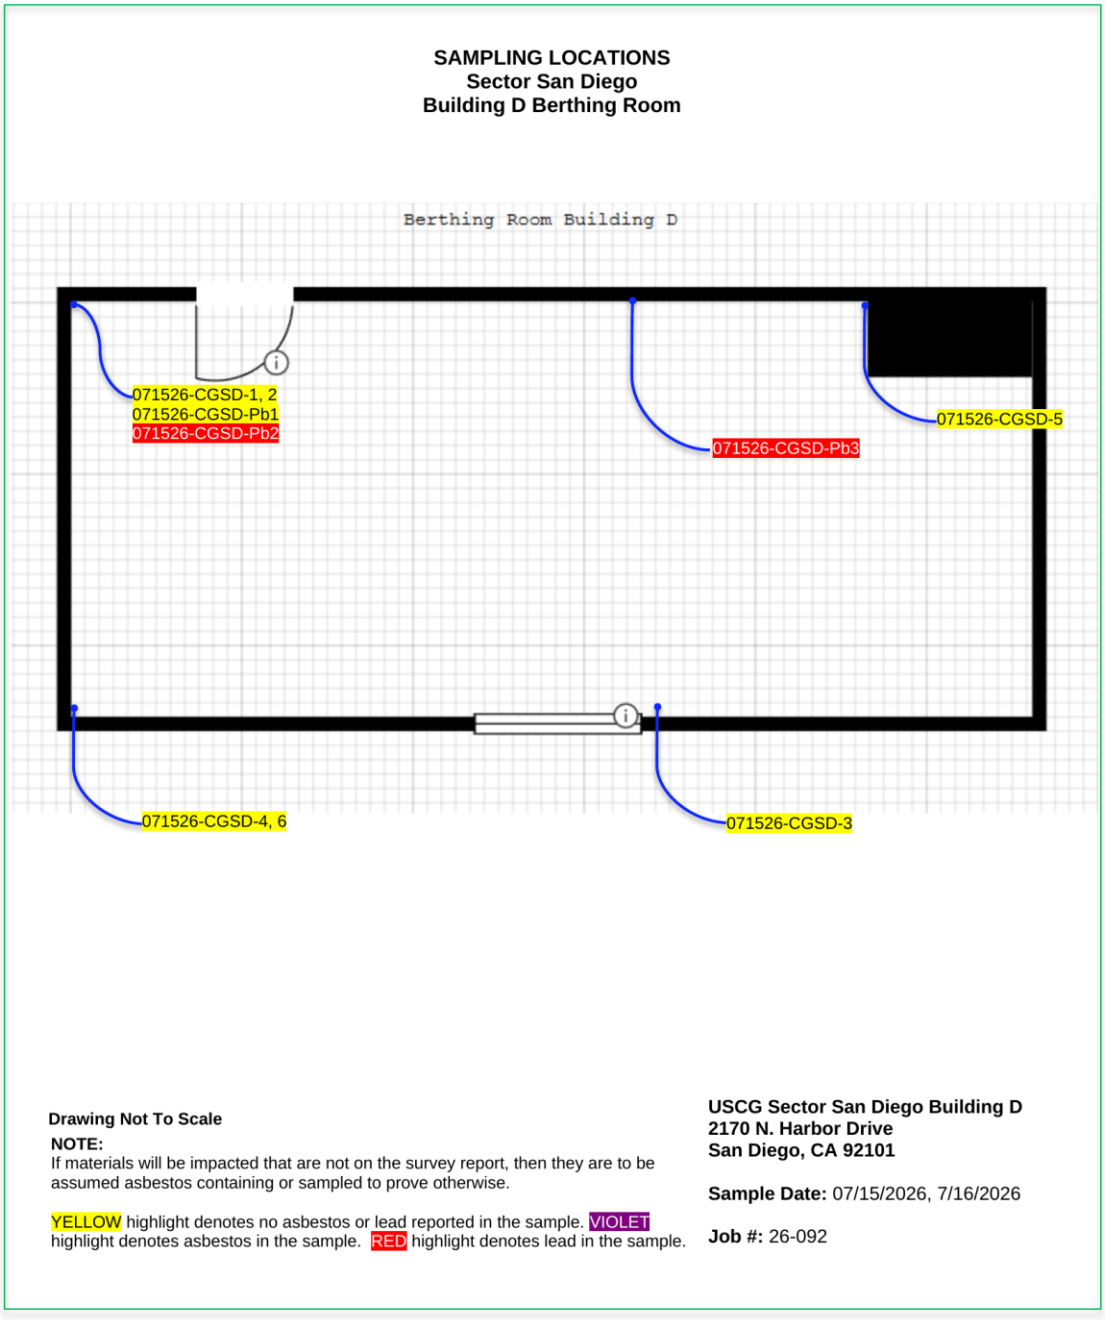
Figure 1. Sample location diagram, Building D (Berthing Room), USCG Sector San Diego (Job No. 26-092).

Detectable lead was confirmed in two materials, both in Building D: ceramic floor tile grout/thin-set at the Berthing Room NW wall (Sample 071526-CGSD-Pb2, 0.0039% by weight) and beige paint on drywall at the Berthing Room north wall (Sample 071526-CGSD-Pb3, 0.00349% by weight). Although these concentrations fall below the federal regulatory definition of “lead-based paint,” they confirm lead is present in these materials. AESS recommends the following:

- Personnel performing demolition, grinding, sanding, cutting, or removal of the ceramic floor tile grout/thin-set and painted drywall at the 071526-CGSD-Pb2 and 071526-CGSD-Pb3 sample locations should be made aware that the material contains lead and should follow applicable OSHA Lead in Construction Standard (29 CFR 1926.62) requirements, including exposure assessment as warranted by the specific task and controls performed.

- Debris and waste generated from removal of these lead-containing materials should be evaluated for appropriate disposal classification (e.g., TCLP or total threshold limit concentration [TTLC] waste characterization) prior to disposal, consistent with California hazardous waste regulations.
- The remaining nine sampled materials (ceramic wall and floor tile and additional painted drywall locations) did not contain lead above the laboratory reporting limit and are not subject to lead-specific handling requirements based on these results.

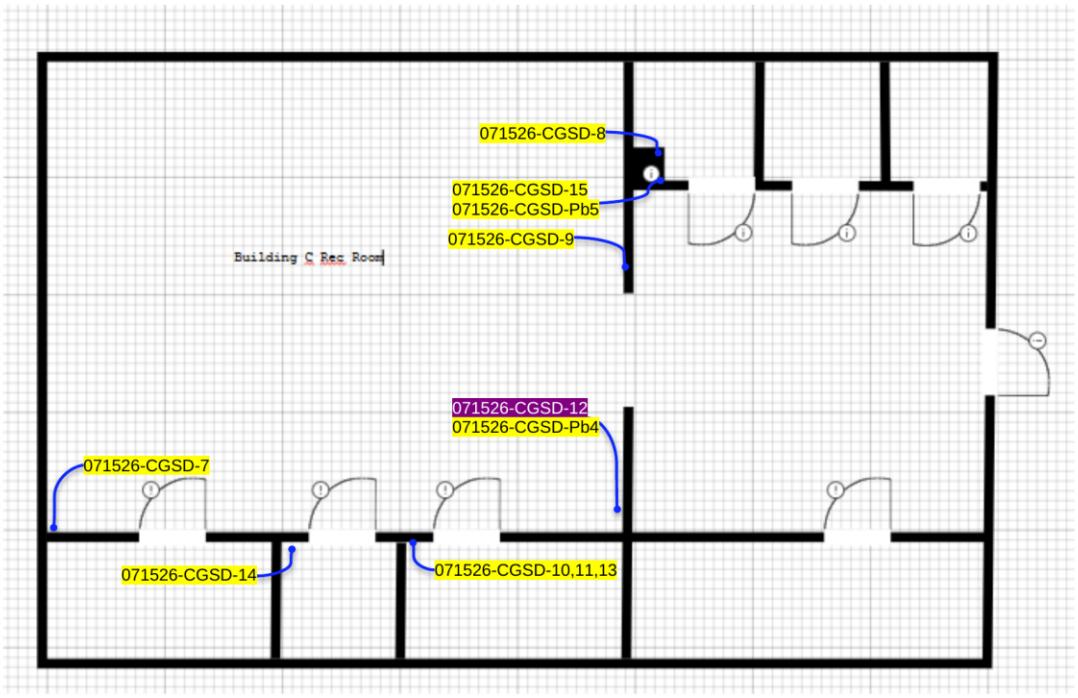
Figure 2. Sample location diagram, Building C (Rec Room), USCG Sector San Diego (Job No. 26-092).

SAMPLING LOCATIONS
Sector San Diego
Building C Rec Room

- The texture/taping mud/drywall system at the Building C Main Rec Room ceiling (071526-CGSD-12) and the Building C-2 Rm C13/C14 bathroom south wall (071526-CGSD-24), and the granular material beneath the ceramic wall tile at the Building C-2 Rm C9/C10 bathroom south wall (071526-CGSD-22), should be presumed to be ACM throughout the associated homogeneous area and handled by a licensed asbestos abatement contractor prior to any activity that would disturb, cut, drill, sand, or otherwise impact these materials.

- Any maintenance, repair, or renovation work planned in the vicinity of these three sample locations should be preceded by notification to the appropriate air quality management district and compliance with applicable NESHAP demolition/renovation notification requirements if the quantity of ACM to be disturbed exceeds regulatory thresholds.

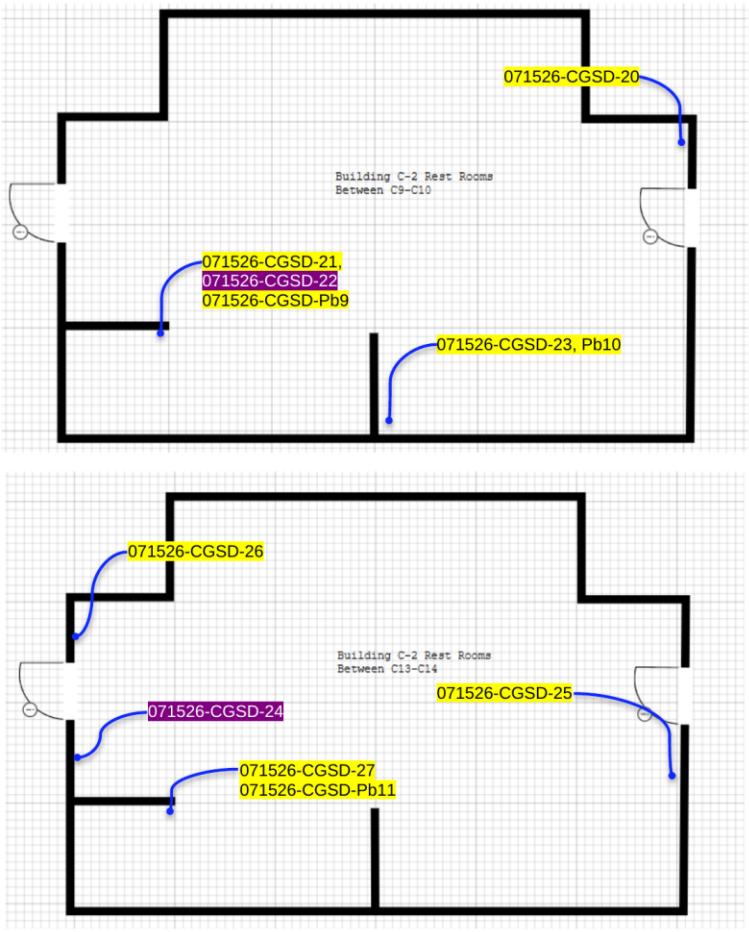
Figure 3. Sample location diagram, Building C-2, USCG Sector San Diego (Job No. 26-092).

SAMPLING LOCATIONS
Sector San Diego
Building C-2
