GAOA MESA FALLS VISITOR CENTER ROOF REPLACEMENT AND MAINTENANCE

INDEX OF SHEETS		
SHEET	**SHEET TITLE**	**NO.**
G-01	COVER SHEET AND LOCATION	1
A1.01	ROOF PLAN	2
A1.02	ROOF OVERHANG FRAMING PLAN	3
A2.01	NORTH ELEVATION	4
A2.02	EAST ELEVATION	5
A2.03	SOUTH ELEVATION	6
A2.04	WEST ELEVATION	7
A4.01	ROOF DETAILS	8
A4.02	ROOF DETAILS	9

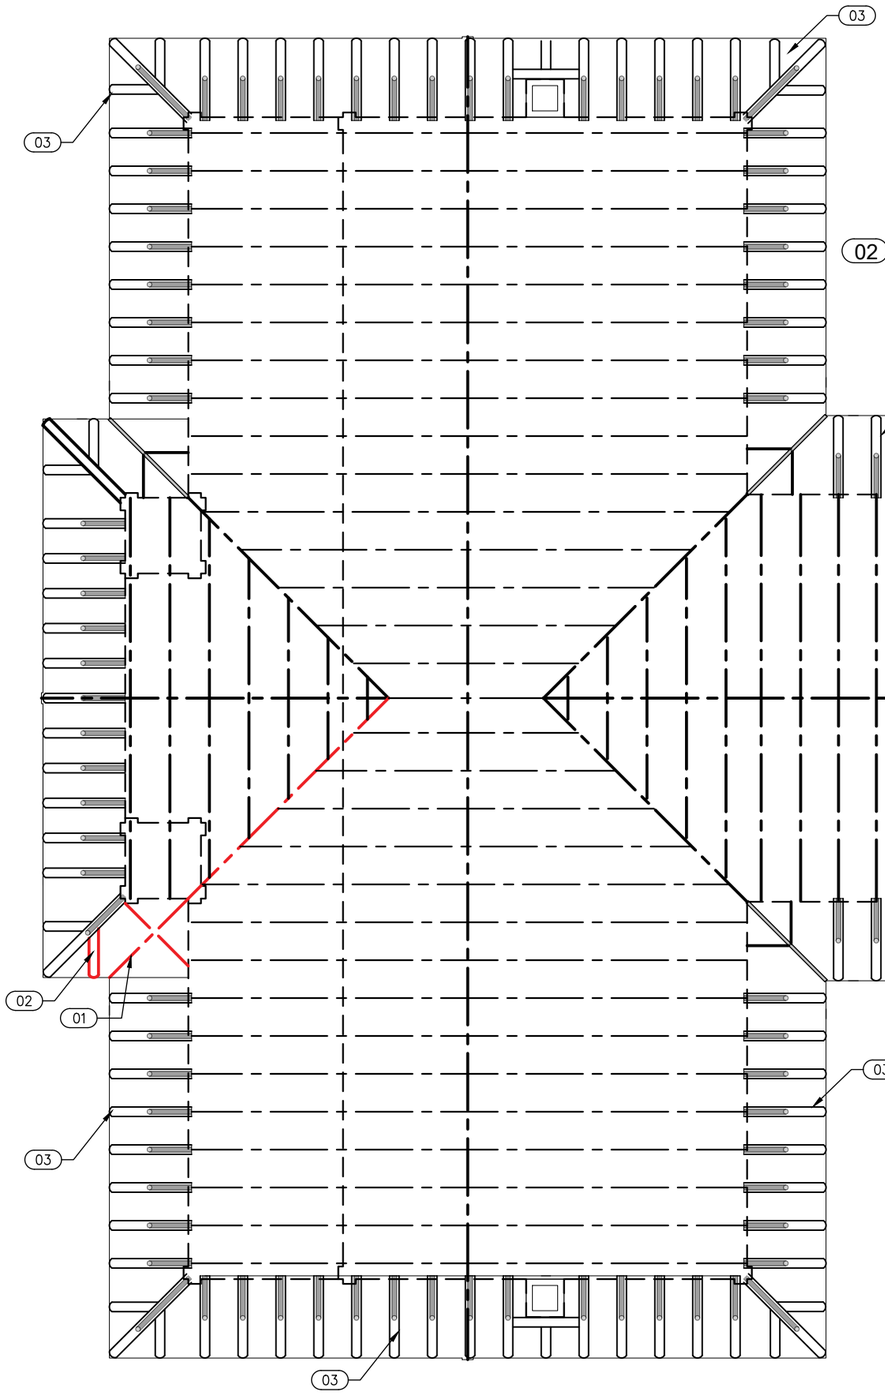
1 ROOF OVERHANG FRAMING PLAN
SCALE 1/4" = 1'-0"

VIEWS OF OVERHANG FRAMING DAMAGE

01 REPAIR FRAMING AND DECKING CONNECTIONS AT CORNER OVERHANG AS NEEDED TO ELIMINATE GAPS. CONSULT COR.

02 REPLACE ROUND FRAMING. PAINT TO MATCH EXISTING AS CLOSELY AS POSSIBLE.

03 OPTION #1:
REPAIR ROOF OVERHANG FRAMING AND PLANK DECKING AS NEEDED. INSPECT ALL ROOF OVERHANG FRAMING AND DECKING AND REPORT FINDINGS TO COR BEFORE PROCEEDING ON REPAIRS.

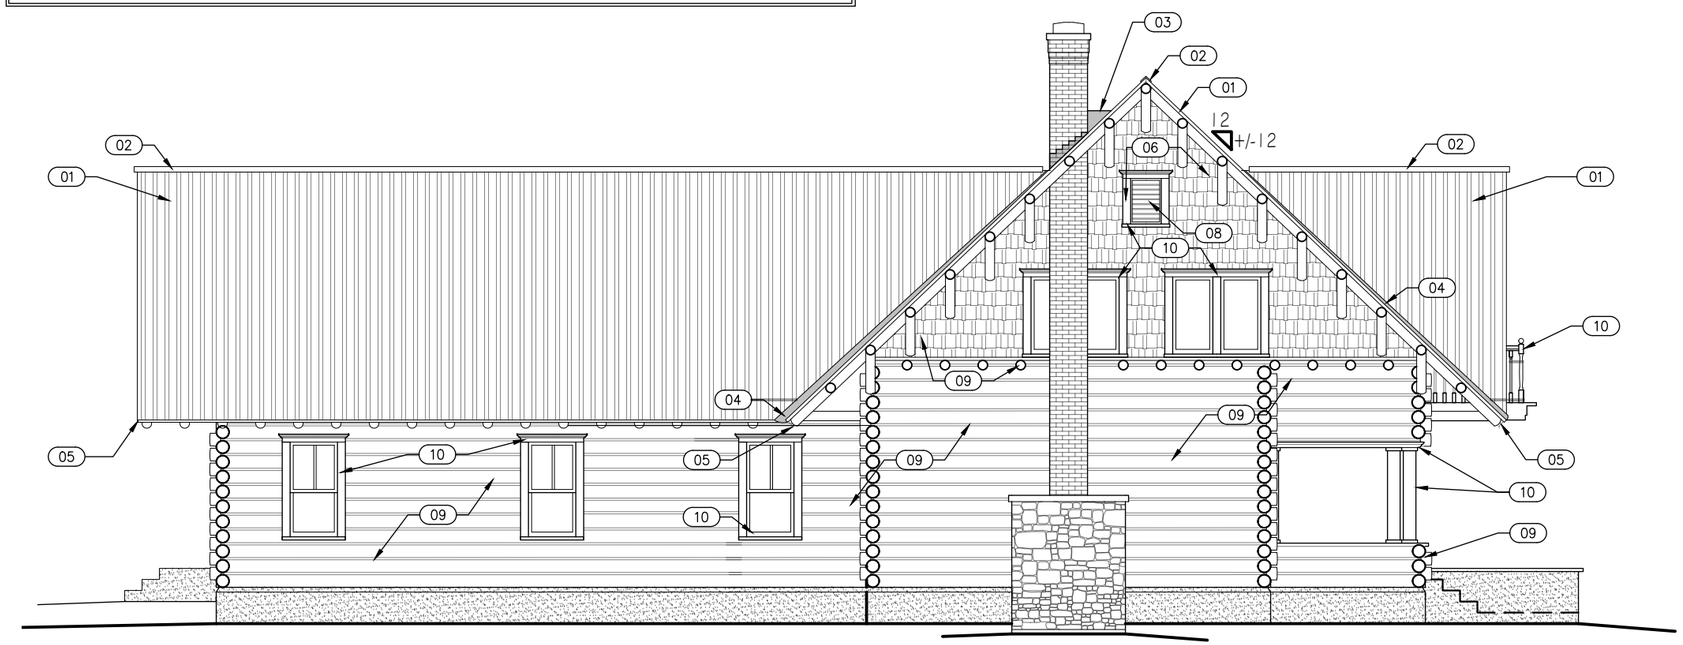
1 SOUTH ELEVATION
SCALE: 1/8" = 1'-0"

06 WOODPECKER DAMAGE: SEAL WALL SHEATHING WHERE DAMAGED. REPLACE LEFT SIDE VENT TRIM. REPLACE OR PATCH AND FILL VENT CROWN MOLDING AND CEDAR GINGERBREAD SIDING. PAINT TO MATCH EXISTING AS CLOSELY AS POSSIBLE.

08 VIEW OF WOODPECKER DAMAGE

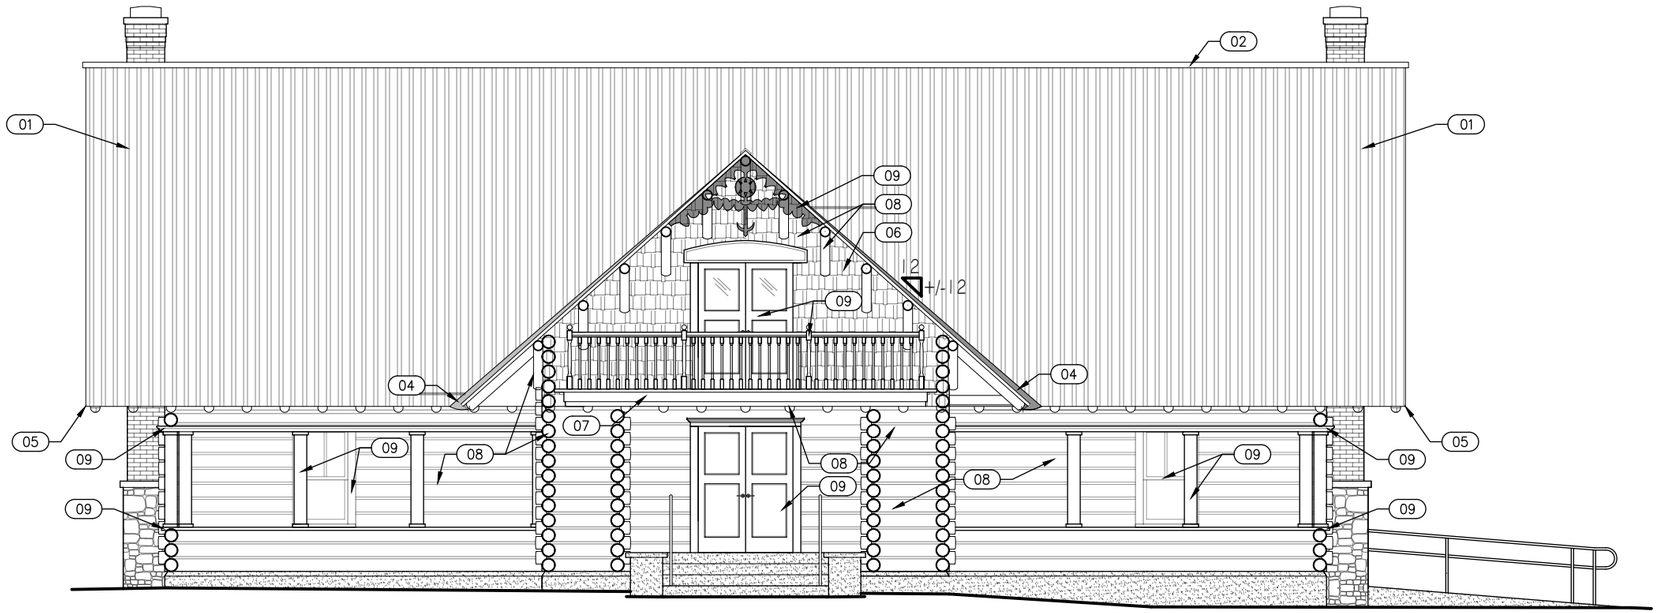
1 WEST ELEVATION
SCALE: 1/8" = 1'-0"

07 FUTURE PROJECT / NOT IN CONTRACT ADDRESS SAGGING FRAMING AT BALCONY AND CORNER OVERHANG.

08 VIEW OF WALL PENETRATIONS

06 SEAL WALL PENETRATION.
