DYE-2 CIRE3 Station

2022-06-16

DYE-2 2022-06-16

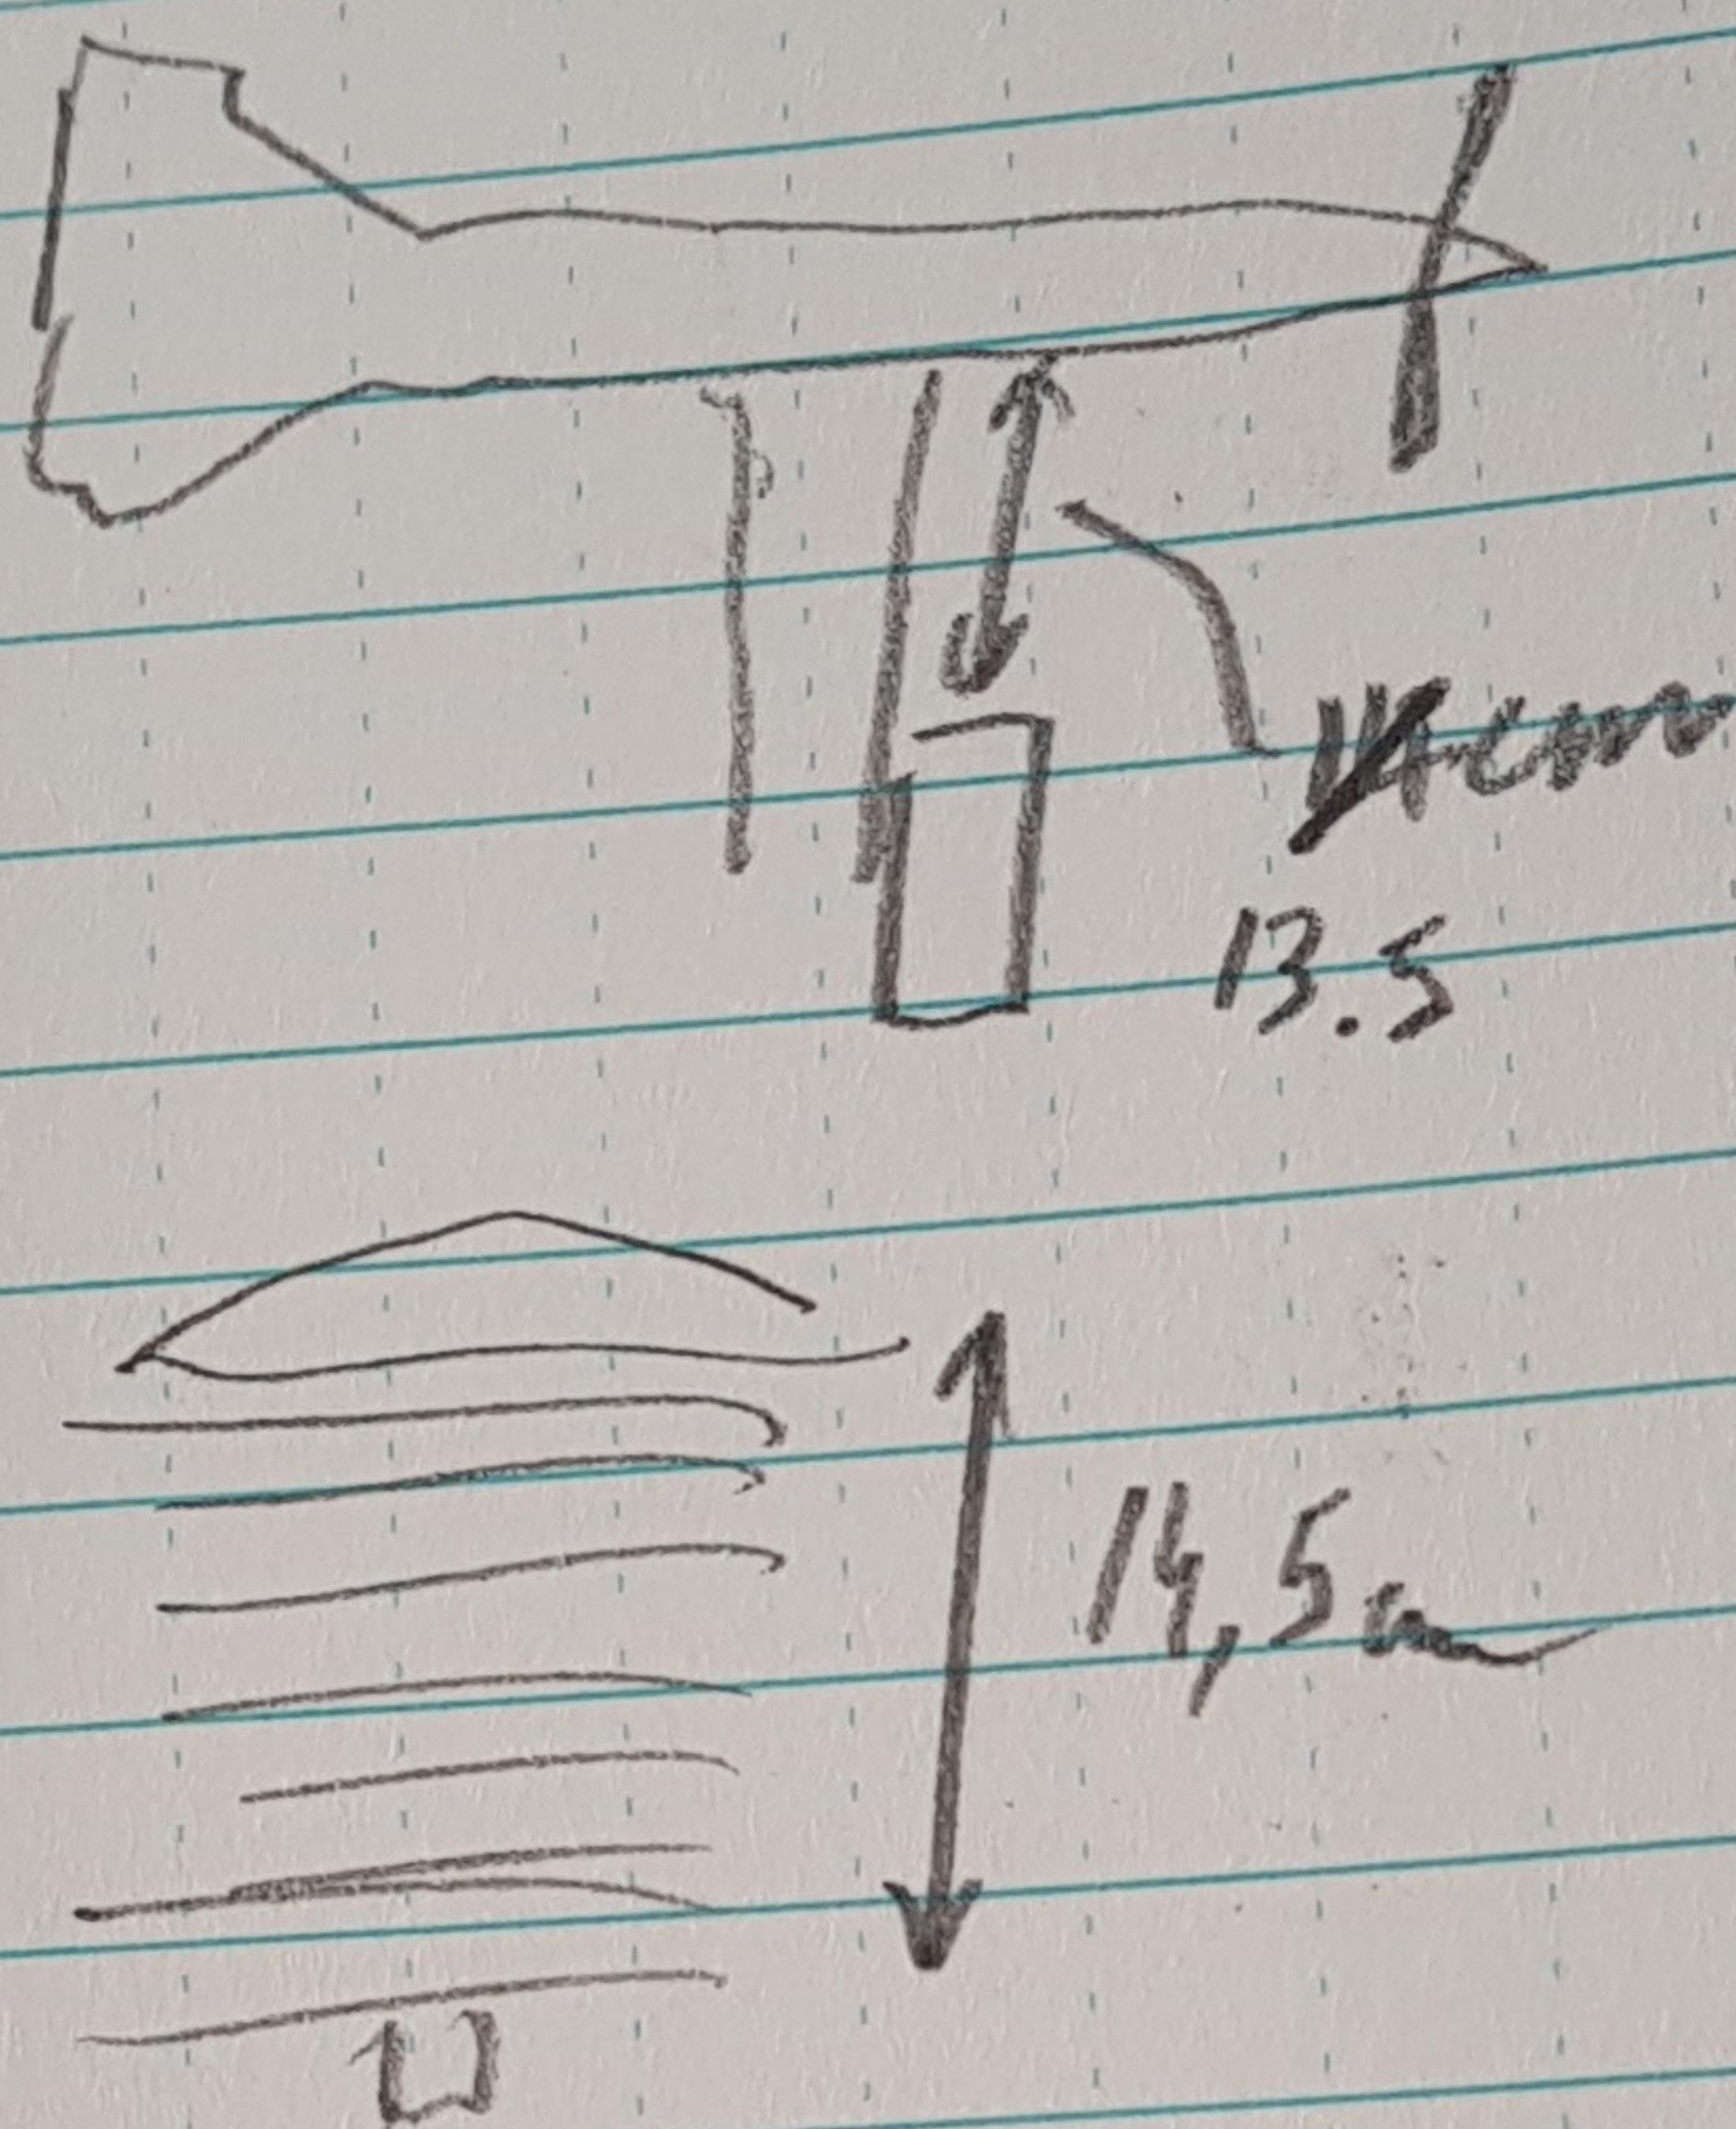
H SR low 279 cm to membrane

H SR high 335 cm to membrane

Lower SR broken membrane

Radiation sensor with
broken dome
+ Sideways
