AWS maintenance / establishment checklist version 5

Station name	2AK-T TOP STATION
Observer(s)	MCIT - DOLA
Purpose of visit	MAINT

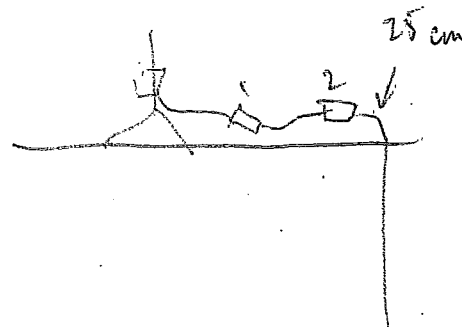
- ?
- buried
↓

New tripod - all sensors transferred
