2. Thermal Report (Sample)

Report Details

- Device Used: Thermal Imaging Camera
- Inspection Date: 10 April 2026

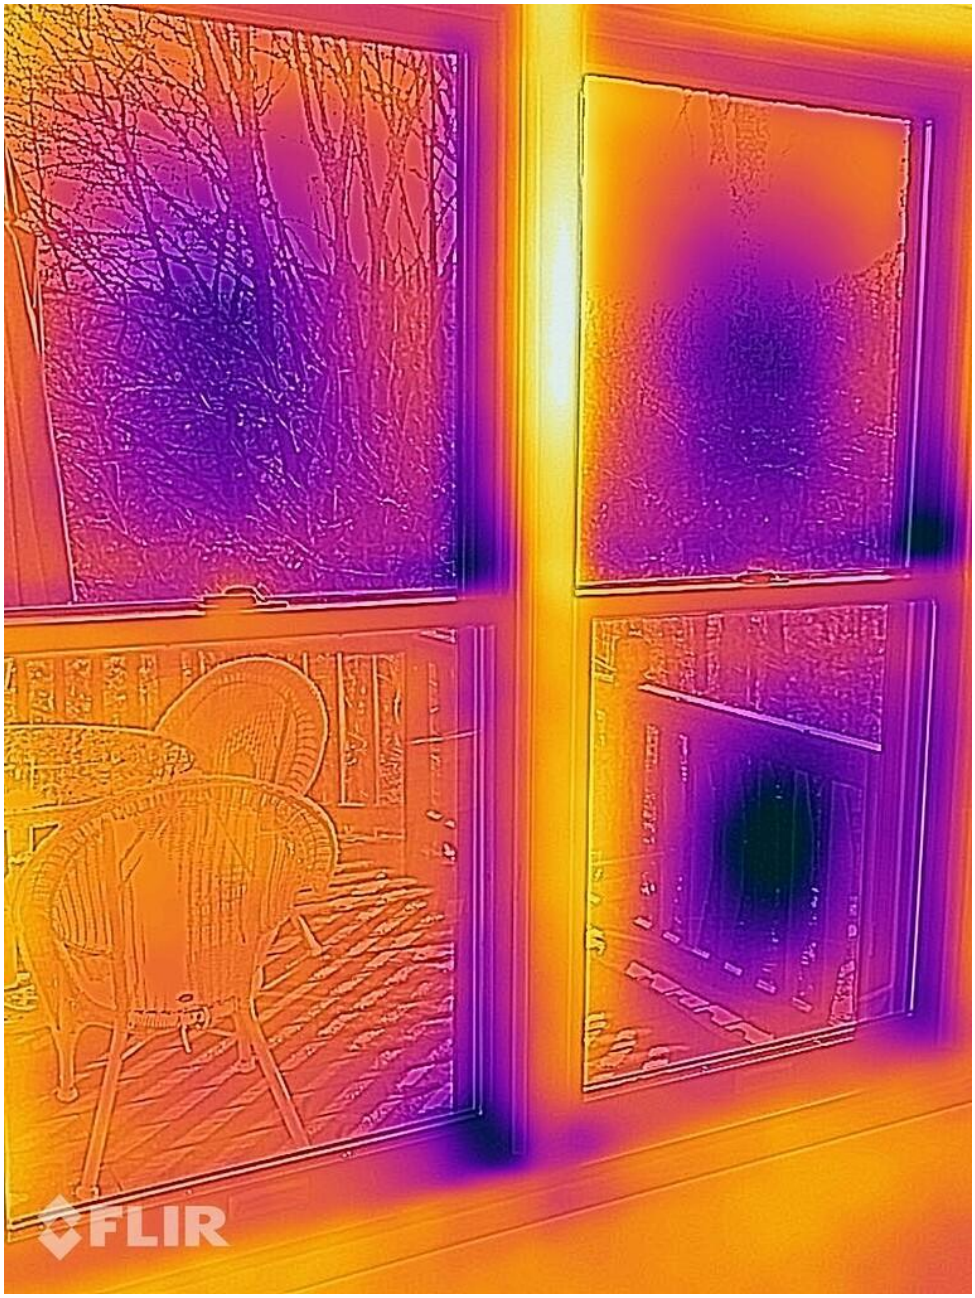
Infrared view of kitchen window. Notice the cooler area along the south edge and below the window.

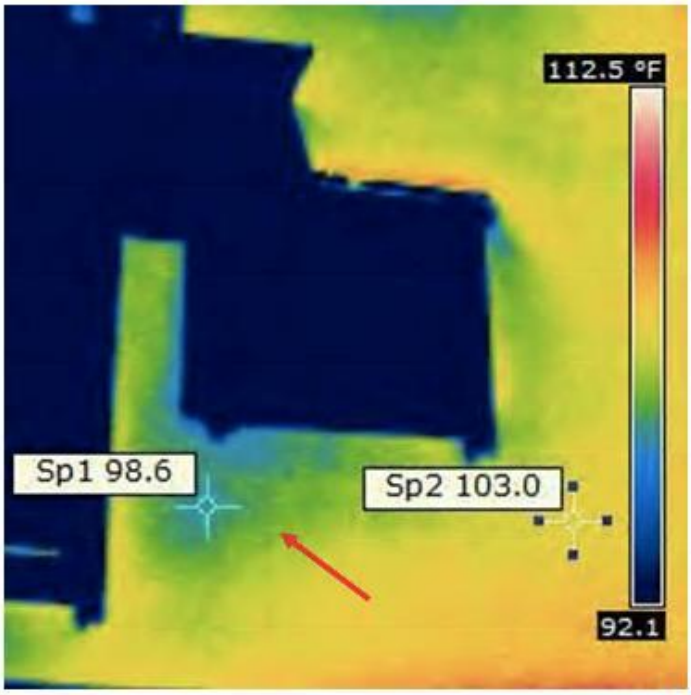
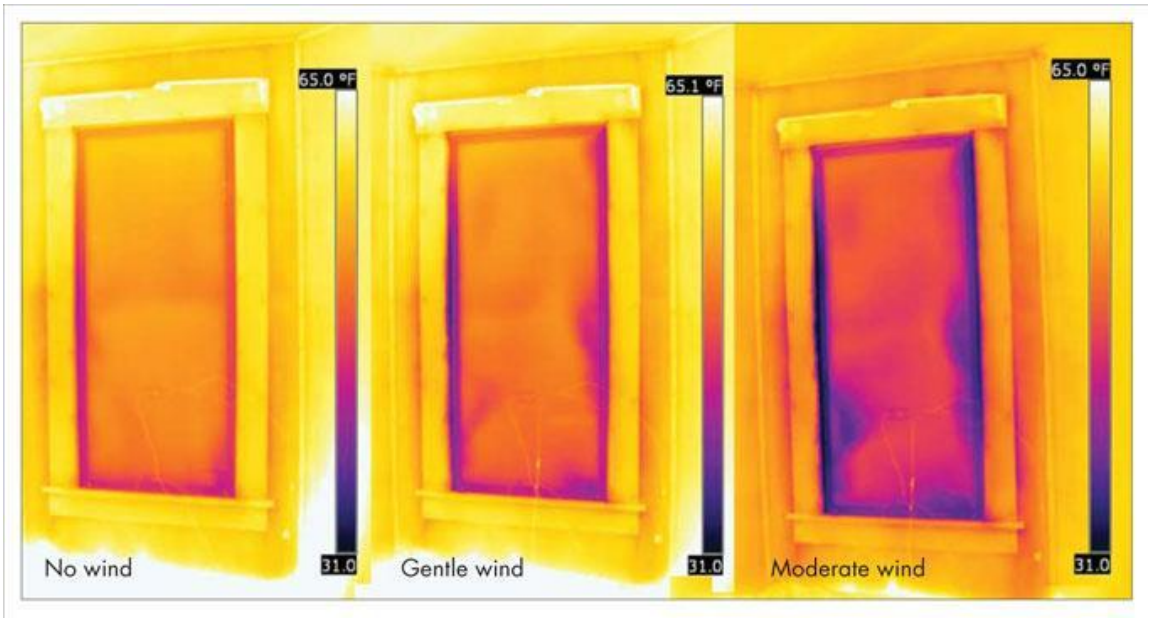
Bedroom Window Area

- Temperature drop near window edges
- Suggests air leakage or moisture

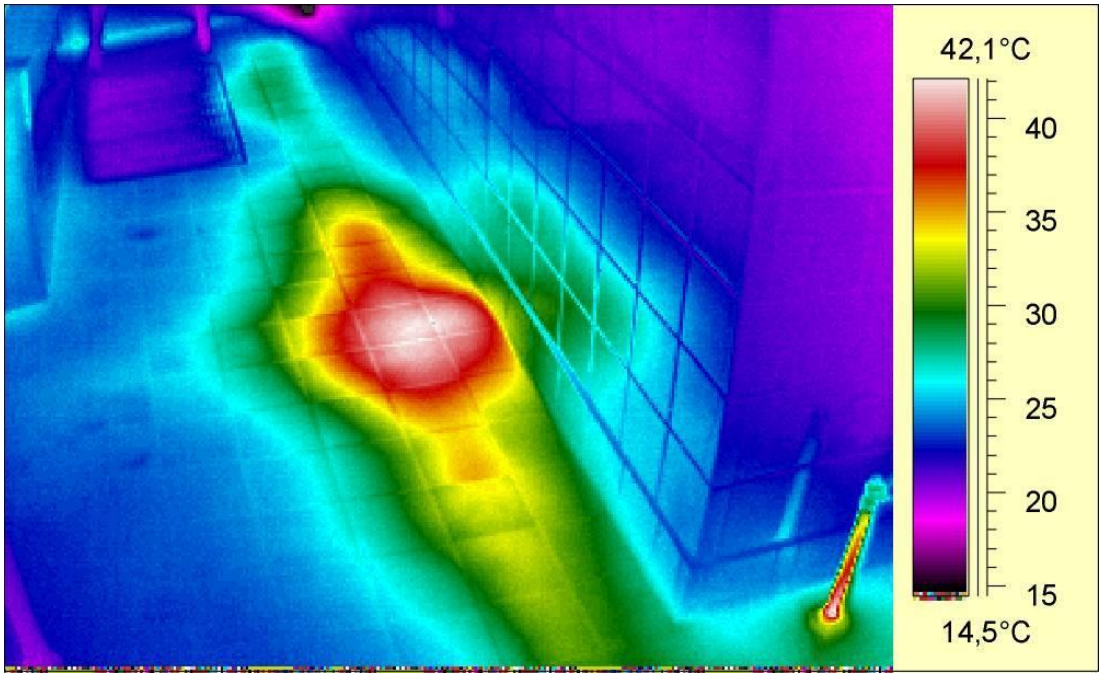
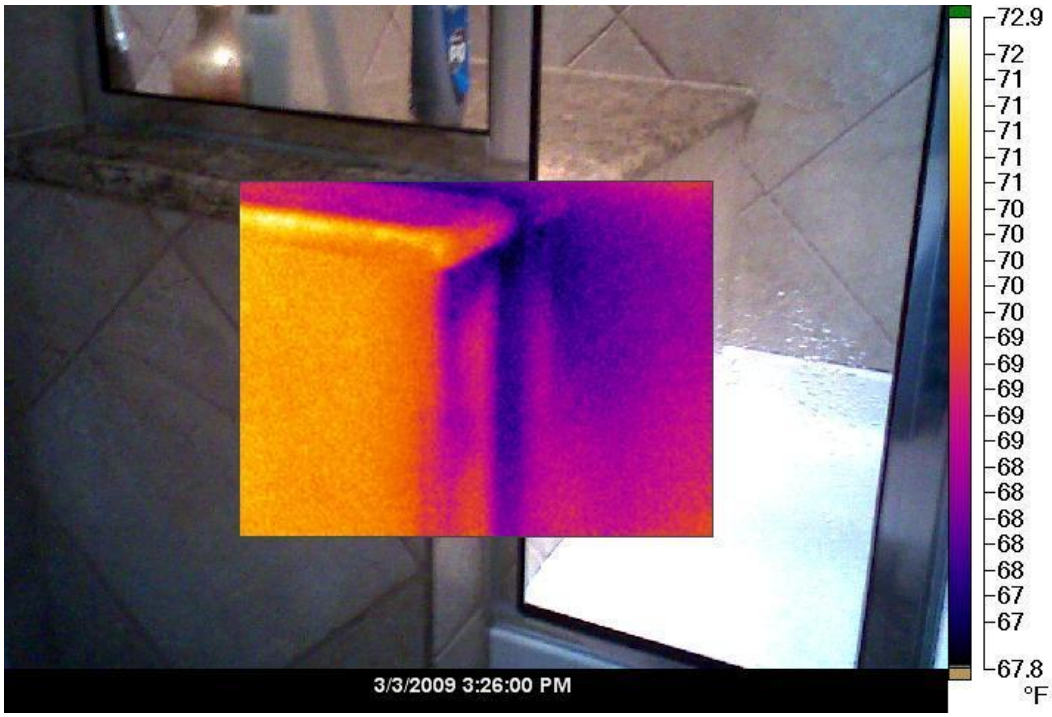
Bathroom Shower Wall

- Uneven heat distribution
- High moisture retention behind tiles
