NautiCAI

OFFICIAL HULL INSPECTION REPORT

1. VESSEL INSPECTION DETAILS (COMBINED REPORT)

Vessel ID:	video1
Report Number:	NautiCAI-2026-03-30-001
Inspection Type:	Automated Underwater Hull Assessment (Multi-Image)
Total Images in This Report:	10
Report Status:	COMPLETED - Audit Trail Generated

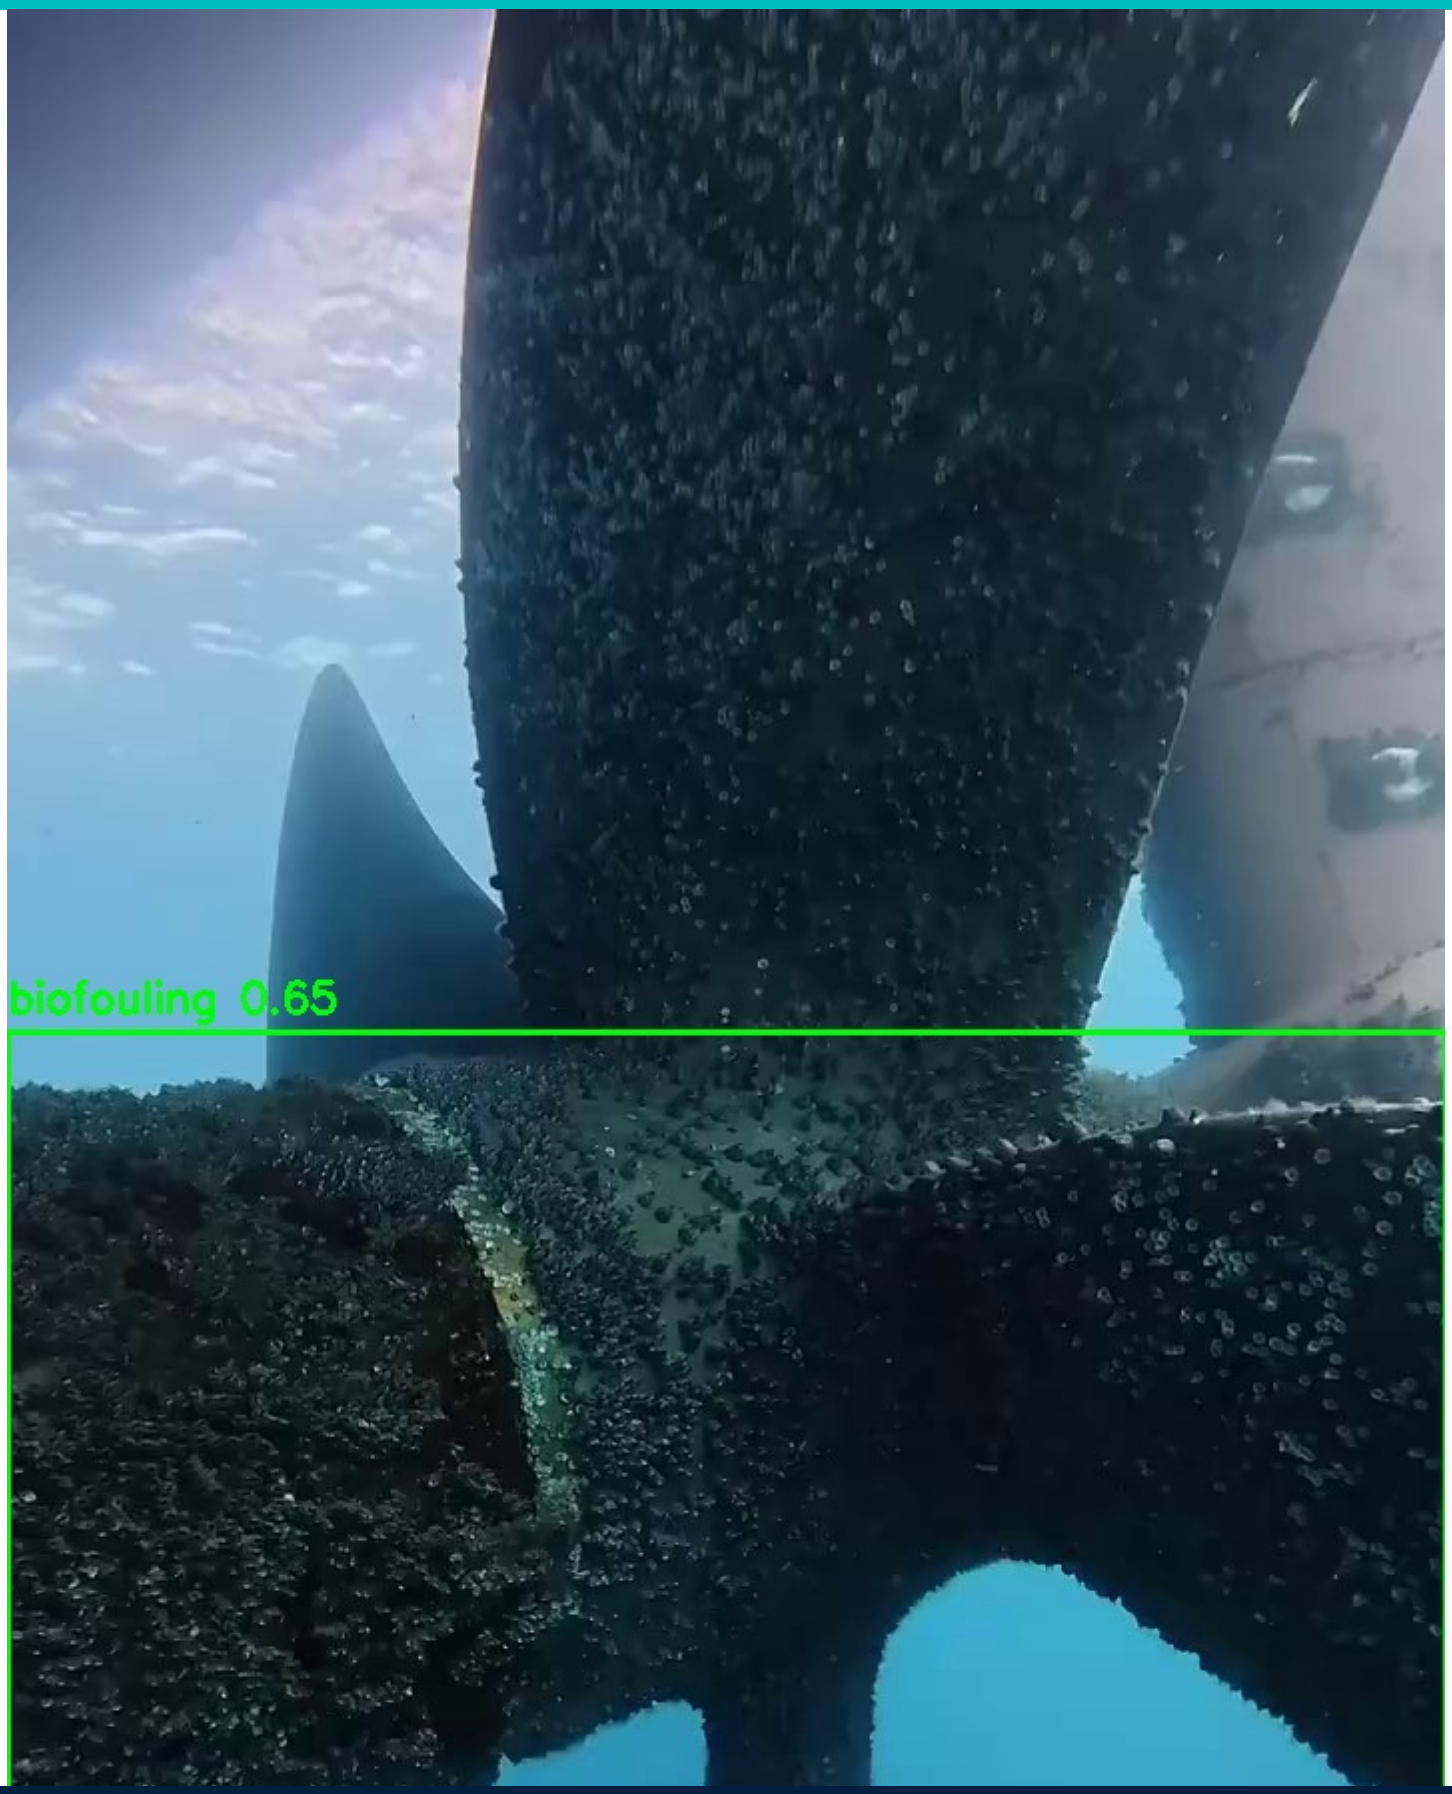
Annotated result - Image 1 of 10

2.1 IMAGE 1 OF 10 - HULL CONDITION FINDINGS

Inspection Date (this image):	2026-03-30 18:15:48
Total Hull Coverage:	53.5177%
Overall Condition:	High
Fouling Areas Identified:	1

FR-4 (Heavy Macrofouling - Critical!)

!! IMMEDIATE CLEANING REQUIRED !!

biofouling 0.65

Required Action: URGENT: Immediate dry-dock cleaning required!

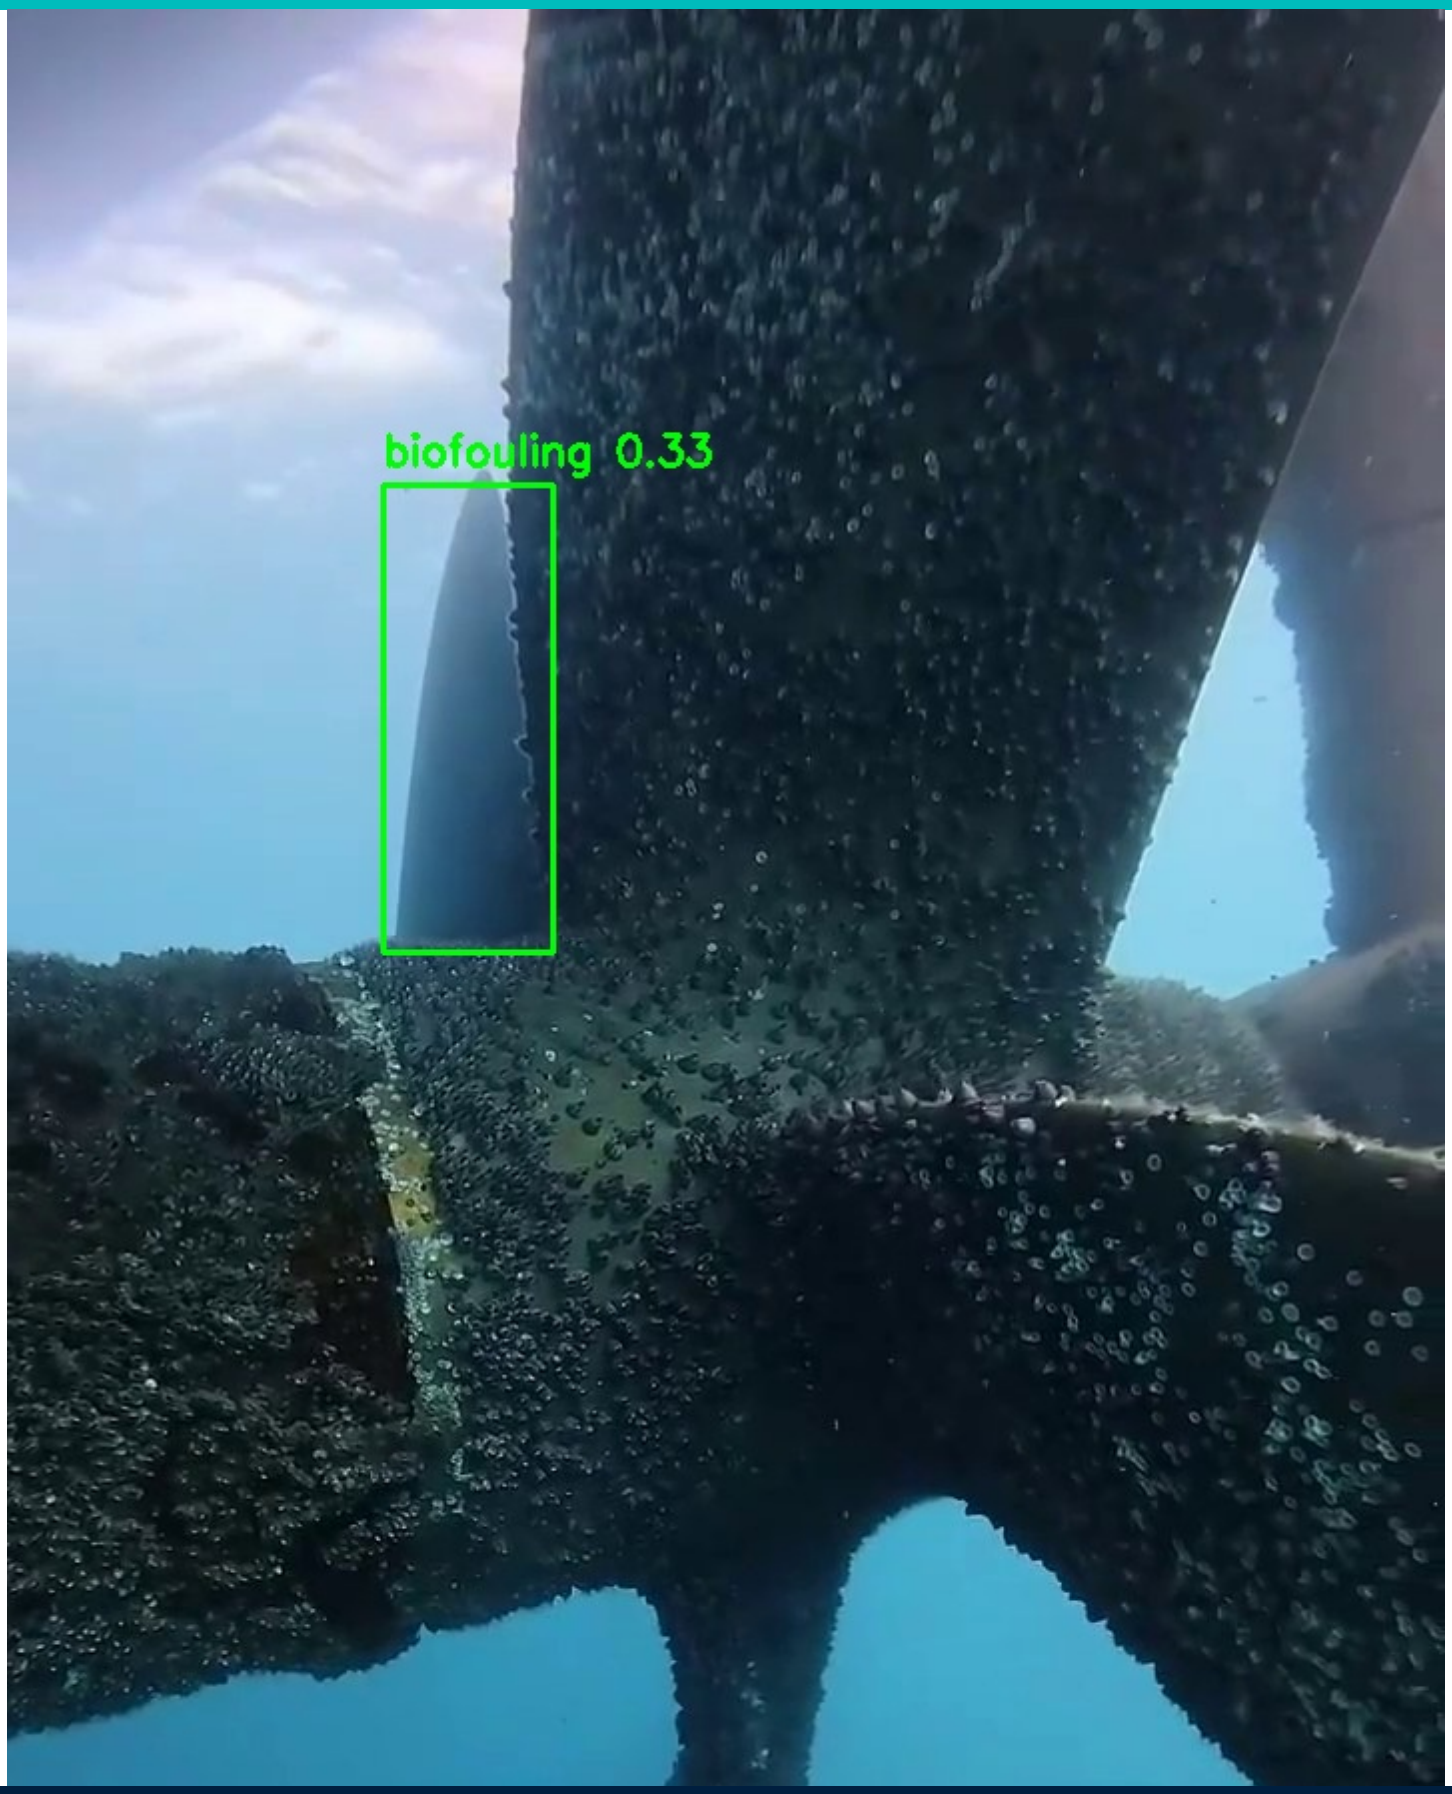
Annotated result - Image 2 of 10

2.2 IMAGE 2 OF 10 - HULL CONDITION FINDINGS

Inspection Date (this image):	2026-03-30 18:15:54
Total Hull Coverage:	1.2104%
Overall Condition:	Low
Fouling Areas Identified:	1

FR-2 (Light Macrofouling)

VESSEL CONDITION IS ACCEPTABLE

biofouling 0.33

Required Action: Monitor vessel condition regularly.
