# Sierra College Penetration Test Report for Challenge Lab

Colby Heilner

5/24/2025

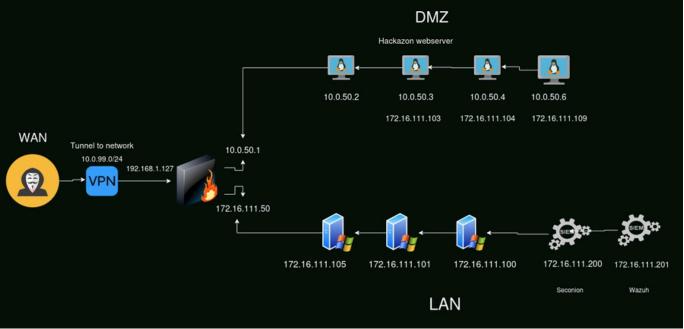
During this penetration test, Colby was tasked with exploiting the lab network. Initial scans targeted 192.168.1.127, using stealth techniques to avoid detection by assumed IDS/IPS (e.g., Snort). The following command was used:

nmap -sS -T2 -Pn --scan-delay 100ms --max-retries 2 -g 53 --data-length 25 -p 8080,2222,80,443,8081,8082,2223 192.168.1.127
