EXCEL ENGINEERING COLLEGE (AUTONOMOUS) - DEPARTMENT OF ECE

SOLAR PANEL DEFECT DETECTION & DIAGNOSTIC REPORT (MATLAB FUSION PIPELINE)

Panel ID: Panel1 Clean | Inspection Date: 15-Oct-2026 10:09:22 | Analysis Method: Dual Thermal-Visual Feature Fusion

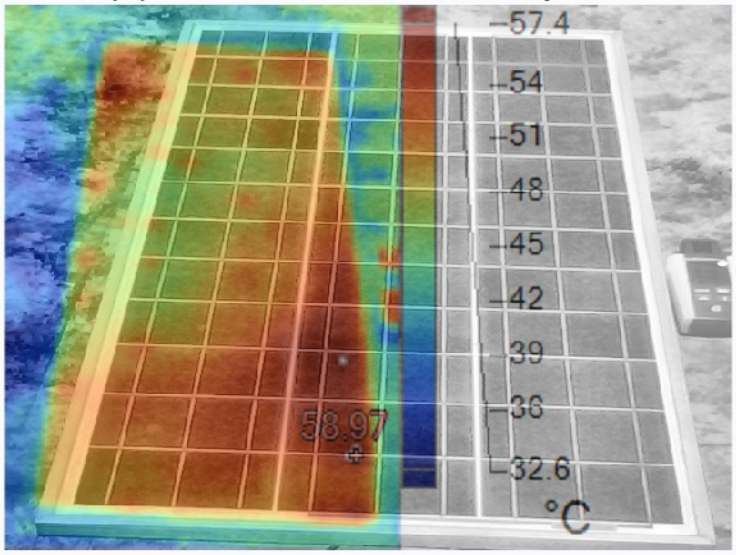
(B) Thermal Thermography (T_{max}: 58.9 °C)

- Primary Defect Identified : Hotspot / Cell Overheating
- Peak Temperature (T_{max}) : 58.87 °C (Ambient Mean: 49.00 °C)
- Temperature Rise (Δ T) : +9.87 °C
- Affected Panel Surface : 15.9 %
- Severity Rating : [CRITICAL]

STATUS CRITICAL

Critical localized thermal hotspot. High risk of EVA browning / backsheet burn-through. Isolate string and replace cell/module immediately.
