EXCEL ENGINEERING COLLEGE (AUTONOMOUS) - DEPARTMENT OF ECE

SOLAR PANEL DEFECT DETECTION & DIAGNOSTIC REPORT (MATLAB FUSION PIPELINE)

Panel ID: Panel1 Clean | Inspection Date: 15-Oct-2026 10:10:21 | Analysis Method: Dual Thermal-Visual Feature Fusion

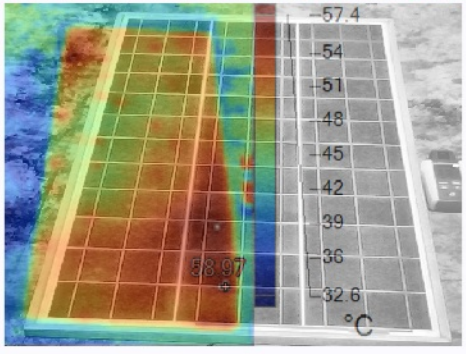
(B) Thermal Thermography (T_{max}: 58.9 °C)

- Primary Defect Identified : Hotspot / Cell Overheating
- Peak Temperature (T_{max}) : 58.87 °C (Ambient Mean: 49.00 °C)
- Temperature Rise (Δ T) : +9.87 °C
- Affected Panel Surface : 15.9 %
- Severity Rating : [CRITICAL]

Critical localized thermal hotspot. High risk of EVA browning / backsheet burn-through. Isolate string and replace cell/module immediately.
