EXCEL ENGINEERING COLLEGE (AUTONOMOUS) - DEPARTMENT OF ECE

SOLAR PANEL DEFECT DETECTION & DIAGNOSTIC REPORT (MATLAB FUSION PIPELINE)

Panel ID: Panel1 Dirt | Inspection Date: 15-Oct-2026 10:09:41 | Analysis Method: Dual Thermal-Visual Feature Fusion

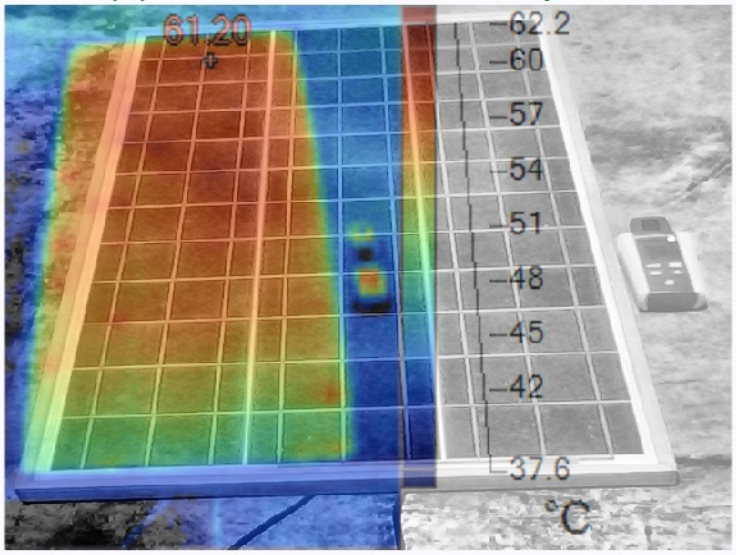
(B) Thermal Thermography (T_{max}: 61.2 °C)

- Primary Defect Identified : Hotspot / Cell Overheating
- Peak Temperature (T_max) : 61.15 °C (Ambient Mean: 51.95 °C)
- Temperature Rise (Δ T) : +9.20 °C
- Affected Panel Surface : 14.5 %
- Severity Rating : [CRITICAL]

Critical localized thermal hotspot. High risk of EVA browning / backsheet burn-through. Isolate string and replace cell/module immediately.
