EXCEL ENGINEERING COLLEGE (AUTONOMOUS) - DEPARTMENT OF ECE

SOLAR PANEL DEFECT DETECTION & DIAGNOSTIC REPORT (MATLAB FUSION PIPELINE)

Panel ID: Panel1 Shadow | Inspection Date: 15-Oct-2026 10:09:50 | Analysis Method: Dual Thermal-Visual Feature Fusion

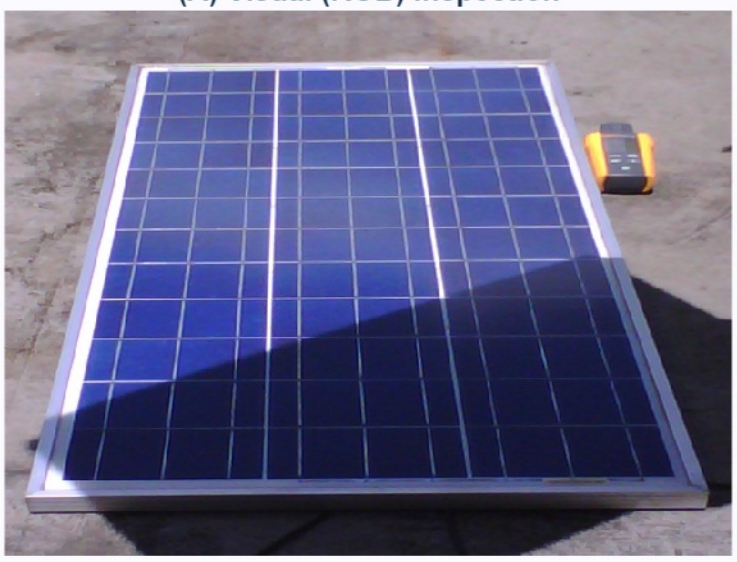
(A) Visual (RGB) Inspection

- Primary Defect Identified : Shadow / Shading Mismatch
- Peak Temperature (T_max) : 58.10 °C (Ambient Mean: 49.91 °C)
- Temperature Rise (Δ T) : +8.20 °C
- Affected Panel Surface : 22.6 %
- Severity Rating : [HIGH]

Significant partial shading detected causing reverse bias heating. Remove physical obstructions and verify bypass diodes.
