Design validation record

Executed laboratory results for prototype pack AQL-P3-017. This signed report is primary test evidence. Inspection after disassembly is recorded separately in AQL-QIR-221.

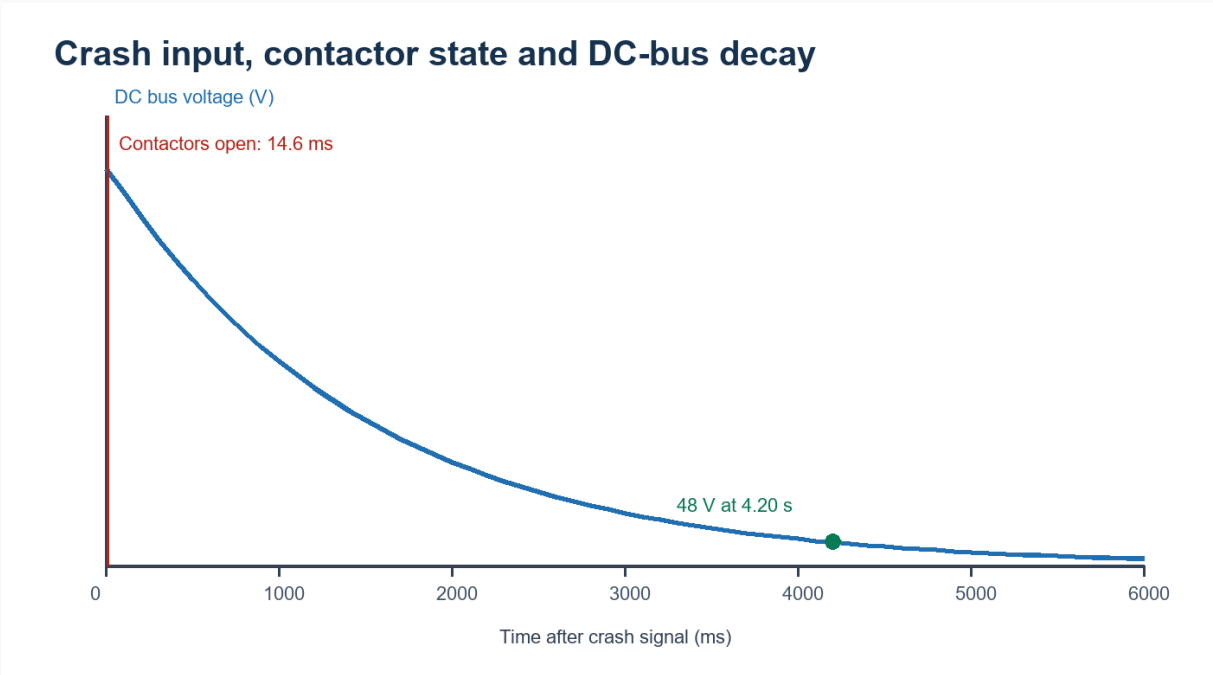
Event	Measured value	Requirement	Result
Crash input asserted	0.0 ms	Reference	Recorded
Both main contactors open	14.6 ms	<= 20 ms	PASS
DC bus at 4.20 s	48 V	< 60 V by 5.0 s	PASS

Figure 2. Recorded DC-bus trace; contactors opened at 14.6 ms and bus voltage reached 48 V at 4.20 s.

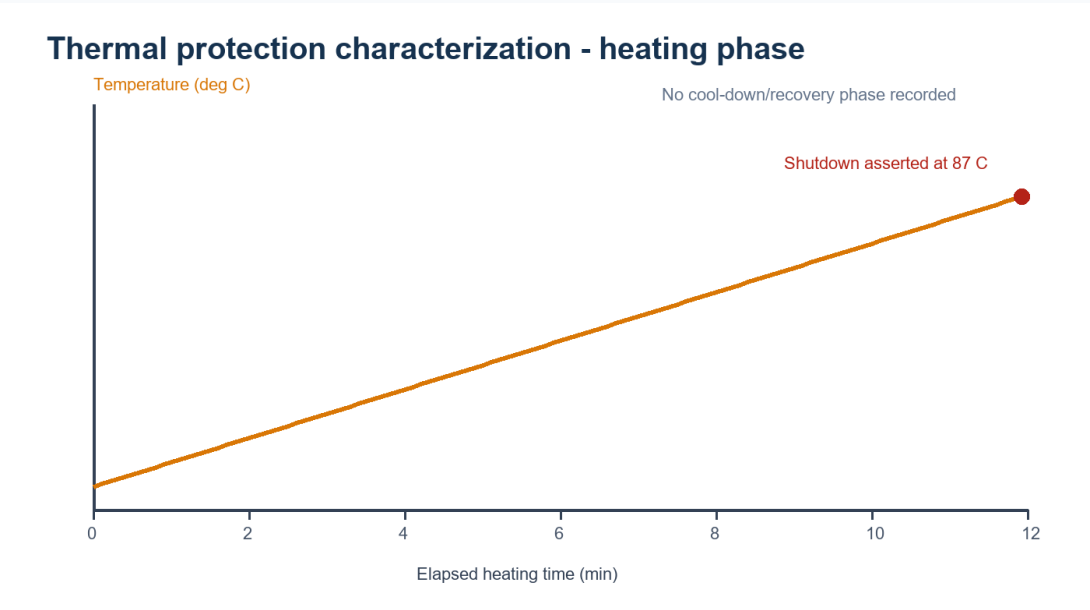
Test	Measured result	Recorded disposition
Thermal shutdown heating ramp	Shutdown asserted at 87 deg C	PASS for shutdown
Recovery below 70 deg C for 60 s	Cool-down phase not run	NOT TESTED
Coolant pressure hold	2.00 bar for 30.0 min	PASS
Visible leakage during hold	0.00 mL observed through chamber window	PASS in-run observation

Figure 3. Heating-phase trace. It proves shutdown behavior but contains no recovery evidence.

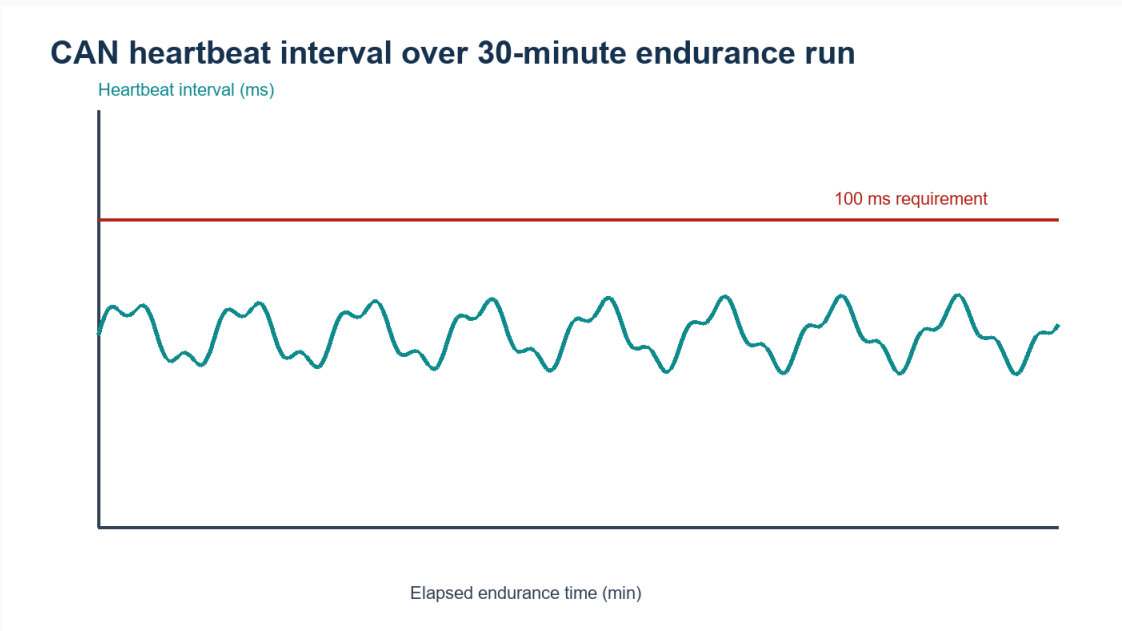
Duration	Messages expected	Messages received	Maximum interval
30.0 min	18,000	18,000	95.1 ms

Figure 4. Heartbeat interval remained below 100 ms for the full 30-minute run; message counter showed zero loss.
