جامعة خليفة
Khalifa University

Inspection Date	07-02-2023	**Report Ref. No.**	MACINS -07/2/2023
Site Name	Main campus	**Location**	OSCE B - 1,2,3,4,5,6,7,8,9,10,11,12,13,14
Inspected By	Roberto Macahig	**Witnessed by**	Ahmed Kamal Abdalgadir Mohamed

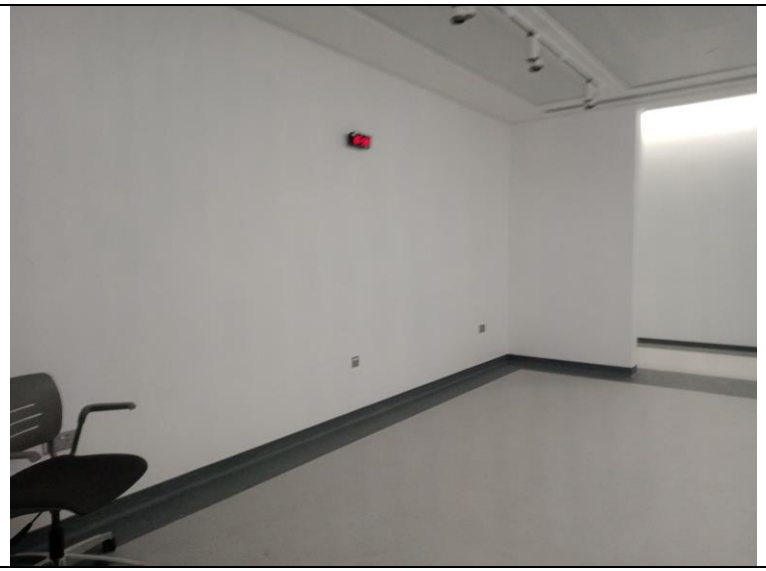
7.	One Manual call point was found deactivated	Yes			√
8.	A trolley is stored in the Emergency Exit staircase	Yes			√
9.	IDF Room Electrical Panel – related to access control is found unsecured and the room needs housekeeping.	Yes	√		
10.	Specific Risk Assessment is to be reviewed according to lab activities	Yes			√

Hard Services			
7.	To be maintained by FM Hard Services		FM - Imdaad	
8.	To be removed from the site by FM Soft Services		FM –West Coast	
9.	To be secured and maintained by FM Hard Services		FM - Imdaad	
10.	To be reviewed and updated.		Lab Primary Contact
