Inspection Date	07-02-2023	**Report Ref. No.**	MACINS 0X -07/2/2023
Site Name	Main campus	**Location**	OSCE A - 13,14,15,16,17,18,19,20,21,22,23,24
Inspected By	Roberto Macahig	**Witnessed by**	Ahmed Kamal Abdalgadir Mohamed

Inspection Type	☑General ☑Housekeeping & Sanitation ☑Fire ☑Electrical ☐Ladders ☑Lab ☐Food ☐Structure ☐Motor Vehicles ☐Landscaping ☐PPE ☑Stores ☑Emergency Evacuation

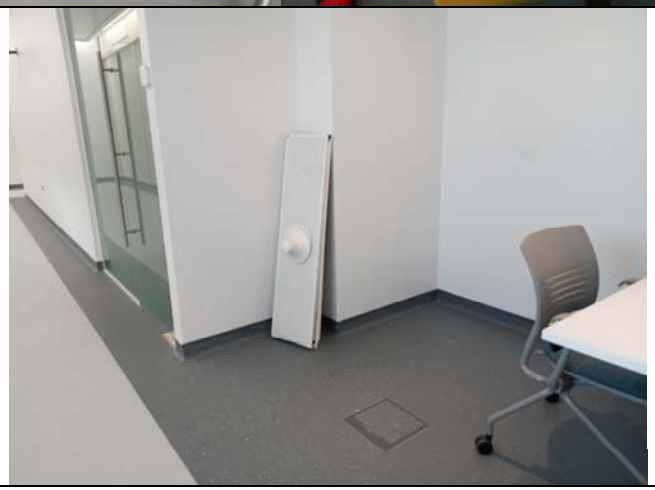
Findings					
	☐ Safety ☐ Environment ☐ Occupational health				
S/N	**Description**	**Significant Risk Yes/No**	**Risk Evaluation**		
			Low	**Med**	**High**
1.	Common First Aid Box and First Aiders to be available in OSCE A	No	√		
2.	Hazardous waste (Biohazard waste) management to be reviewed as bins were available, however, is actual waste will be produced on-site, and if biohazard spill kit(to be updated) is required.	Yes	√		
3.	Lab information notice, RACE C to be available in the lab (primary contact, hazards in the lab, emergency information)	Yes		√	
4.	Ceiling tiles with sharp edges were found stored in the corridor	Yes	√		
5.	Two Emergency Exit Sign lights were found defective	Yes			√
6.	Corridor Ceiling Internal smoke detector found deactivated	Yes			√

7.	One Manual call point was found deactivated	Yes			√
8.	A trolley is stored in the Emergency Exit staircase	Yes			√
9.	IDF Room Electrical Panel – related to access control is found unsecured and the room needs housekeeping.	Yes	√		
10.	Specific Risk Assessment is to be reviewed according to lab activities	Yes			√

Corrective actions				
S/N	**Description**			
	Short Term Action	**Long Term Action**	**By Whom**	**By When**
1.	To be installed in the common area.		Lab Primary Contact	
2.	To be reviewed and decided for collection points.		Lab Primary Contact	
3.	To be installed in the common area. Signs are to be provided on-site.		Lab Primary Contact	
4.	To be removed from the site by FM Hard Services		FM - Imdaad	
5.	To be maintained by FM Hard Services		FM - Imdaad	
6.	To be maintained by FM		FM - Imdaad

Hard Services			
7.	To be maintained by FM Hard Services		FM - Imdaad	
8.	To be removed from the site by FM Soft Services		FM –West Coast	
9.	To be secured and maintained by FM Hard Services		FM - Imdaad	
10.	To be reviewed and updated.		Lab Primary Contact
