INDOOR ENVIRONMENTAL ASSESSMENT

Reference report - Sample Job 01

Property: Sample Property 01, Ontario

Inspection date: October 6, 2026

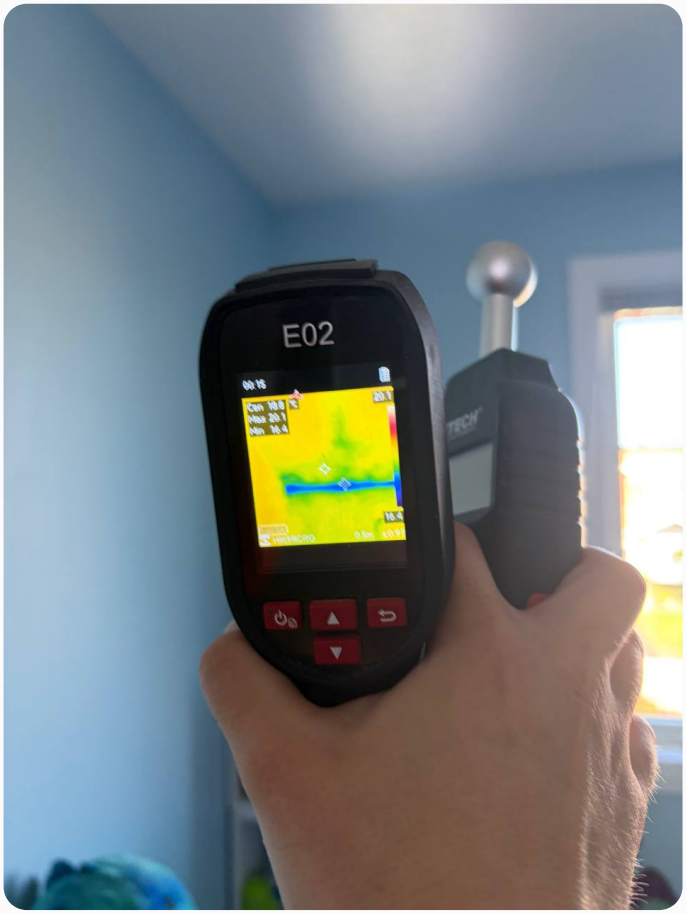
Swab test #2

Swab test #3

Instant swab test revealed positive results for biological contaminant

► Professional Mold Remediation services

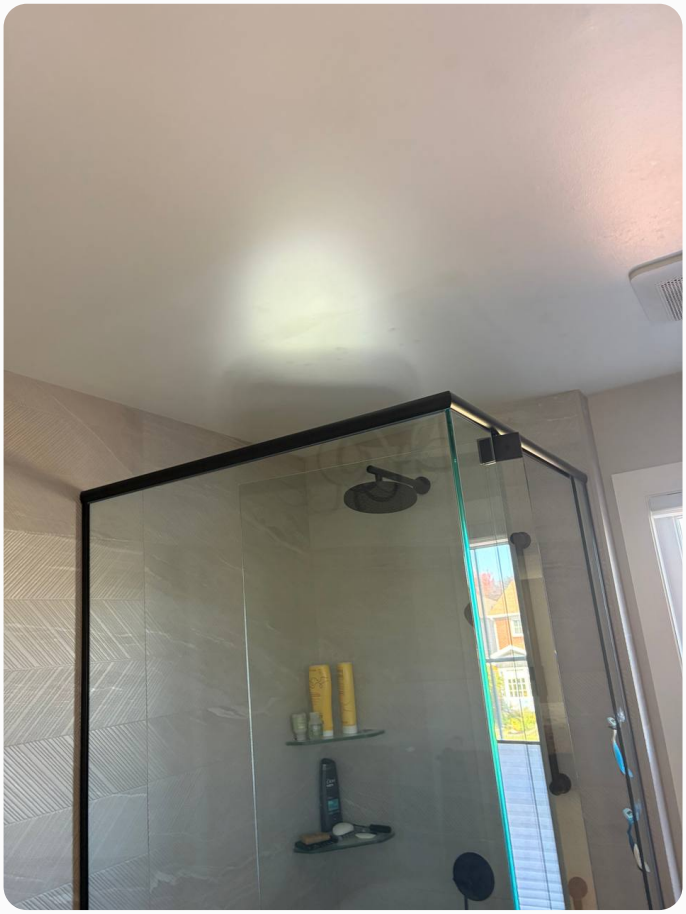
► Multiple thermal anomalies were detected throughout the property, mainly on the top floor but also on the main floor in the living room below the roof
► Another thermal anomaly was detected in the laundry room on the ceiling

Thermal anomalies detected throughout the property #1

Thermal anomalies detected throughout the property #2

► Contact a roofer to inspect the roof above the living room area on the main floor

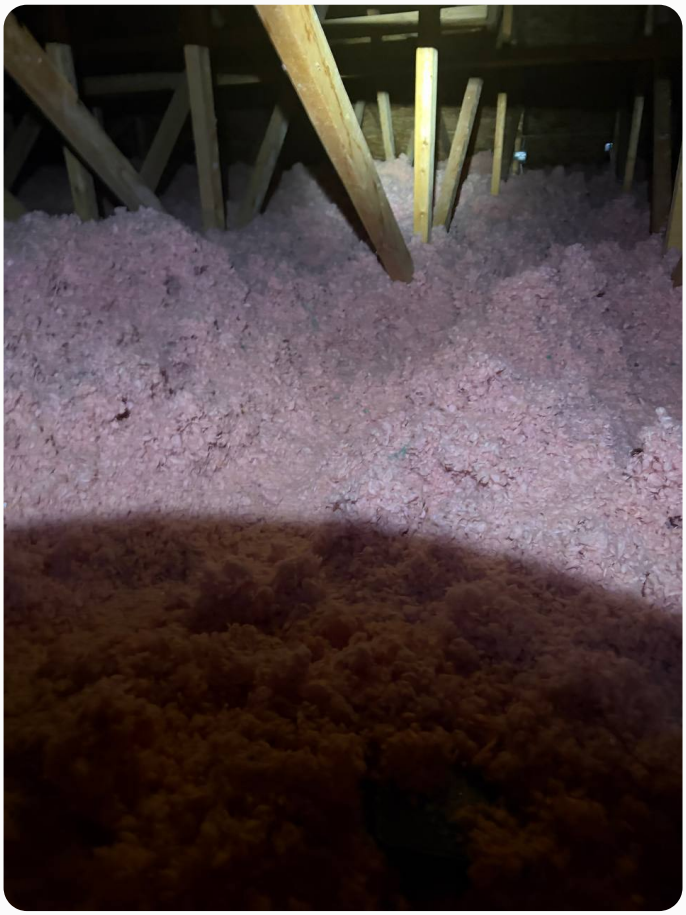
► Visible discoloration was observed in both washrooms upstairs
► Ceiling fans were functional during the inspection
► Standing water was observed in an en-suite washroom
► A ball-slope-test failed in the shower enclosure area
► The bathtub faucet was not fixed and the moisture content below was elevated
► Visible discoloration was observed around the grout and silicone sealant in the en-suite washroom
► Attic inspection was conducted and it was concluded that the insulation was unevenly distributed and heavily disturbed, leading to thermal inconsistencies
► Visible discoloration was present in the attic
► Exterior inspection concluded two main defects: drainage and depression around the main entrance

Ball slope test - failed

Visible discoloration in washrooms #1

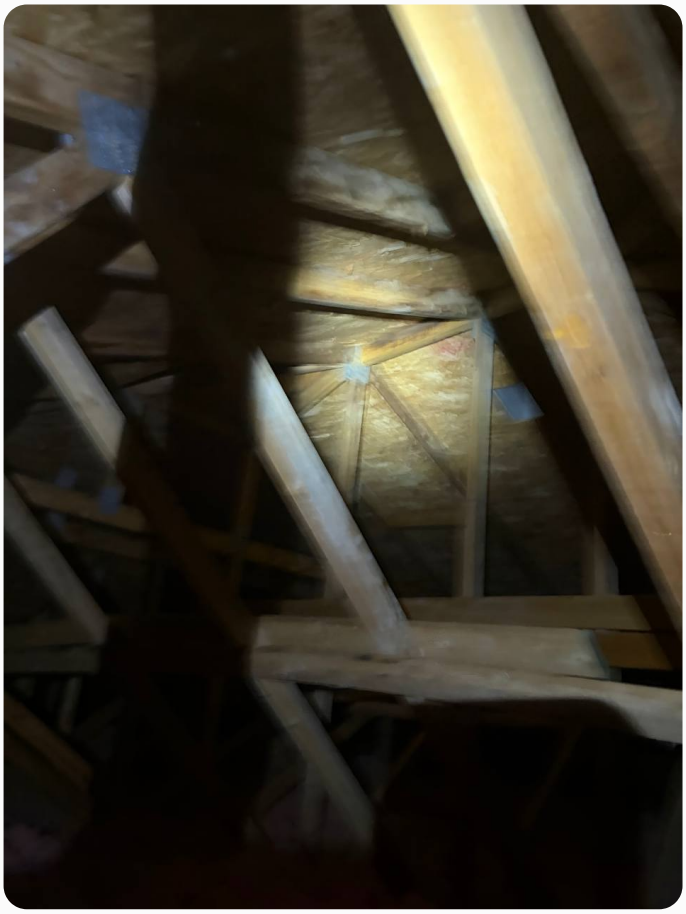
Attic inspection - disturbed insulation and visible discoloration #1

Attic inspection - disturbed insulation and visible discoloration #2

► Contact an insulation company to address the insulation issue in the attic
