# PLAYING WITH **FIRE**

**The massive fire that broke out on May 25 in Rajkot's TRP Game Zone and claimed 33 lives, including that of several children, highlights the severe safety lapses by the authorities and operators**

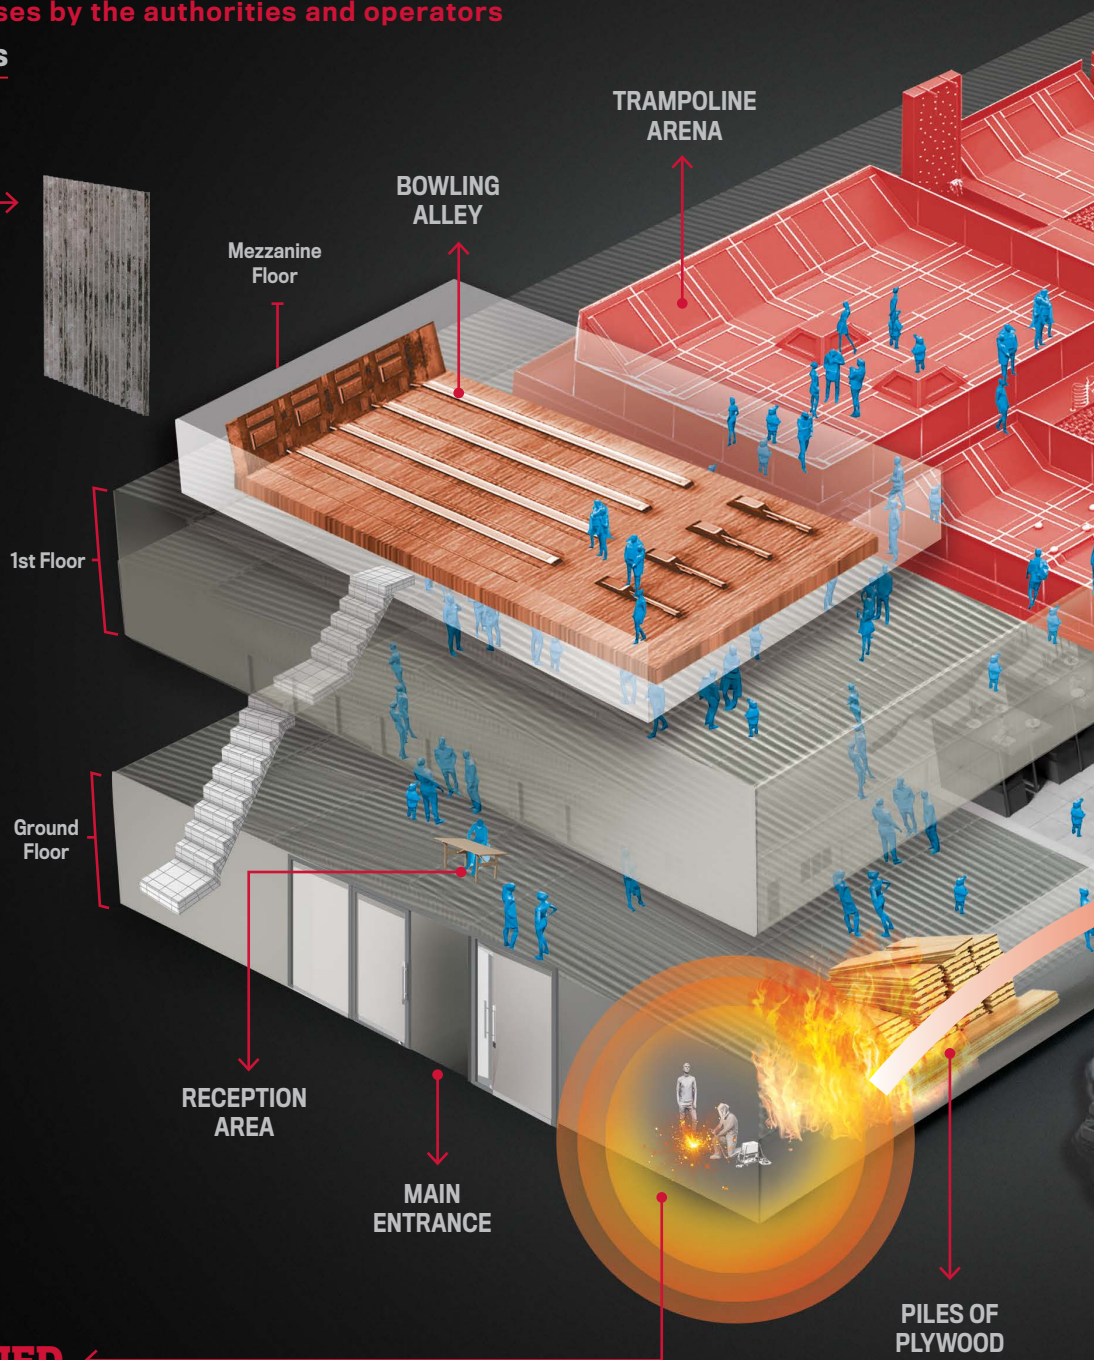
The whole two-storey facility was made of tin. Almost all the walls were lined with highly inflammable plastic foam sheets

- The game zone had only one door for entry and exit besides a flight of stairs. When the fire started, those on the first floor had no exit to escape through
- TRP mall workers had no clue about the fire rescue protocol. They closed connecting glass doors, trapping people on the first floor
- 2,000 litres of diesel, 1,500 litres of petrol and LPG cylinders were stored at the facility for generators, go-karting and F&B service requirements respectively
- Within a few minutes of the fire, a loud explosion brought down the tin shed, and reduced the place to cinders

A spark from the welding work on the ceiling is believed to have touched plastic sheets lying below. Piles of plywood close-by resulted in rapid spread of the fire. Within 45 seconds, the blaze was uncontrollable
