ANATOMY OF A DISASTER

THE TRIPLE TRAIN CRASH AT BAHANAGA BAZAR STATION NEAR BALASORE HAS LEFT 288 PEOPLE DEAD, OVER 1,100 INJURED AND SEVERAL QUESTIONS UNANSWERED. HERE'S A BLOW-BY-BLOW ACCOUNT OF WHAT TRANSPIRED ON JUNE 2

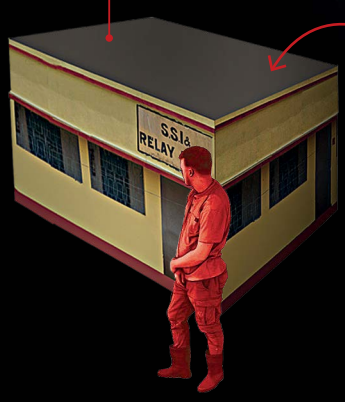
- The loco pilot sees that even the Home Signal post, 180 m from the station, is green, continues at 128 kmph
- The signal error sends the train into the loop line instead of the main line, where it crashes into the stationary freight train

- The loco pilot of the Coromandel Express sees the green light at the Distant Signal post 2 km from the station, and continues at the maximum speed of 130 kmph
- The signal should actually have been yellow because, by then, the main line is erroneously connected to the loop line. The train should have slowed down

- The SSI informs the SM that the work is done, reconnects boom barrier to interlocking system **(not physically verified by SM/SSI)**
- This is where the anomaly that resulted in the crash is suspected to have occurred
