MAINTENANCE AND REPAIR

HOW THE BRIDGE COLLAPSED

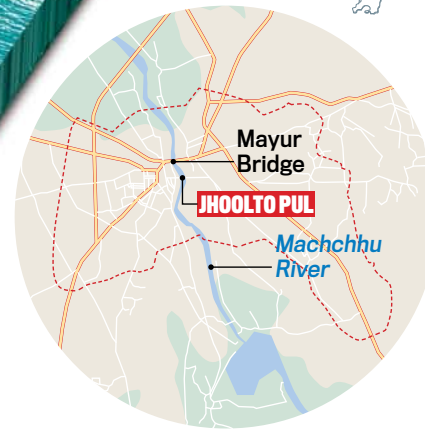
- Based on the available visuals and eyewitness accounts, one of the two suspension cables seems to have snapped, triggering a cascading effect that led to the breaking of the deck
- Another possibility is that the connections securing the vertical cables with the deck broke, especially at one end of the bridge, letting the unsuspended section with the people on it fall into the river
- The bridge was overcrowded
- Excessive swaying of the bridge has been suggested as another possible factor that needs to be probed
- The original wooden deck was replaced with a heavier aluminium one during recent repairs, but the cables were not strengthened. This caused greater strain on the connecting mechanism
