VISION PROFILE EXTRUSIONS

Sample Approval Form

Die #: 4683C
Description: 3-1/4" Operable Casement Frame

Die #: 4685C
Description: 3-1/4" Fixed Casement Frame

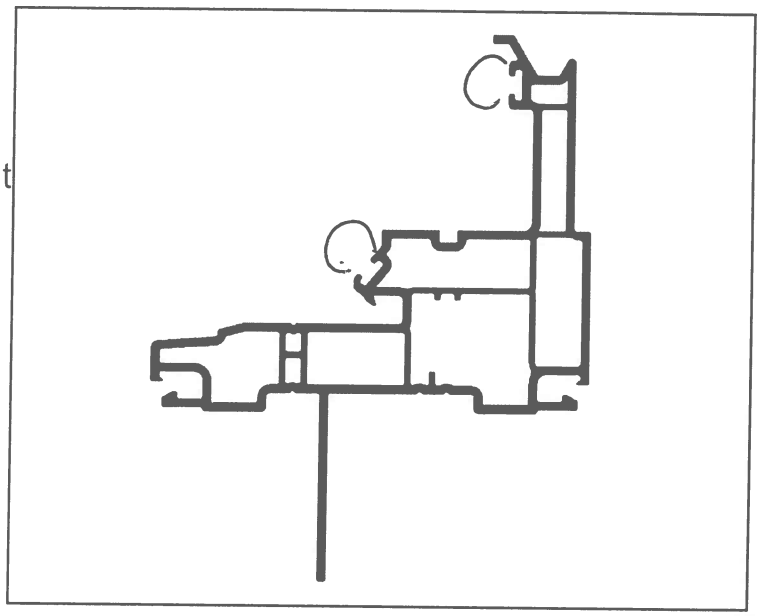
Comments: Comments emailed on 11/15/21, with response on 11/23/21. Though the sample did not have capstock, we are presuming this profile can be capstocked as shown on the prints.

2. Operable frame (4683):
   a. Fin is correct length and properly located off the front face of the profile.
   b. Overall exterior dims look good.
   c. The cavity in the tower is a little undersized. This is important b/c there is a support horn we slide into the cavity for punching the operator & locks. With that said, this sample did fit on the dies.
   d. I noticed the coex bulb was not extruded on these samples. For production runs we will need to ensure that this coex bulb is applied to both places indicated in the drawing.
   e. Though the vertical webs are a little skewed btwn cavities 1-3, the foam inserts fit, and these are comparable to what we see now.

2. Operable casement frame (4683)
   a. Please note typical fin tolerances are +/- 0.050
   b. Ok
   c. I will make note of this area to be no less than 0.840 which is still working in your punch
   d. Matthew explained about the situation, the flex posts are being modified to accommodate the fin.
   e. We will continue to monitor with the foam gauges we made last time we ran into issues.

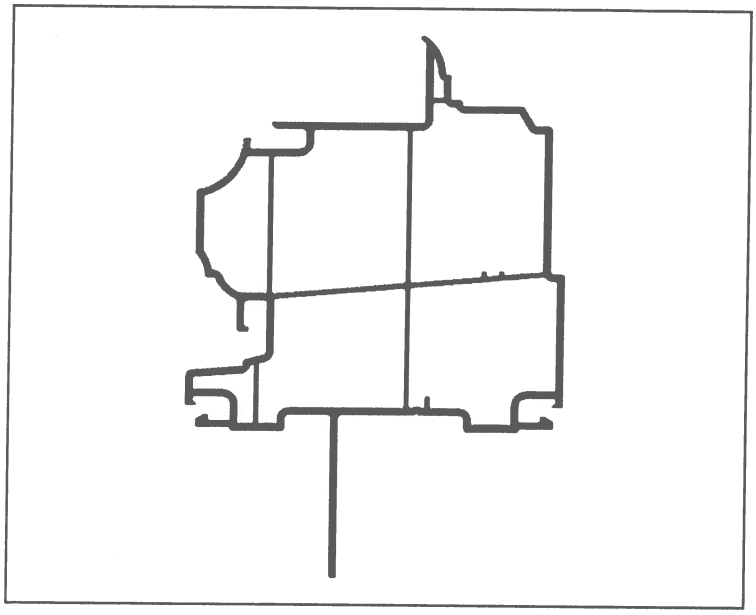
Comments: Comments emailed on 11/15/21, with response on 11/23/21. Though the sample did not have capstock, we are presuming this profile can be capstocked as shown on the prints.

1. PWCMT (4685):
   a. Fin is correct length and properly located off the front face of the profile.
   b. The height of the profile (without fin) was -.025" under nominal, and the overall height with fin was -.040" under nominal.
   c. The horizontal wall of the glazing pocket is pitched back towards the glazing tower by a degree.

d. I realize that internal webs & cavities are always difficult. With that said I wanted to comment on what I found. I numbered the five primary cavities, and cavity #1 was undersized, as well as one dimension from cavity #4. With that said, the foam inserts did fit in all cavities. This is simply something to keep an eye on.
e. I noticed that the web btwn cavity 1 & 5 has a defect. The vertical web fractured from the corner to the weep slot when punched. However, even on the unpunched piece I was noticed this web was already cracked. So I think there is an existing hairline fracture from the extruding process.

1. Fixed Casement Frame (PWCMT) 4685
   a. Please note typical fin tolerances are +/- 0.050
   b. The tool was cut using the same program as the older tool, we noticed on the older no fin tool it was also short -0.020. We will try to improve this area and should also increase as we run & tool wears in.
   c. We will look into this during production but at a +/- 1 degree it is currently acceptable
   d. We will maintain internal webs as straight as possible, Can you provide us the foam dimensions so we can cut gauges to check these cavities during production.
   e. We can take a closer look and have them polish this area before anodizing which should correct this issue.

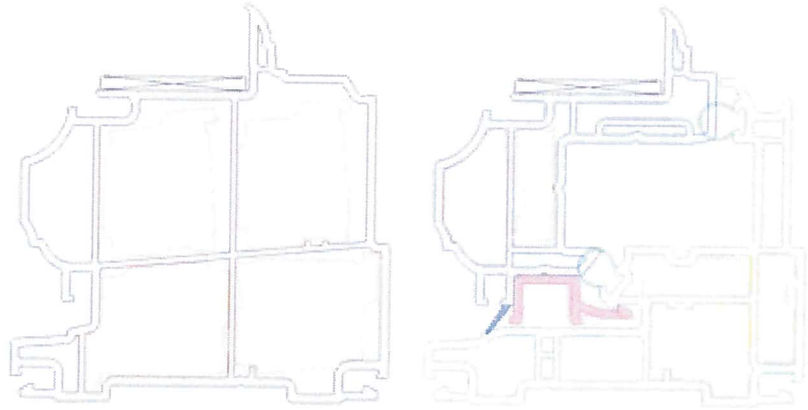
Good morning. Thank you for your response. Attached is the AutoCAD file for our foam inserts used in the csmt platform, and the screenshot below shows where they go.
