## Assessment Report

11696 Accord Cv, Arlington, TN 38002  
**112**

03/06/2024 10:41

<b>Project Name:</b>	11696 Accord Cv, Arlington, TN 38002	
<b>Client:</b>	112	
<b>Address:</b>	11696 Accord Cv, Arlington, TN 38002	
<b>Date Created:</b>	03/06/2024	
<b>Main SQFT:</b>	1814	
<b>Bed/Bath:</b>	4 bd. 2 ba.	
<b>Year Built:</b>	2003	
<b>Budget Total:</b>		<b>\$ 6226.10</b>

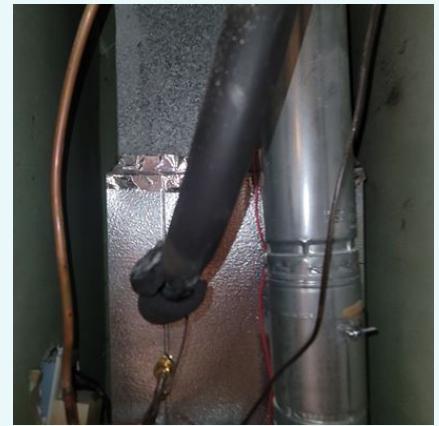
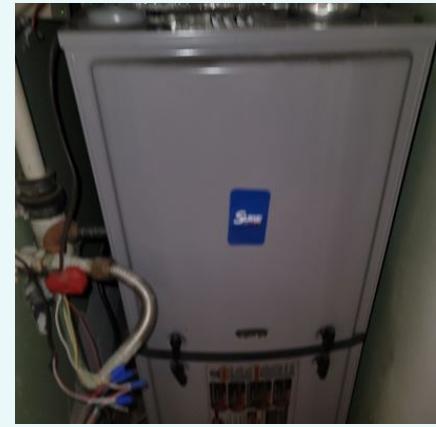
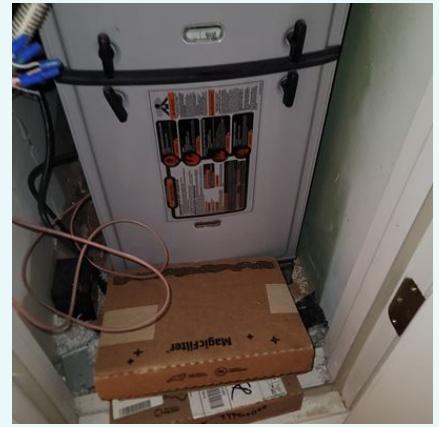
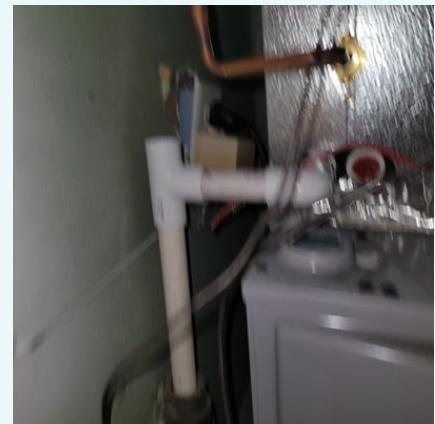
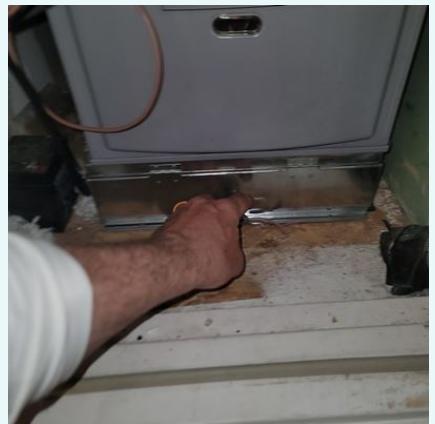
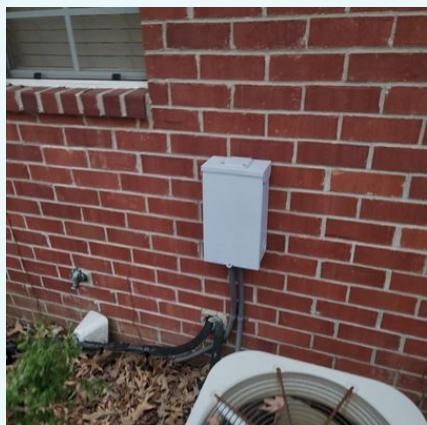
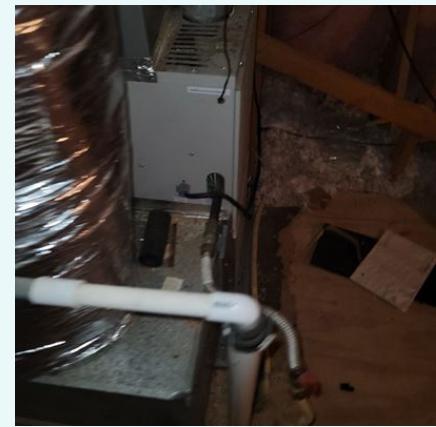
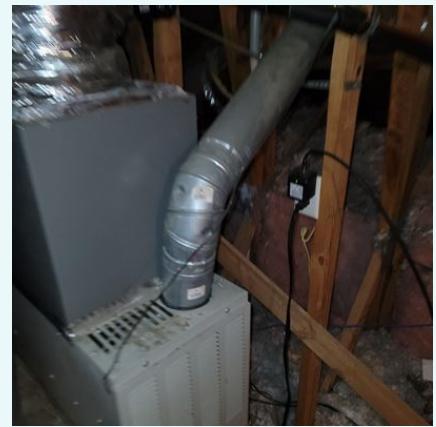
Mechanical - HVAC  
03/05/2024 17:09

Main Systems	Rating	Comment	Quantity	Unit Price	Total Price
<b>Roofing:</b>	Good Condition	Notes: new condition. less than 2 years Type: Architectural			
<b>Mechanical - HVAC:</b>	Good Condition	Notes: at unit in attic. flex gas pipe needs to be supported by blocking and tightened up. odor of gas in attic. cutting off at meter until repairs complete only see 1 thermo Stat. not sure. get ac guy to check. Type: Split - G (2.5 Ton split)	1	\$0	
<b>Mechanical - Water Heater:</b>	Good Condition	Notes: 1-4-2018 model. on and hot. Type: G - 50 Gal	1	\$0	\$0.00
<b>Foundation   Slab on Grade:</b>	Repairs Needed	Notes: Concrete subsiding/upheaval on front walk. Re-level with foam injection method.	1	\$450	\$450.00
<b>Electrical Panel:</b>	Good Condition	Notes: no breakers tripped. ac kicked on.	1	\$0	\$0.00
<b>Septic   Well:</b>	No	Notes: city sewer

Elara Standard Items	Rating	Comment	Quantity	Unit Price	Total Price
<b>Standard RR Package:</b>	Yes	Notes: needs package Description: Includes smoke/CO detector batteries	1	\$175	\$175.00
<b>HVAC- Basic Service- Inspect/Clean/Filters:</b>	Service	Notes: add two 50.00 charges for fan trip switches. Description: Visual Inspection & Cleaning inclusive of Coil Cleaning	2	\$150	\$300.00

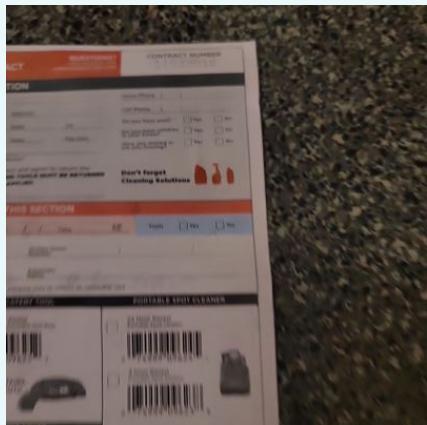
Cleaning- Flooring - Entire House  
03/05/2024 17:17

<b>Cleaning - Post Renovation:</b>		Description: Interior Cleaning	1800	\$0.18	\$324.00
<b>Cleaning- Flooring - Entire House:</b>	Steam Clean Tile	Notes: carpet receipt is here. can not make out the writing. clean with enzyme for odors Description: Steam Clean and Spot Treat All Carpet Throughout the Home - per Room.	1	\$340	\$340.00
<b>Fireplace (inspect/clean/service):</b>	Replace		0		
<b>Keyed Hardware- Exterior Door-Knobs and locks:</b>	Replace		0

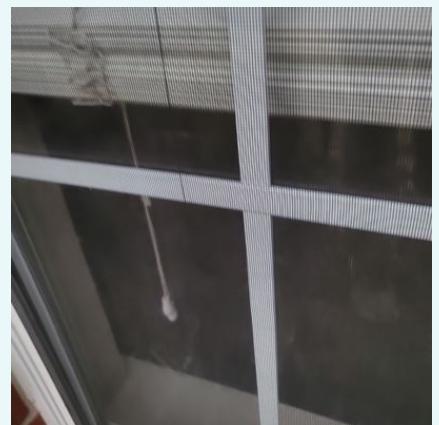
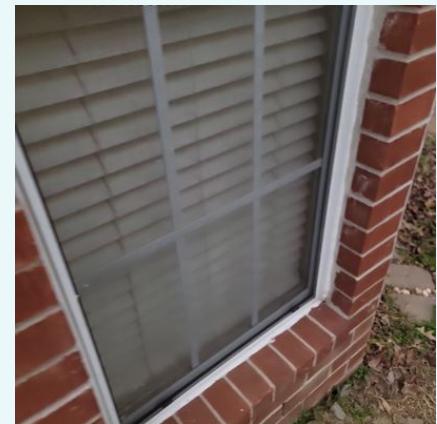
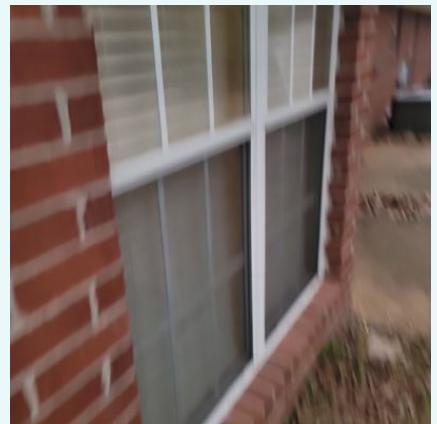
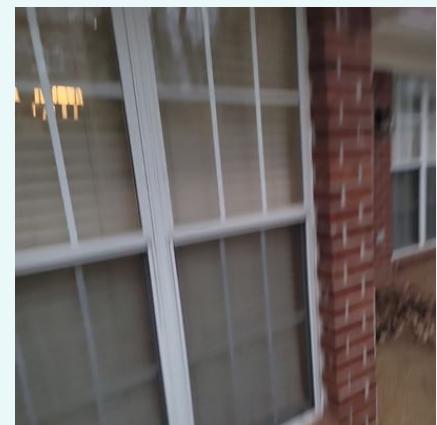
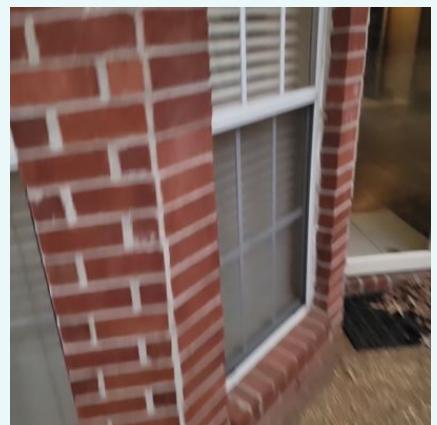
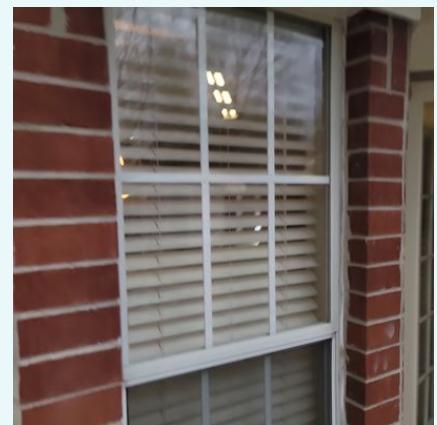
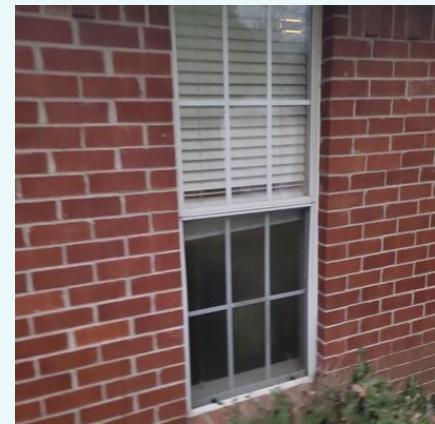
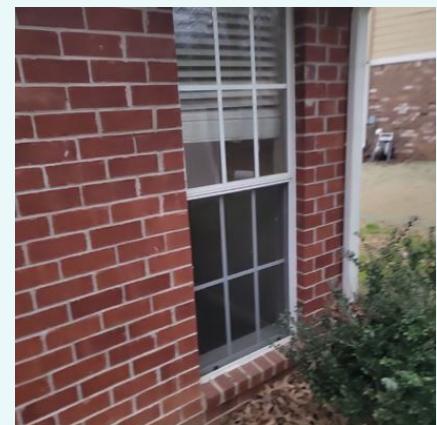
Window Maintenance Package  
03/05/2024 17:20

<b>Windows   Whole House:</b>	Replace	Notes: broken lower ig unit front left of door. bedroom 1. order-usually takes 7 business days to receive then install it	1	\$350	\$350.00
<b>Storage Shed   Outbuilding:</b>	Good Condition	Notes: good shape lock keys at rear door hanging on wall	1	\$0	\$0.00
<b>Exterior- Siding Repairs:</b>	Repair	Notes: remove and replace rotten garage main door jamb leg. 2x8x8. treated and paint.	1	\$150	\$150.00
<b>Plumbing- Exterior Repairs:</b>	Repair	Notes: install drain clean out. reattach dryer vent guard : 3 in PVC Dwv Mipt Cleanout Plug	1	\$13.69	\$13.69

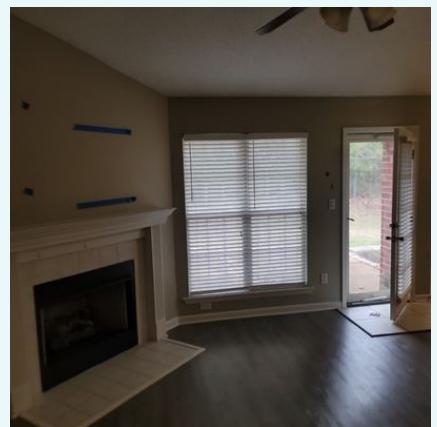
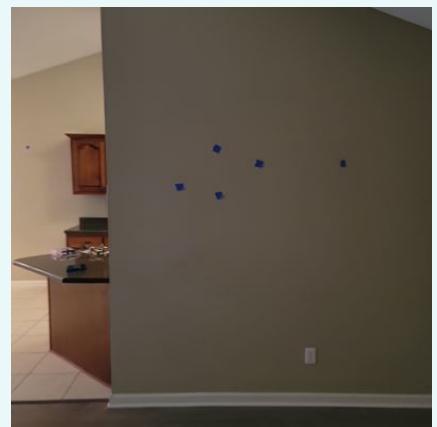
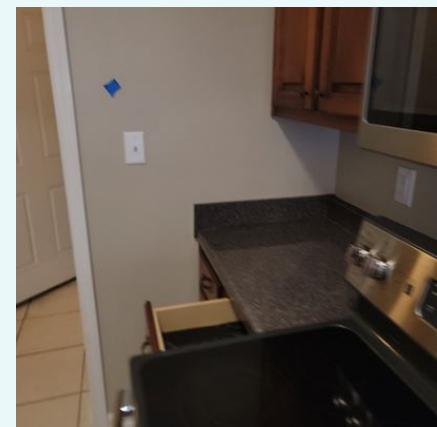
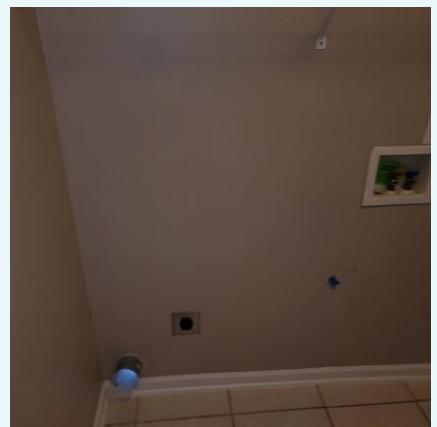
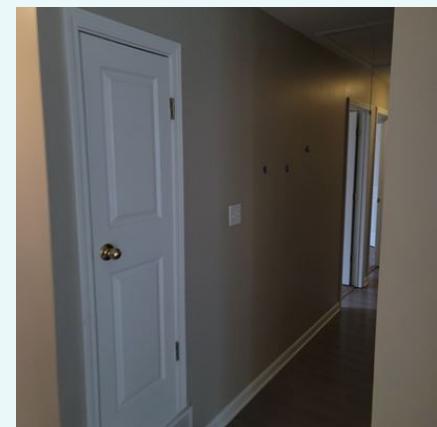
Interior Wall Paint | Whole Home  
03/06/2024 10:19

shell finish. paint touchups in different colors and sheen			
<b>Interior Wall Paint   Whole Home:</b>	Repaint	Notes: repaint house walls. slight trim touch ups included. not much on trim.	1900	\$1.25	\$2375.00

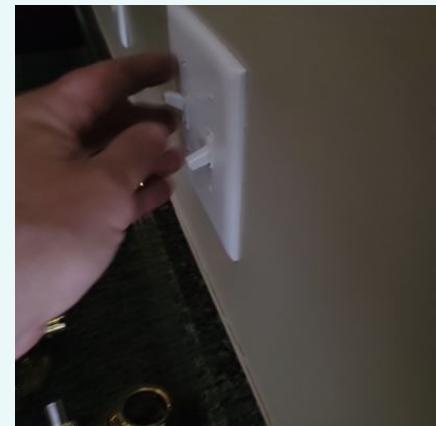
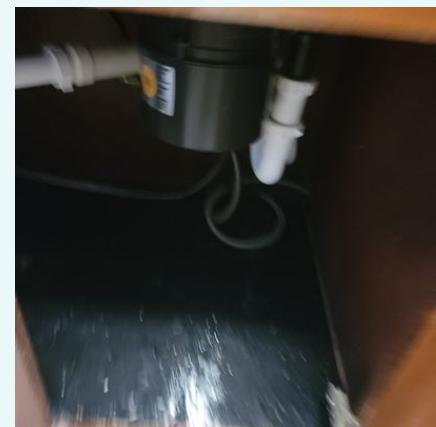
<b>Electrical Fixture:</b>	Replace	Notes - To include finish type: florescent-needs led to replace. more cost efficient-won't have to replace 4 foot bulbs light works sporadically two switches not wired correctly or missing a 3 way switch. needs to replace or check a switch. does not switch from both sides of kitchen. bid fir new light. new switch,electrician check and test to function. Type: Flush Mount	1	\$225.00	\$225.00
<b>Garbage Disposal:</b>	Good	Notes: good. little noisy	1	\$0	\$0.00
<b>Range   Oven:</b>	Good	Notes: good unit. little rust on oven drawer	1	\$0	\$0.00
<b>Refrigerator:</b>	Good	Notes: na- very cold,clean unit	1	\$0	\$0.00
<b>Dishwasher:</b>	Good	Notes: na	1	\$0	\$0.00
<b>Microwave:</b>	Good	Comments: good,Notes: good shspe- dirty	1	\$na

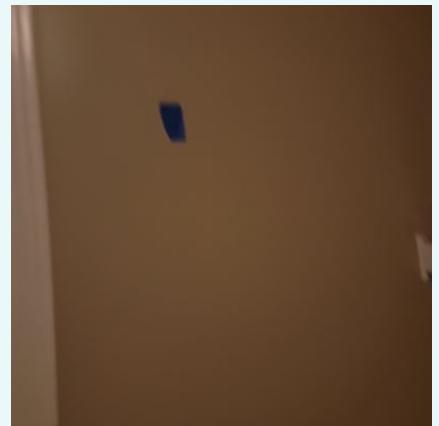
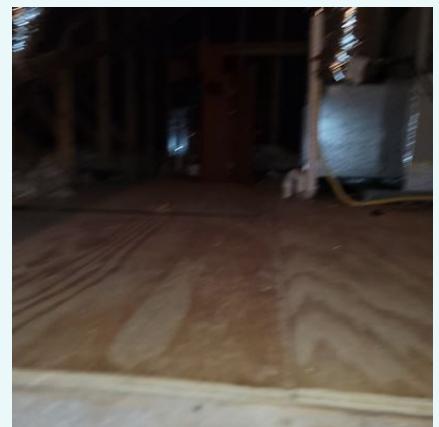
Drywall  
03/05/2024 18:03

Laundry Room	Rating	Comment	Quantity	Unit Price	Total Price
<b>Room Dimensions:</b>		General Dimensions: 6x7			
<b>Interior Paint (Room):</b>	Repaint		0		
<b>Drywall:</b>	Repair	Notes: paycheck work for repaint	3	\$25	\$75.00
