Bearing temperature drift on the HX-400 pump series

Technical Note TN-2026-014 · Halvorsen Fluid Systems, Reliability Engineering

Document	TN-2026-014, revision A
Issued	12 March 2026
Author	Ingrid Moe, Reliability Engineering
Applies to	HX-400, HX-420 and HX-460 centrifugal pumps
Status	Released for field service

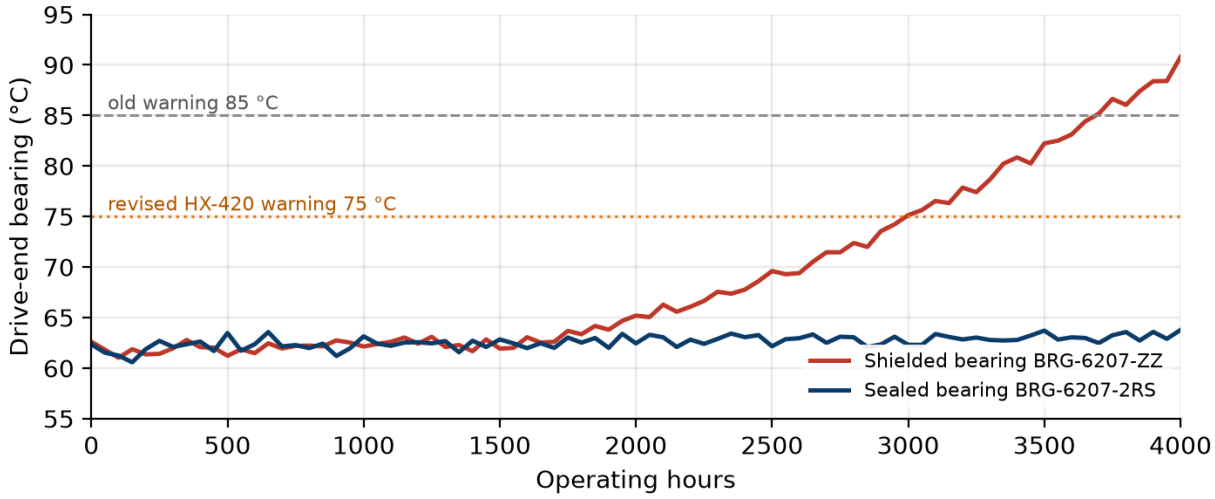
Figure 1: Drive-end bearing temperature of two HX-420 pumps on the same site, one with the shielded bearing BRG-6207-ZZ and one with the sealed bearing BRG-6207-2RS, over the first 4,000 operating hours.

Figure 1 shows the pattern seen across the affected sites. Both pumps start at the same temperature. After about 1,500 hours the pump with the shielded bearing begins to drift upwards and crosses the old warning threshold shortly after 3,000 hours, while the pump with the sealed bearing stays within two degrees of its starting value.

Teardown of six failed bearings showed dry, darkened grease and polished raceways, the typical signature of lubricant starvation rather than overload or misalignment. The shielded bearing has a small gap between the shield and the inner ring. At high operating temperature the base oil of the grease migrates out through that gap, and the remaining thickener no longer lubricates the rolling elements. Friction then rises, which raises the temperature further and speeds up the loss of oil. The sealed bearing has a contact seal instead of a gap and keeps its grease charge for the full service interval.

The sealed bearing BRG-6207-2RS is now the standard drive-end bearing for the whole series. It has been fitted in production from serial number HX4-26-0410 onwards. Pumps below that serial number keep the shielded bearing BRG-6207-ZZ until their next bearing change, at which point the sealed bearing must be fitted instead. The two parts are dimensionally identical and no other component changes, so the replacement can be done during a routine service visit.
