Bearing temperature drift on the HX-400 pump series

Technical Note TN-2026-014 · Halvorsen Fluid Systems, Reliability Engineering

Document	TN-2026-014, revision A
Issued	12 March 2026
Author	Ingrid Moe, Reliability Engineering
Applies to	HX-400, HX-420 and HX-460 centrifugal pumps
Status	Released for field service

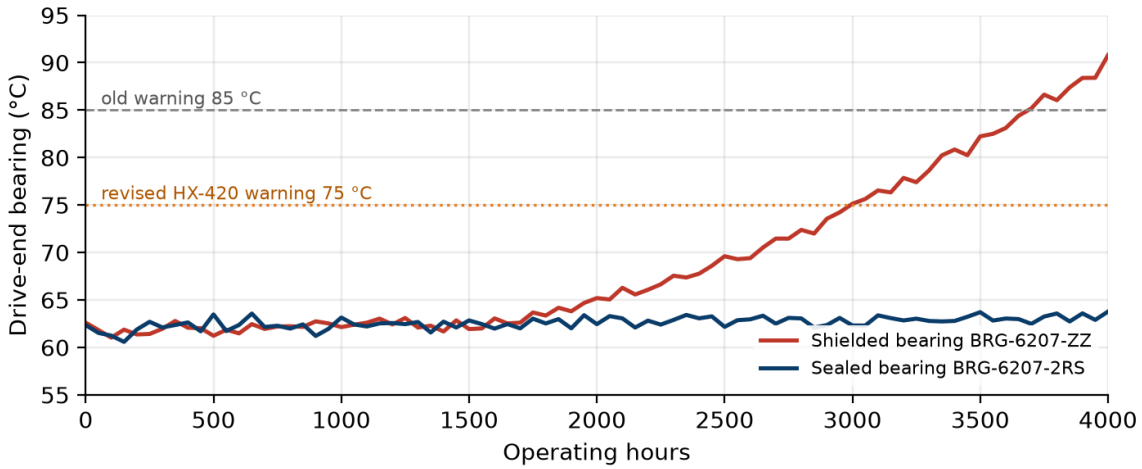
Figure 1: Drive-end bearing temperature of two HX-420 pumps on the same site, one with the shielded bearing BRG-6207-ZZ and one with the sealed bearing BRG-6207-2RS, over the first 4,000 operating hours.

Figure 1 shows the pattern seen across the affected sites. Both pumps start at the same temperature. After about 1,500 hours the pump with the shielded bearing begins to drift upwards and crosses the old warning threshold shortly after 3,000 hours, while the pump with the sealed bearing stays within two degrees of its starting value.

Teardown of six failed bearings showed dry, darkened grease and polished raceways, the typical signature of lubricant starvation rather than overload or misalignment. The

shielded bearing has a small gap between the shield and the inner ring. At high operating temperature the base oil of the grease migrates out through that gap, and the remaining thickener no longer lubricates the rolling elements. Friction then rises, which raises the temperature further and speeds up the loss of oil. The sealed bearing has a contact seal instead of a gap and keeps its grease charge for the full service interval.

The sealed bearing BRG-6207-2RS is now the standard drive-end bearing for the whole series. It has been fitted in production from serial number HX4-26-0410 onwards. Pumps below that serial number keep the shielded bearing BRG-6207-ZZ until their next bearing change, at which point the sealed bearing must be fitted instead. The two parts are dimensionally identical and no other component changes, so the replacement can be done during a routine service visit.

Until the shielded bearing has been replaced, the drive-end bearing must be re-greased more often than the maintenance manual specifies. Once the sealed bearing is fitted, the manual's interval applies again for the HX-400 and HX-460, but the HX-420 keeps a shorter interval because of its higher running temperature.
