Car Damage Assessment Report

Image: 000320.jpg

Date: 2026-03-15 15:13

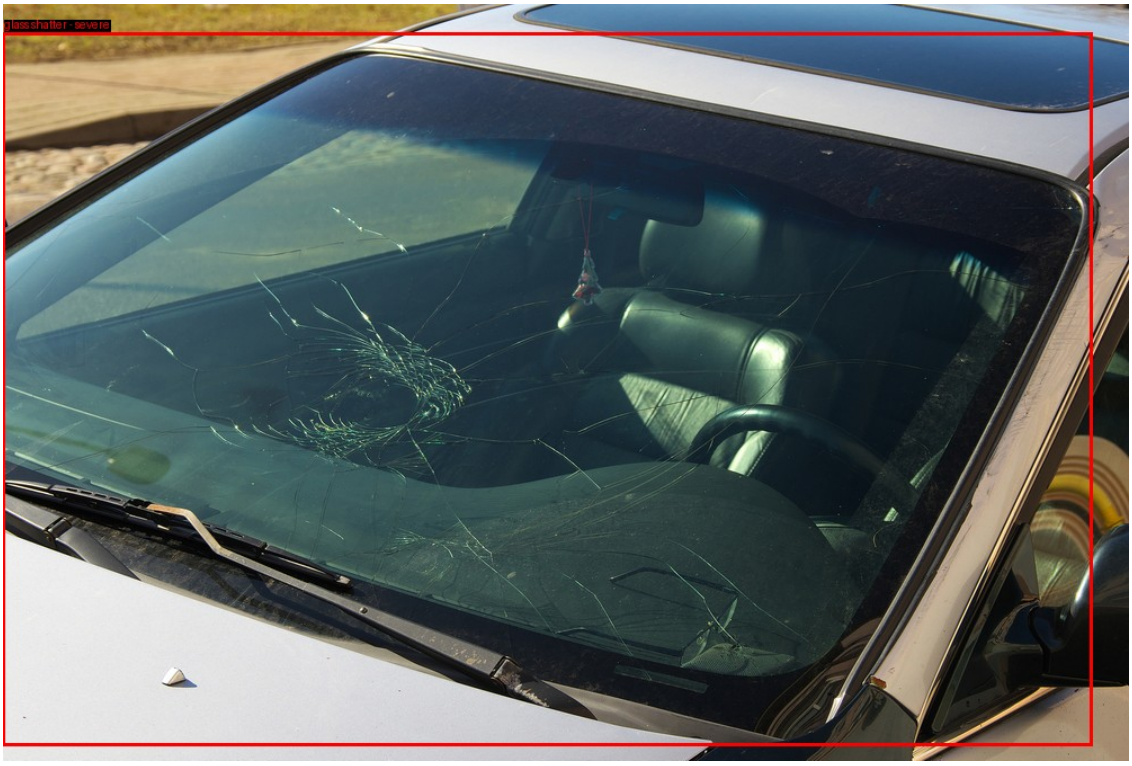
#	Type	Severity	Location	Cost Range	Repair Method
1	glass shatter	severe	windshield	$400-$1,500	Full glass replacement (OEM)

Damage #1: Glass Shatter

Type: glass shatter
Severity: severe (confidence: 70%)
Location: windshield (confidence: 83%)
Cost estimate: $400 - $1,500
Repair method: Full glass replacement (OEM)
