Name	043jld2a.zip	Id.	22845 - QED OK
Report Generated on	Oct 4, 2025, 7:56:51 PM	Customer	InstantDFM

Summary - General - Original

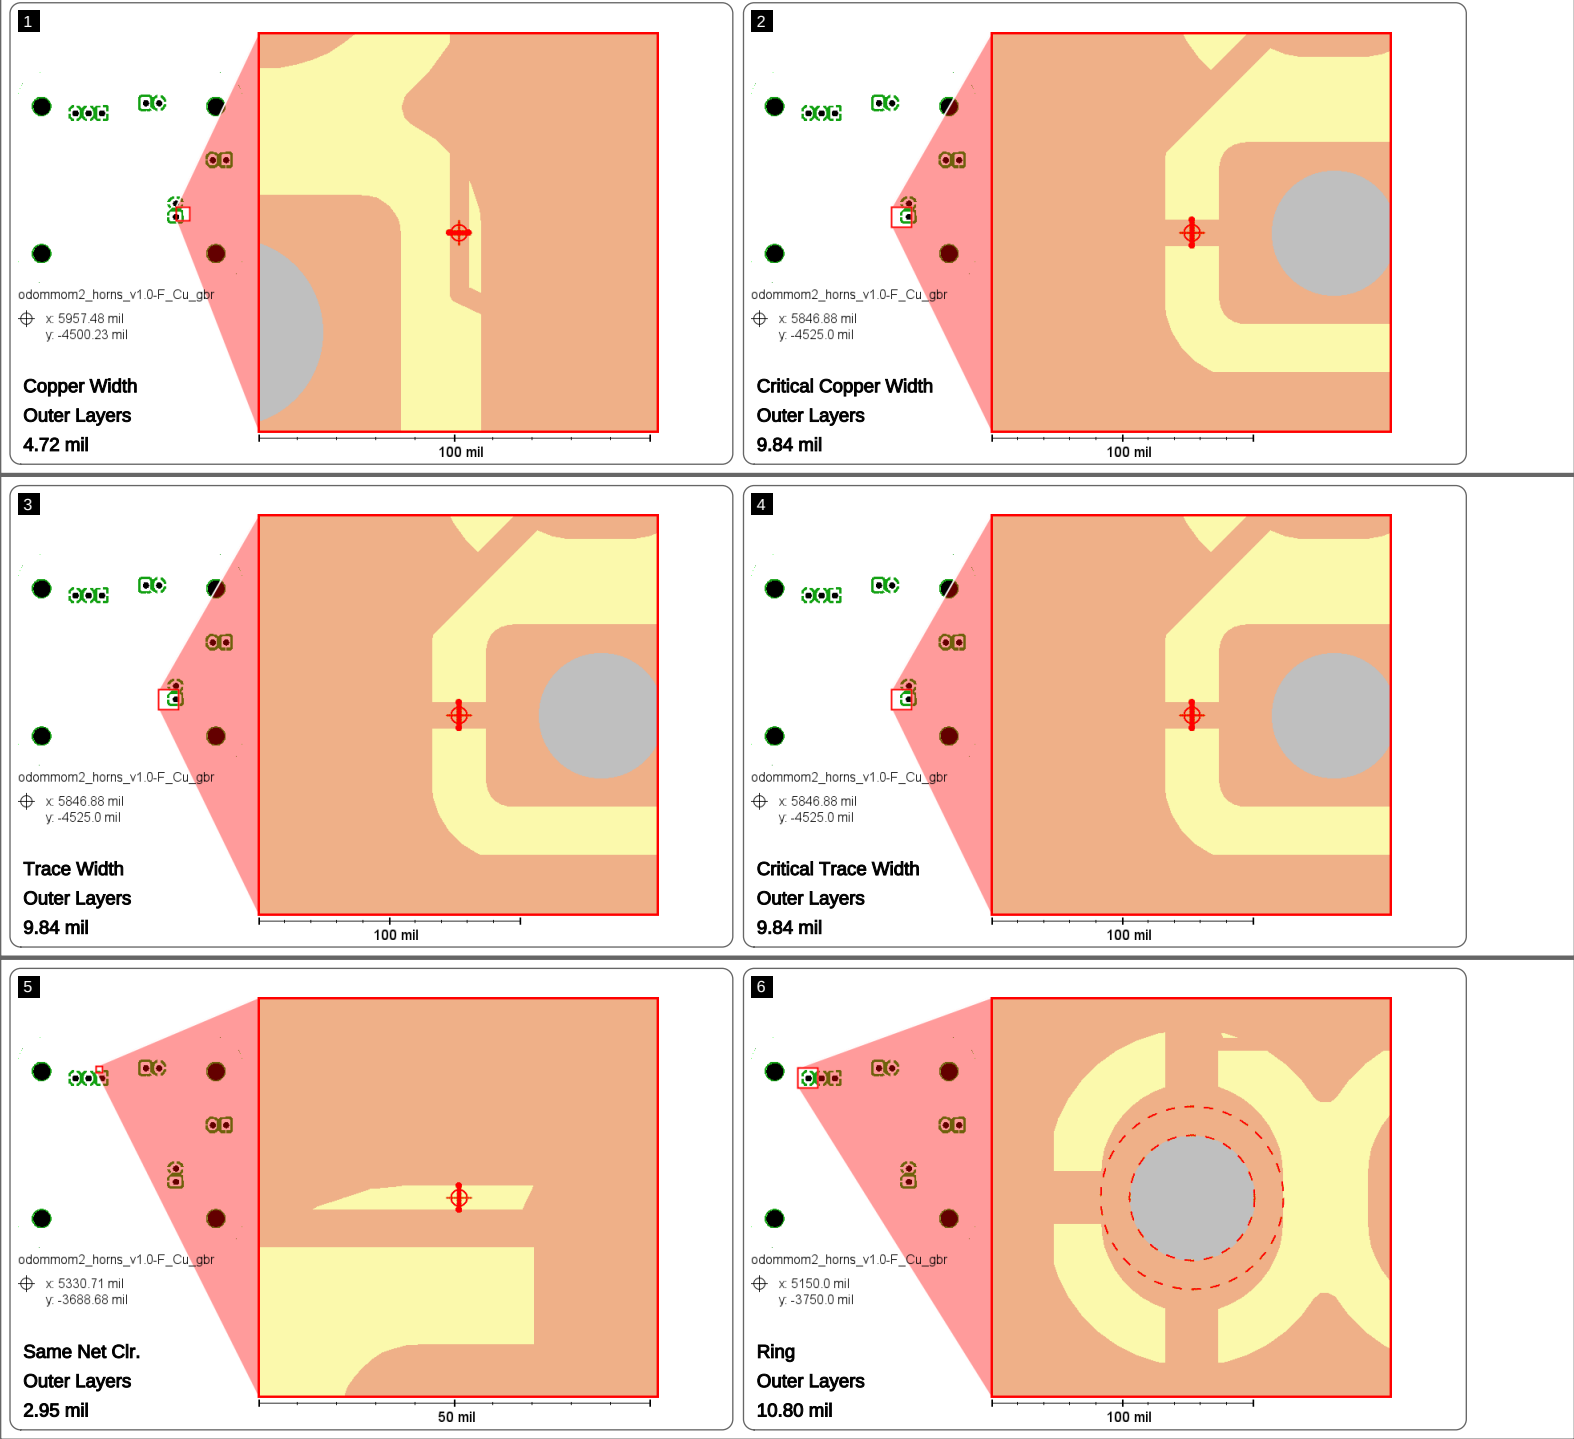
Summary Minimum Design Characteristics - Locations - Original

Type	Copper Width	Critical Copper Width	Trace Width	Critical Trace Width	Copper to Copper Clr.	Trace to Trace Clr.	Same Net Clr.	Ring	Copper to Plated Clr.	Copper to NPTH Clr.	Copper to Outline Clr.
	mil	mil	mil	mil	mil	mil	mil	mil	mil	mil	mil
Outer	¹ 4.72	² 9.84	³ 9.84	⁴ 9.84	>32.00	>32.00	⁵ 2.95	⁶ 10.80	>32.00	⁷ 9.85	⁸ 0.00
