Problems feeding thin paper on the Muller Spine Creaser

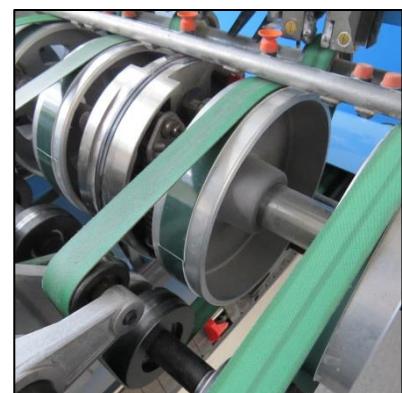
Customer have informed us of a bubbling or fish tailing effect which can occur while creasing approximately the last 75mm of the cover on the Muller gather, stitch and trim cover feeder machines.

Loosen the drum tape tensioning arm

Position the special tape on to the cleaned drum making sure it is placed directly under the belt.

Cut the tape so there is no overlap and then retention the belt.
