Electrical Work Request Form

Request Number	1WRELAM575	Date required	2025-08-06
Location	Lot 3 B1		
Requestor	Ben Maher	Assigned Worker	Adam Murray
Description Of Task Requested			
Relocate sumo, LG 83, ELV panel and ELV lights

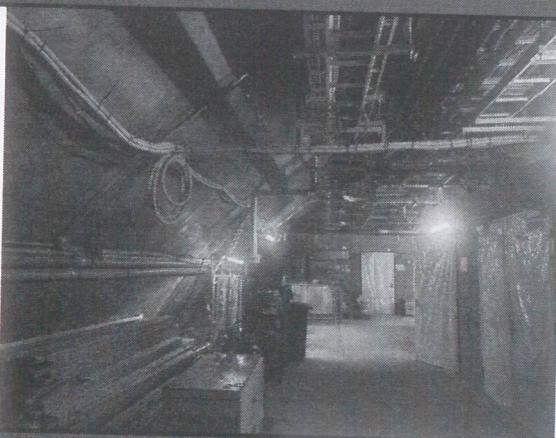
Request Number	1WRELAM596	Date required	2025-08-12
Location	Lot 2 south		
Requestor	Ben Maher	Assigned Worker	Trent Minton
Description Of Task Requested			
relocate RIS south DB into lot 2 B8 south hammer head

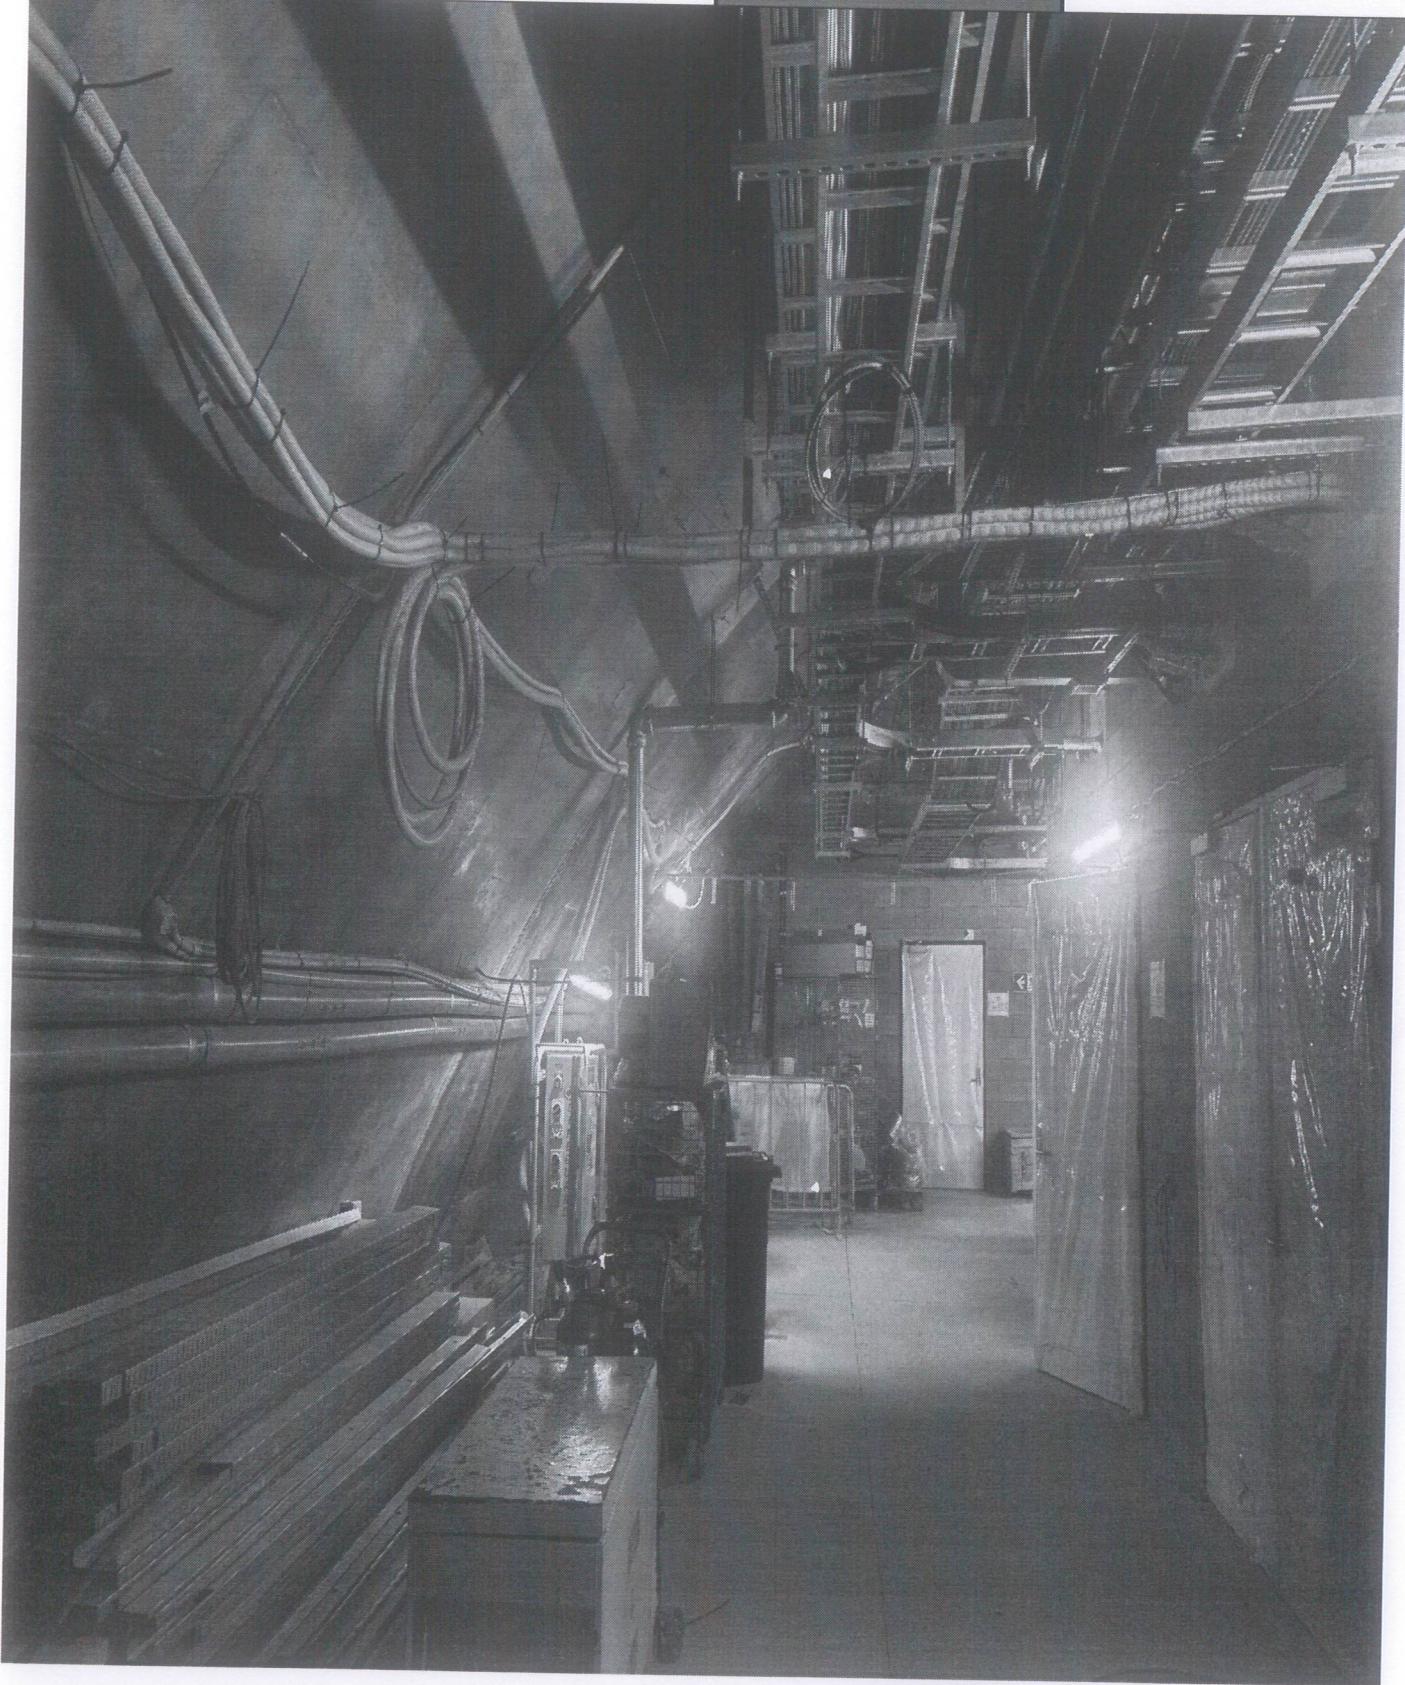
Request Number	1WRELAM580	Date required	2025-08-14
Location	Lot 2 B4 North		
Requestor	Ben Maher	Assigned Worker	Brendan Johnson
Description Of Task Requested			
Re feed lot 2 b4 goods lift. Relocate isolator			
Electrical supervisors' comments			
Lower cable to below roof height. Relocate isolator to lift. Remove all redundant cabling			
Electrical Design Required?	No	COC Required?	Yes
		Test Document Number	TS 846
Design Comments (consider cable sizing, circuit loading, Voltage drop fault, loop impedance, lighting level design, requirement to update drawings etc)			
Additional Photos

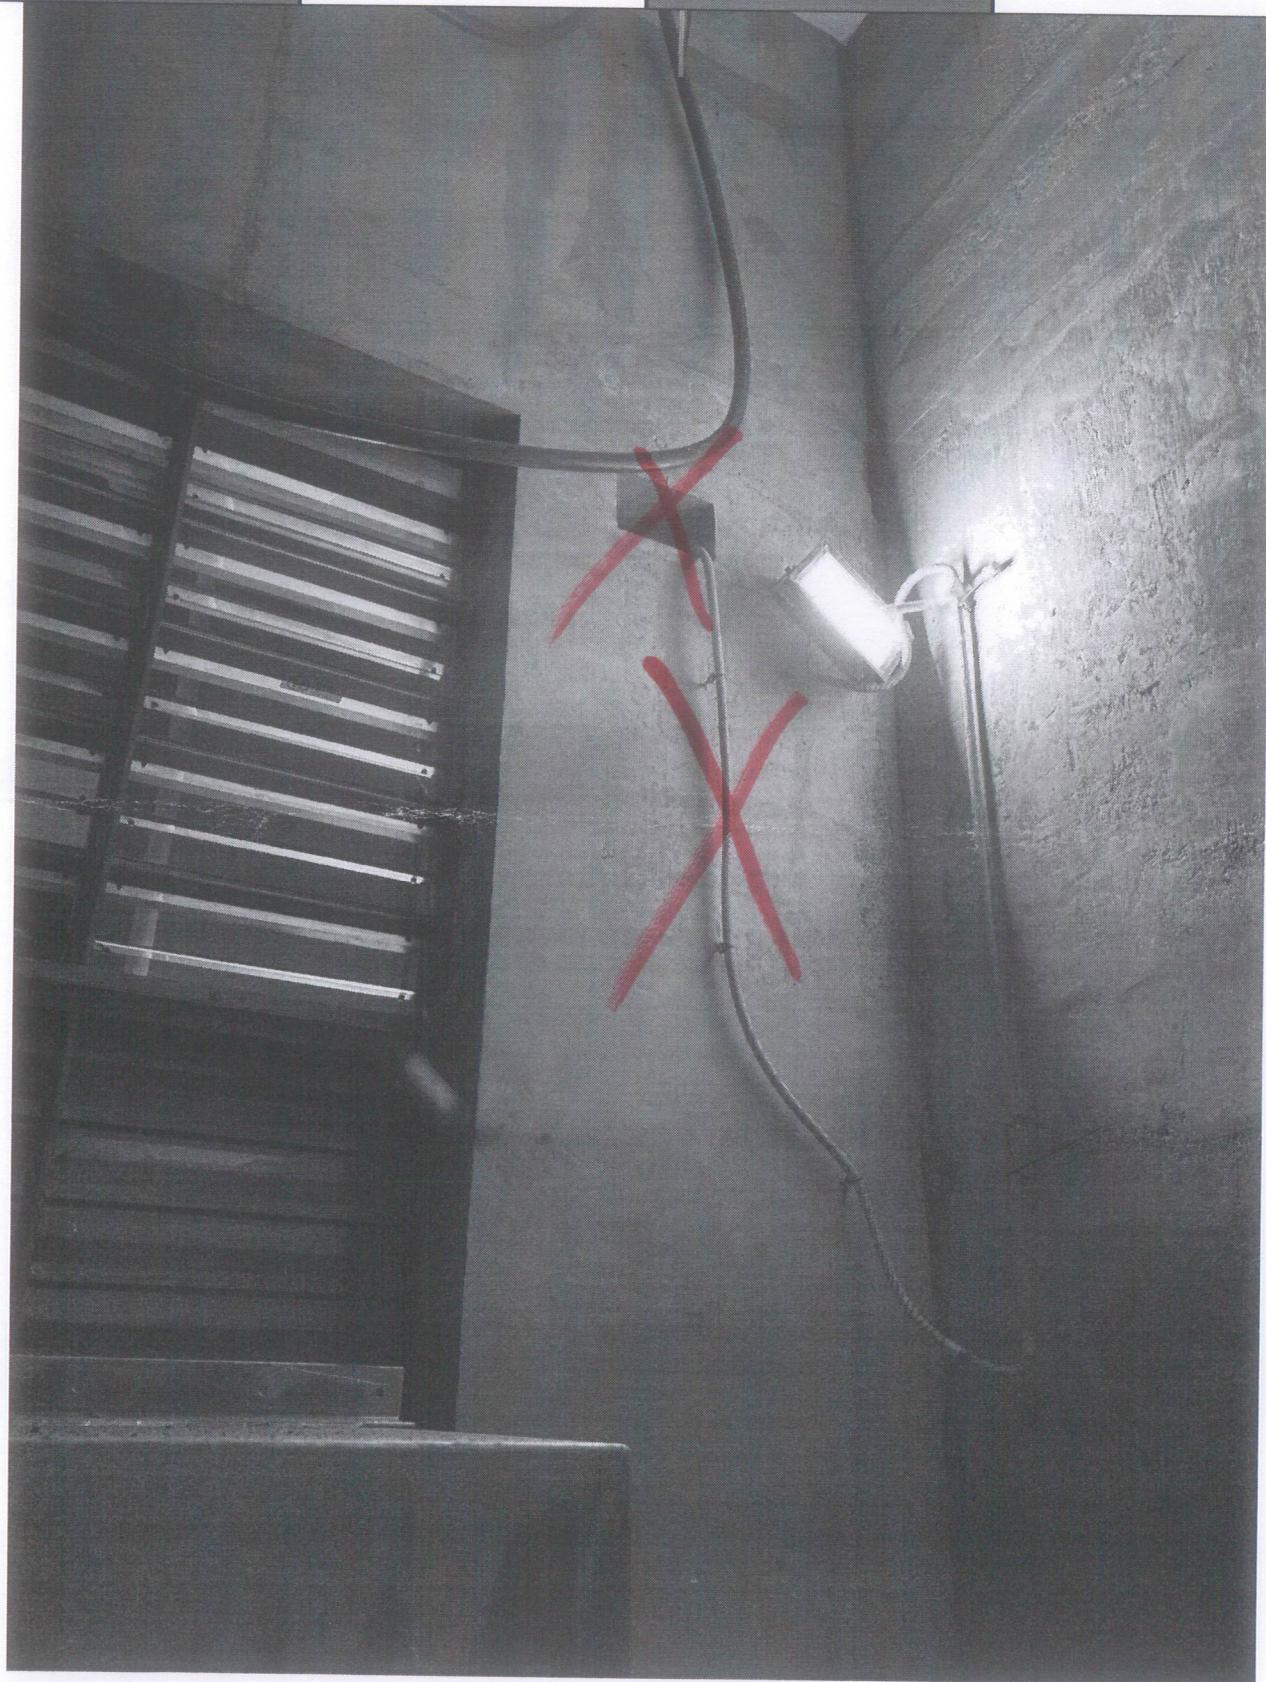
Request Number	1WRELAM552	Date required	2025-08-01
Location	Lot 1 B7		
Requestor	Ben Maher	Assigned Worker	Brendan Johnson
Description Of Task Requested			
Remove floodlight cable from pено and refeed through round pено below			
Electrical supervisors' comments			
N.A			
Electrical Design Required?	No	COC Required?	Yes
		Test Document Number	
		TS 840	
Design Comments (consider cable sizing, circuit loading, Voltage drop fault, loop impedance, lighting level design, requirement to update drawings etc)			
Additional Photos			
Electrical Worker Completed the Work	B. Johnson	Electrical Workers Signature

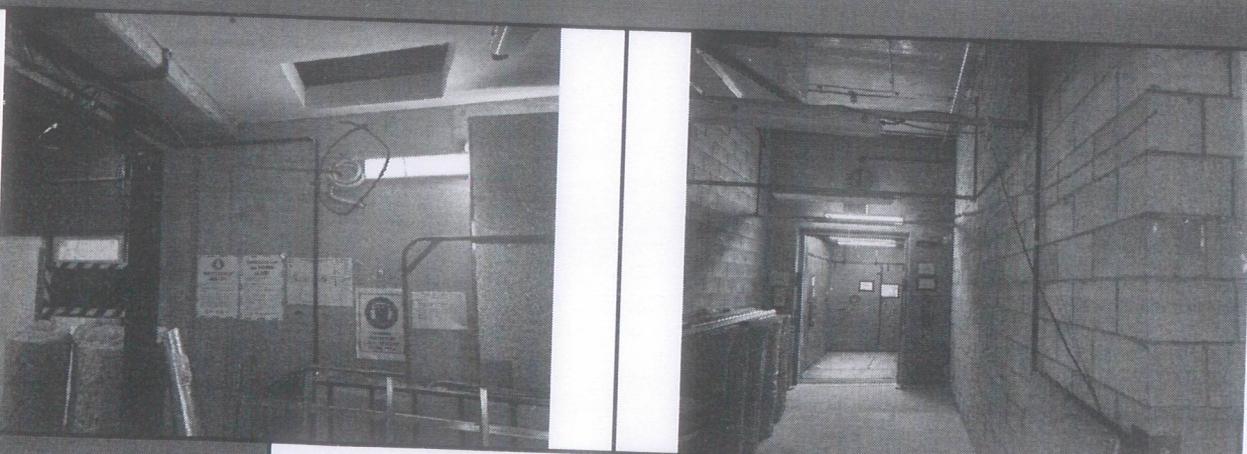
Request Number	1WRELAM550	Date required	2025-08-01
Location	Lot 2 B6 north		
Requestor	Ben maher	Assigned Worker	Brendan Johnson
Description Of Task Requested Refeed light outside lift. Light can no longer run through wall due to cladding starting

Refeed light from BOH light string and remove conduit etc going through wall
