FIELD NOTES

PROJECT: Rockwood 10

SUBJECT: Paver Band and General Site Walk

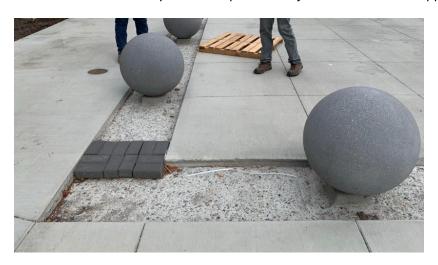
2. Plaza Paver Band

- a. Team reviewed on-site and confirmed polymeric sand set installation is acceptable (see RFI 474)
- b. Width of concrete band varies by at least 75". Subcontractor will have to take great care to evenly distribute pavers and joints for consistent appearance.

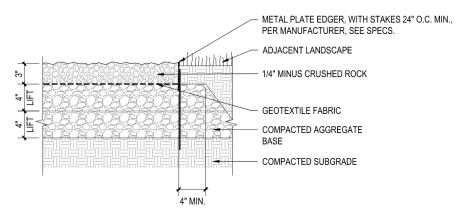
5. Gravel Paving (throughout site)

- a. Compacted Aggregate Paving detail and specification calls for 1/4" minus crushed rock. Approved sample had fines as required. Material on site does not appear to contain fines. Without fines aggregate material will not lock together as a "firm and stable" surface and therefore will not meet ADA standards as intended.
- b. Confirm material used and ensure fines will be present in final installation.
