# Uniform Residential Appraisal Report

17132 EDGEWATER LN, HUNTINGTON BEACH, CA 12345

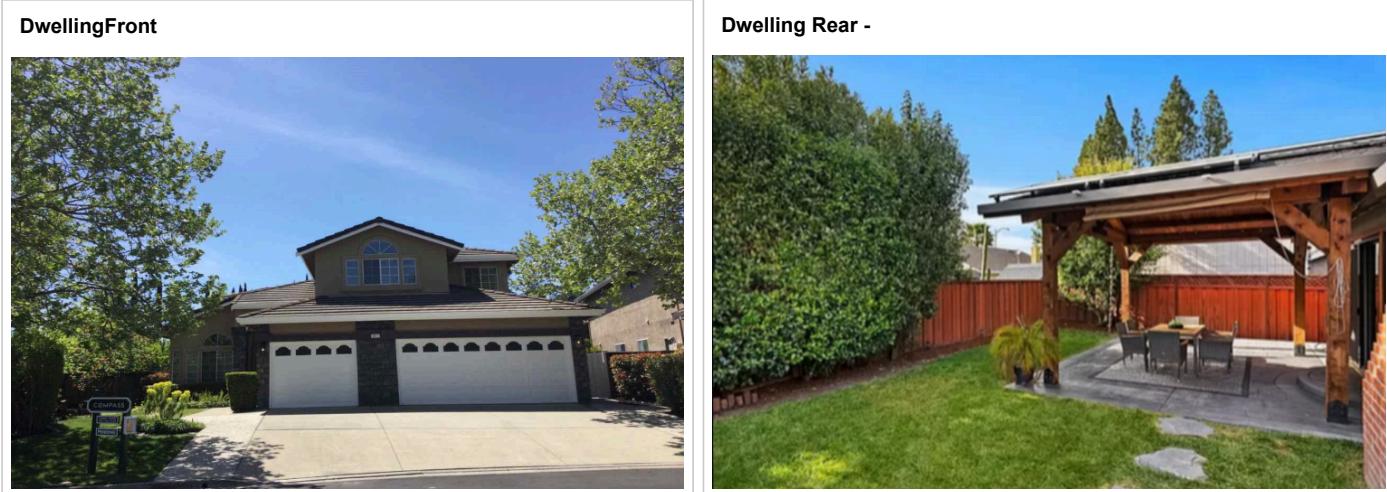
Feature	Location	Description	Affects Soundness or Structural Integrity	Recommended Action
Roof	Section of Roof	Damaged roof with missing flashing leaving the roof permeable to water intrusion.	Yes	Repair

The Sales Comparison Approach is the only approach given weight in this report. The As Is Overall Condition Rating is C5 due to the damaged roof with missing flashing; although there are no apparent active leaks this leaves the roof permeable to water intrusion. This appraisal is made subject to repairing the roof and the appraised Overall Condition rating of C4 is made on the basis of a hypothetical condition that the repair has been completed.
