QUALITY REPORT - FINAL INSPECTION QUALITY CONTROL DEPARTMENT	CODIGO/CODE	CORP-CAL-CF-001
		VERSION/VERSION	2
		FECHA / DATE	29/09/2026
		HOJA/SHEET	1

CERTIFICATE NUMBER : **752111**

CLIENT: AMERICAN GLASS PRODUCTS COMPANY **PRODUCTION ORDER:** 000011318623 **COLOR:** GREEN LIGHT

VEHICLE: CHEVROLET EXPRESS VAN **COMPOSITION:** L39-5 **THICKNESS(mm):** 42.340

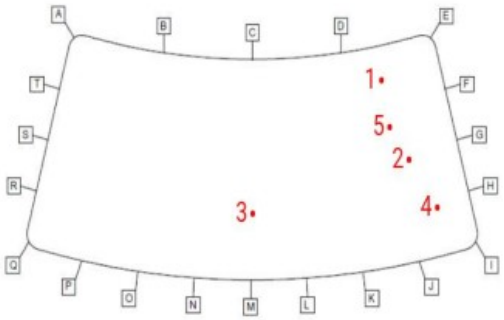
Appareance 1

ITEM	ZONE	DEFECT	SIZE
1	B	Intern Scratch	5.00
2	B	Color dot	0.80
3	B	Impurity	0.80
4	B	Not visible stain Day Light	0.00
5	B	Bearing	0.00

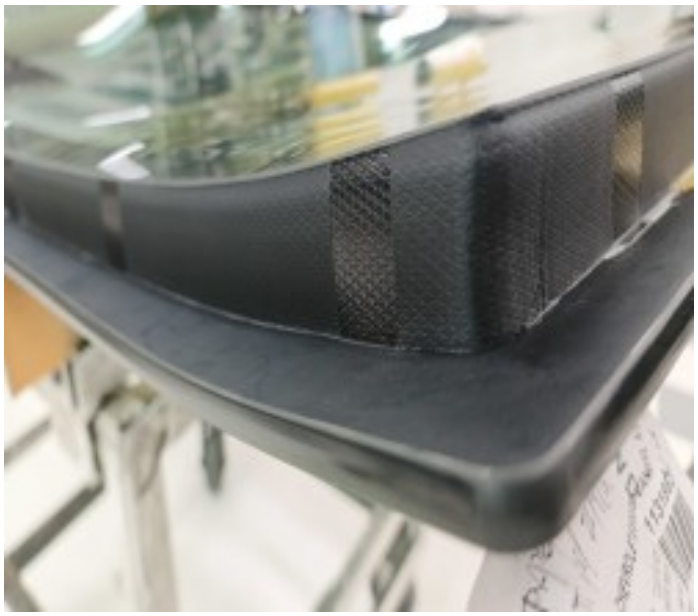
Appareance External Face

Distortion without zebra

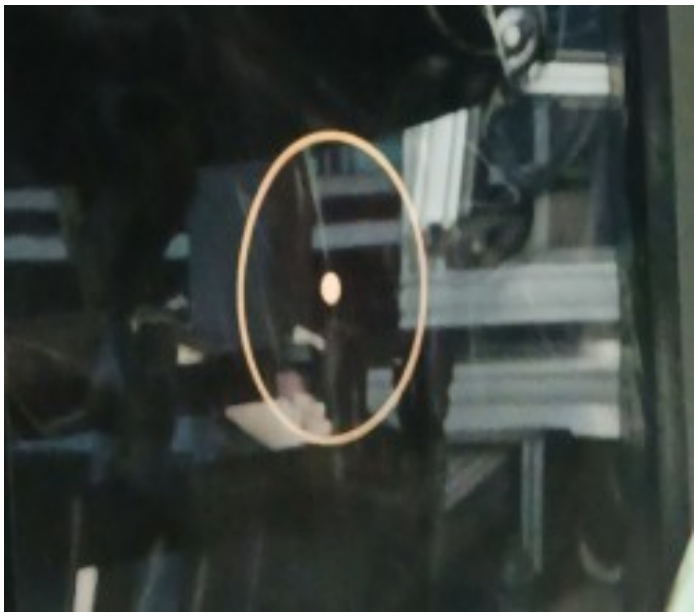
Double Image 1

Distortion with zebra at 0°

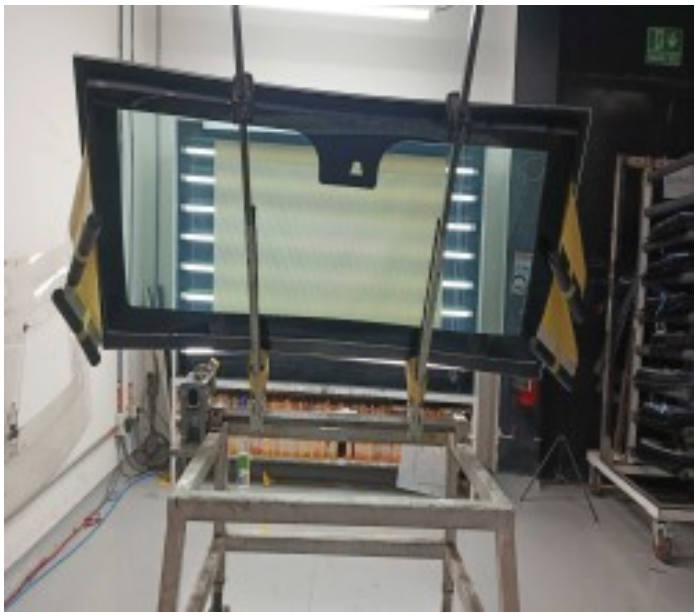
Distortion with zebra at 45°
