QUALITY REPORT - FINAL INSPECTION
QUALITY CONTROL DEPARTMENT

CODIGO/CODE	CORP-CAL-CF-001
VERSION/VERSION	2
FECHA / DATE	19/09/2026
HOJA/SHEET	1

CERTIFICATE NUMBER : **737828**

VEHICLE: LAND ROVER SENTINEL 4D UTILITY **COMPOSITION:** L60-5 **THICKNESS(mm):** 61.480

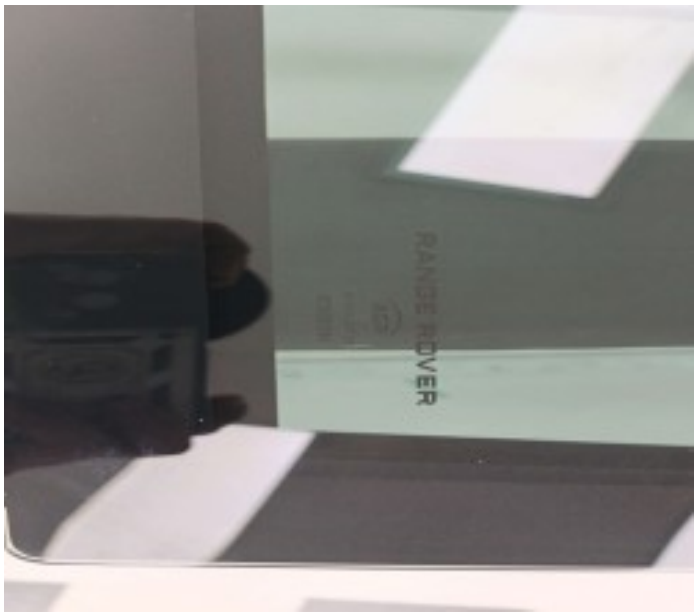
Logo - Traceability

ITEM	ZONE	DEFECT	SIZE
1	B	Fluff	10.00
